## **Mobile Trailer 1T-40.0.2 Failure February 2, 2005**

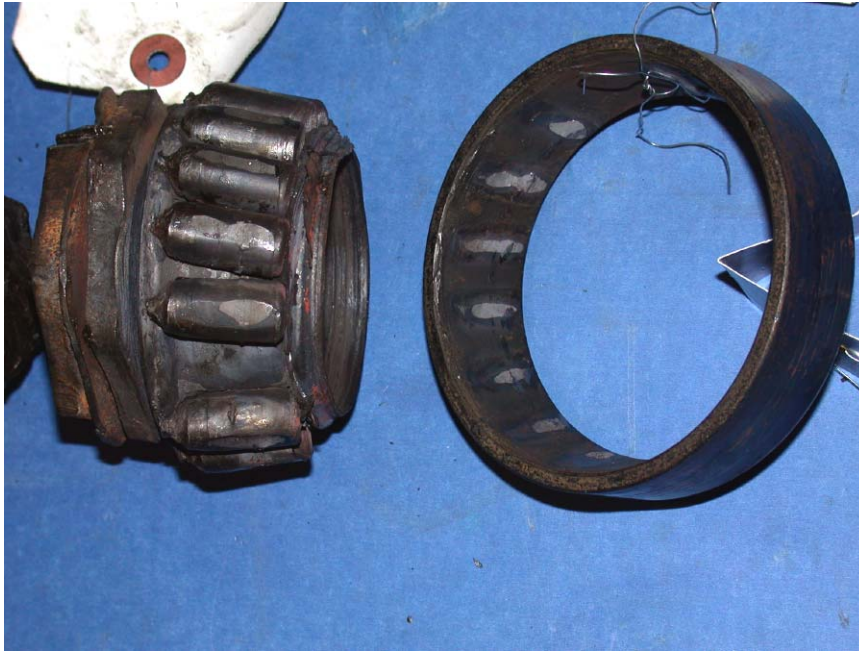
occurred revealed catastrophic and complete failure of the bearings on those wheels. Figure 1, below, illustrates the extent of damage found and is representative of the five bearings that failed on the three subject wheels. Because of the extent of damage to the failed bearings, little useful information as to the cause of failure was obtained from those bearings.

**Figure 1:** Outer bearing from spindle #10. Rollers are welded to the inner race.

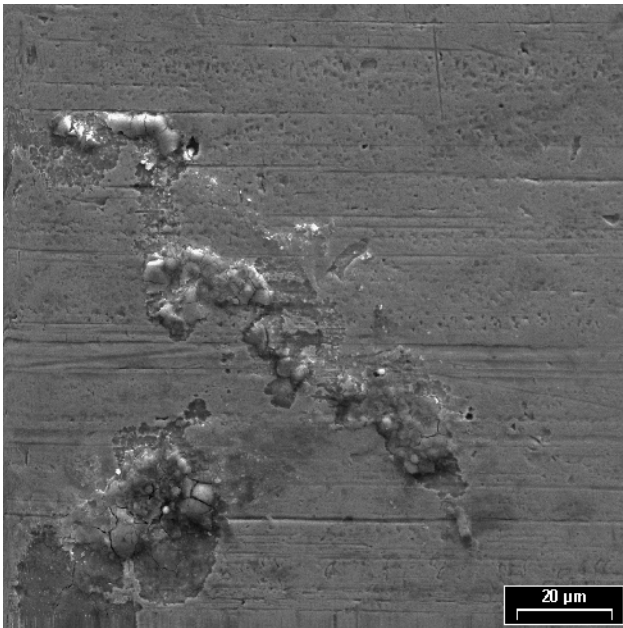
**Figure 3:** Scanning electron micrograph of electric discharge damage on roller from spindle #10 inner bearing.

The melting, pitting, and surface oxidation seen in Figure 3 is characteristic of arcing damage produced by low voltage electric discharge through the bearing. A potential difference of as little as two volts is known to cause this type of damage. Once damage to the bearing roller and race surface is initiated by electric discharge, the damage expands during operation by forming fatigue cracks in the surfaces that result in spalling of small particles from the bearing surface that expands the damage area, Figure 4. The wear debris produced by local spalling migrates to other areas of the bearing, spreading damage throughout the bearing. Once this damage mechanism has initiated, total bearing failure can occur in a very short period of time in heavily loaded bearings. It is likely that arcing damage from potential discharge across the bearings on Spindles #9, #10 and #14 also initiated the failures at those locations.

It is also recommended that there needs to be a complete grounding study of the auto transformer trailers currently in company Substation yards to verify that proper grounding of each trailer type is accomplished when the trailers are being stored and/or when they're in service. These studies should include a determination of the feasibility of applying grounding connections between the transformer, transformer pad and trailer dollies on each mobile auto-transformer unit. These requirements may also have to be stipulated in future orders for auto-transformers from company suppliers.

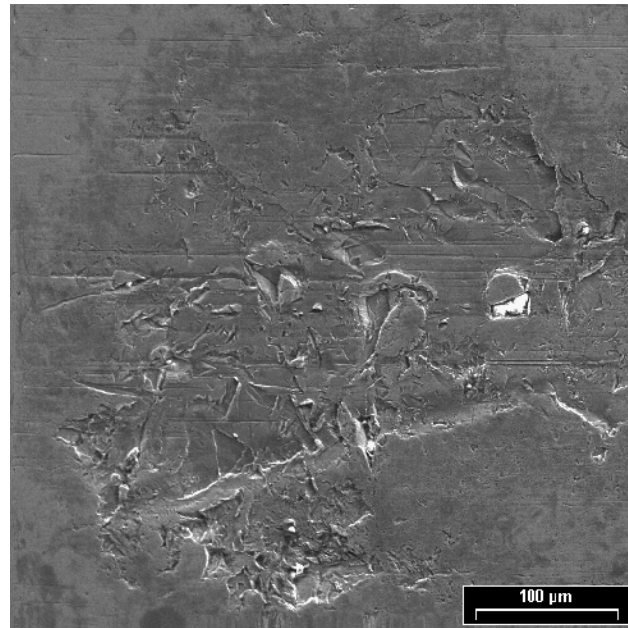
Figures 3 and 4 are scanning electron micrographs that show surface damage on a bearing with linear frosting damage that did not fail; this damage is representative of the damage found on the other aft carriage bearings examined.

**Figure 4:** Scanning electron micrograph of spalling on roller from spindle #10 inner bearing.
