NEON TRANSFORMER ELECTRIC ARCS AS VIABLE IGNITION MECHANISMS FOR WOOD STRUCTURAL MEMBERS

RESTAURANT FIRE INVOLVING NEON TRANSFORMERS

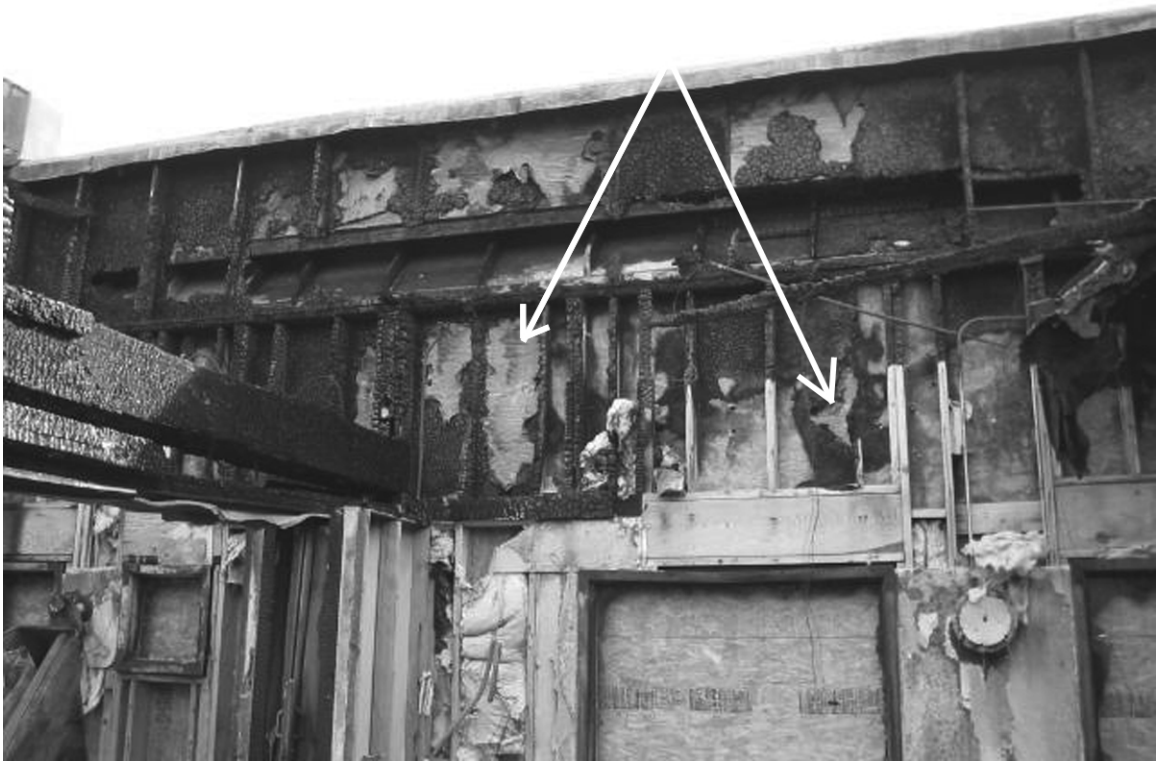
During their investigation, the fire department recovered two neon transformers from the southeast room of the restaurant. One of the neon transformers was found on the floor near the southeast corner of the room close to the east wall, while the other remained attached to the east wall just below roof level and about 20 feet from the southeast corner of the building. Their investigation led them to conclude that the area of origin of the fire was in this southeast room where they identified two V-shaped burn patterns on the east wall that represented the lowest burn areas in the building (see Figure 1).

Figure 1 - Two v-patterns in area of origin

Further investigation indicated the second larger V-pattern (see Figure 1), which was approximately 19 feet from the south corner of the east wall, was primarily caused by the asphalt which ran out of the neon transformer that had remained attached to the wall, but had tipped on its side, spilling the asphalt down the wall during the fire.

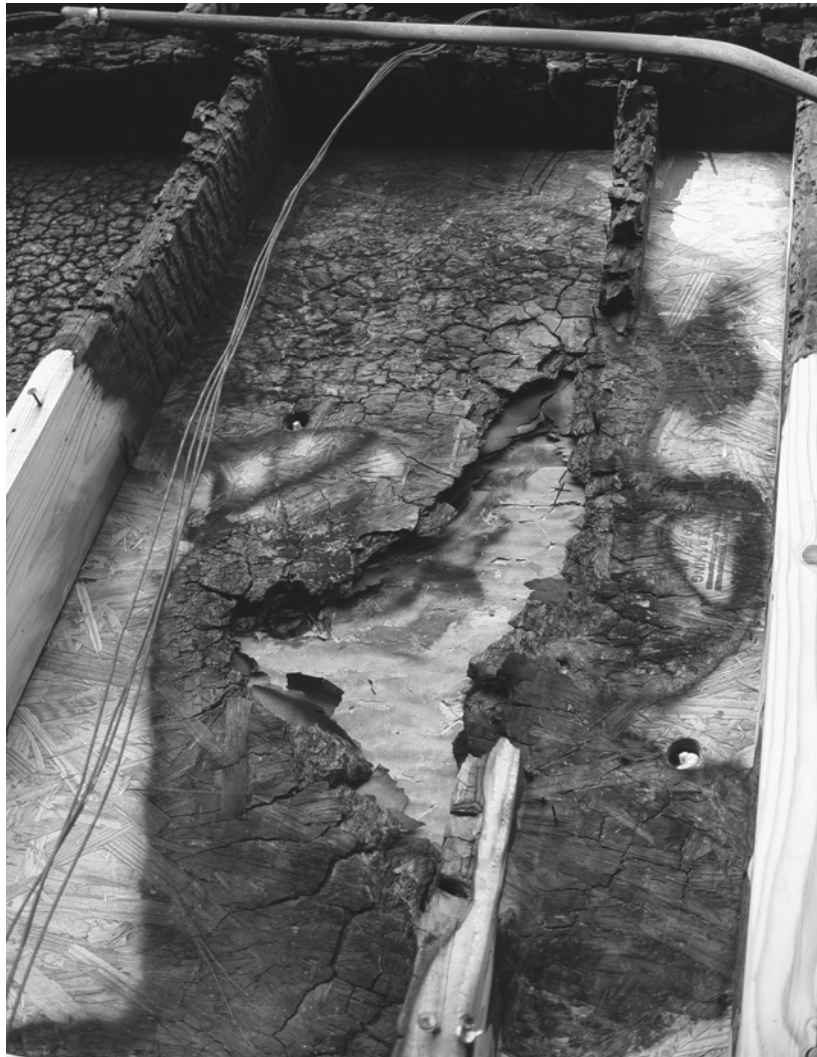
Investigation concluded that the fire patterns indicated that the point of origin of the fire was at the V-pattern which was approximately 13 feet from the southeast corner of the building, where two of the secondary output high voltage GTO wires from the neon transformers and their aluminum flexible conduits, would have been located after they were disconnected and pushed back into the wall from outside the building.

Close inspection of the V-pattern at the point of origin indicated burn-through of the OSB on the inside surface of the exterior wall and scorching of the stucco, all the way through the wall. Signs of scorching were observed on the internal and external surfaces of the stucco at this location (see Figure 2 and Figure 3). Additional photographs are available at www.wendellhull.com.

Figure 2 - Stucco scorching inside at point of origin

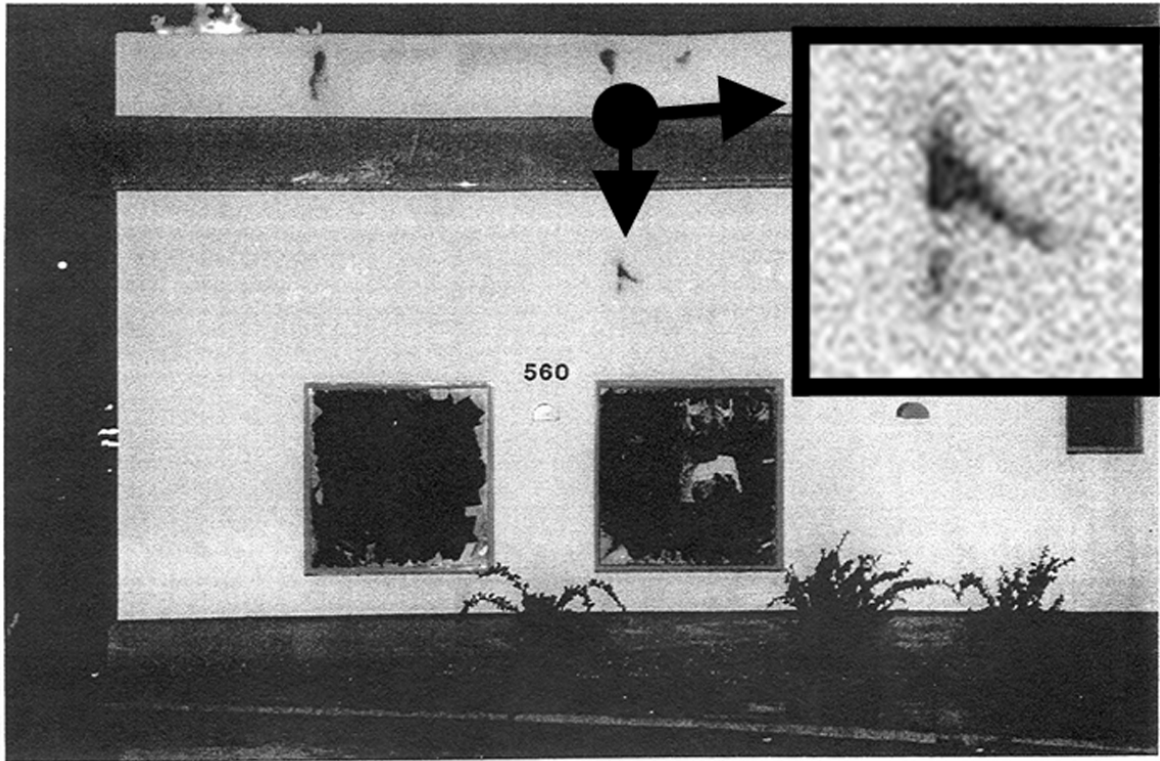
Figure 3 - Stucco scorching outside at point of origin

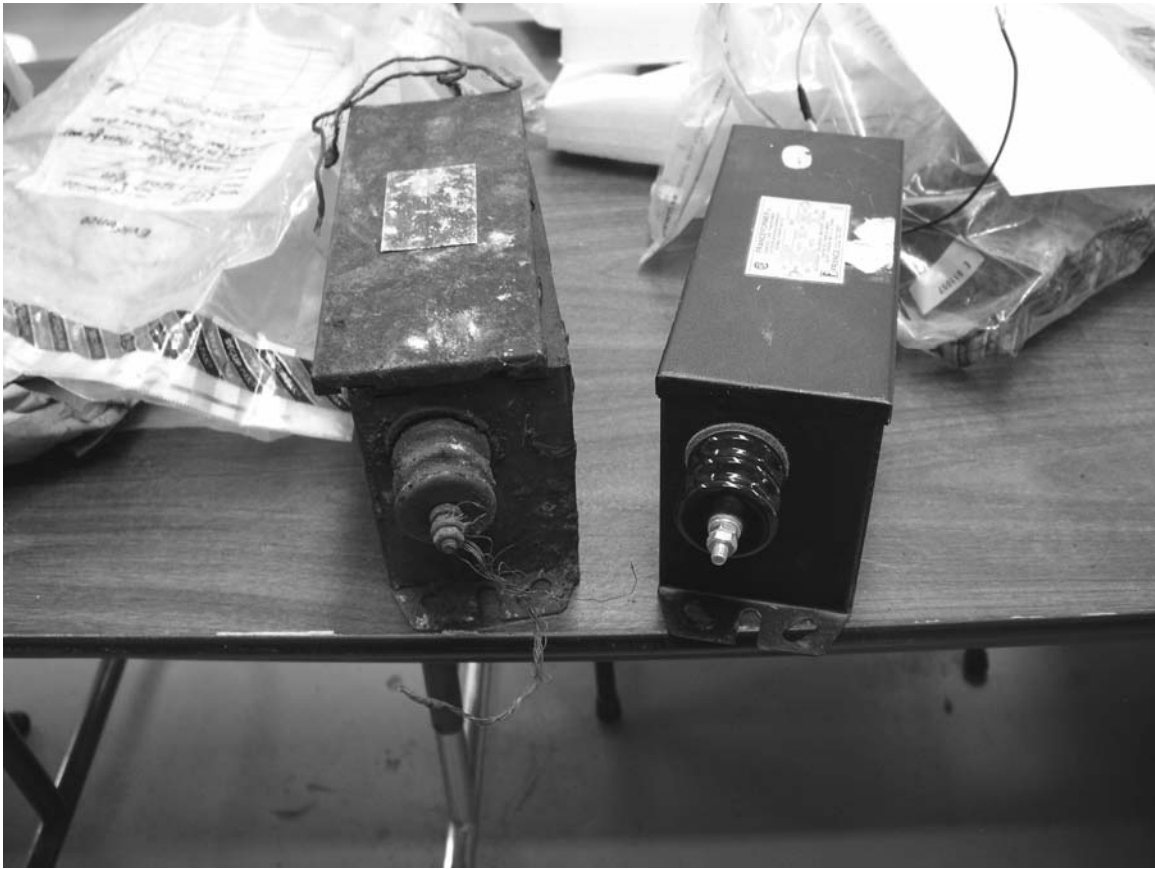
A photograph of one of the recovered neon transformers from the subject fire and an exemplar new transformer is shown in Figure 5. Typical neon sign transformers range in size from approximately 3"x 6" x 8" to 5" x 8" x 12" and weigh up to about 25 pounds. Part of their weight is associated with the asphalt with which they are filled. The asphalt serves as an insulator, a heat sink, and for the purpose of muffling noise produced by the transformer windings.

Figure 5 - Recovered and new neon transformers

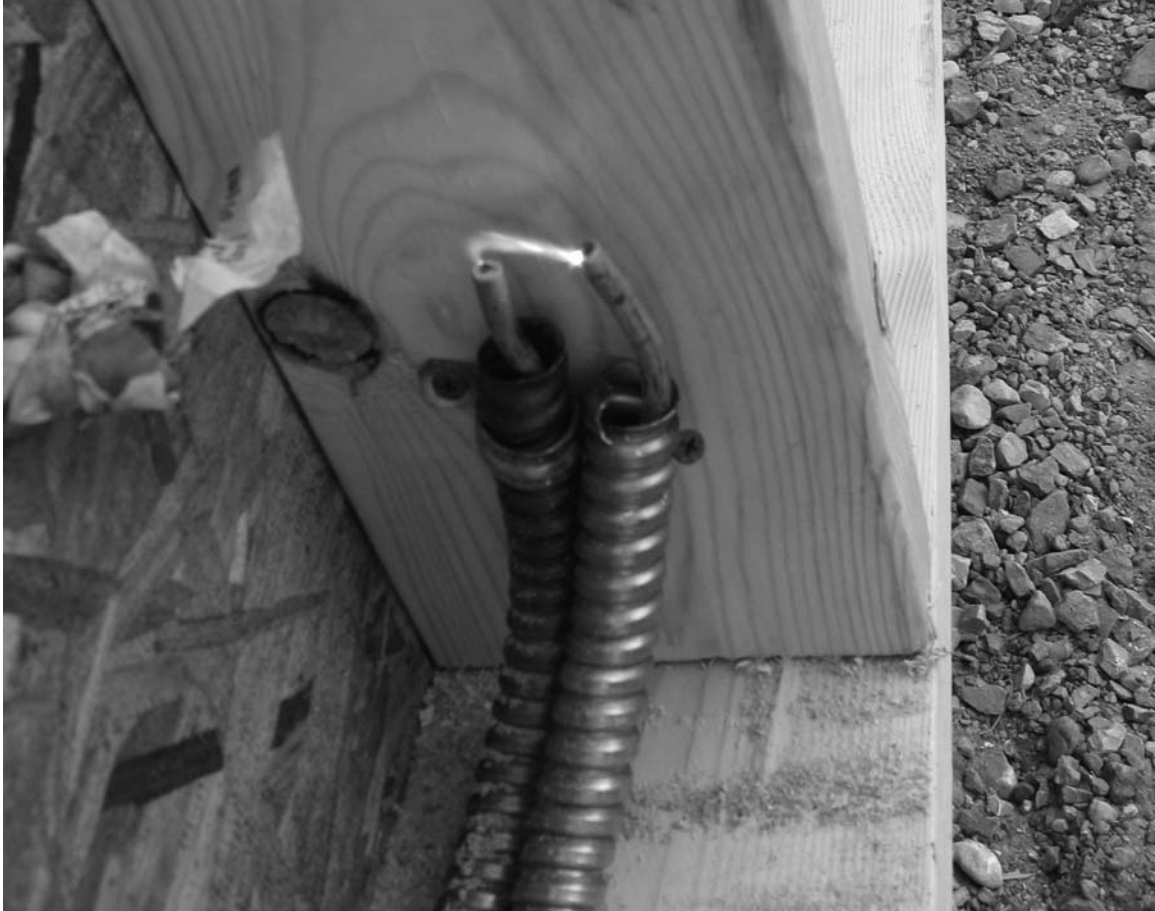
In conjunction with the observations of the potential for multiple arcing opportunities, as noted above, it was observed in early testing that arcs could be initiated through air over substantial distances. It was found, for instance, that a 12,000 volt rated transformer could initiate and sustain an arc between its two GTO output wires over a distance of ¾" without great difficulty (see Figure 7), while a 15,000 volt rated transformer could initiate and sustain an arc in air over a distance of 1". Surprisingly, this far exceeds the commonly accepted 75,000 volts per inch rule of thumb for arcing in air. It is thought that the difference is potentially associated with the shape of the pointed GTO wires compared to arcing between relatively large spherical electrodes believed to have been used in the test configuration for the classic rule of thumb testing.

Figure 7 - Three quarter inch long arc from a 12,000 volt neon transformer

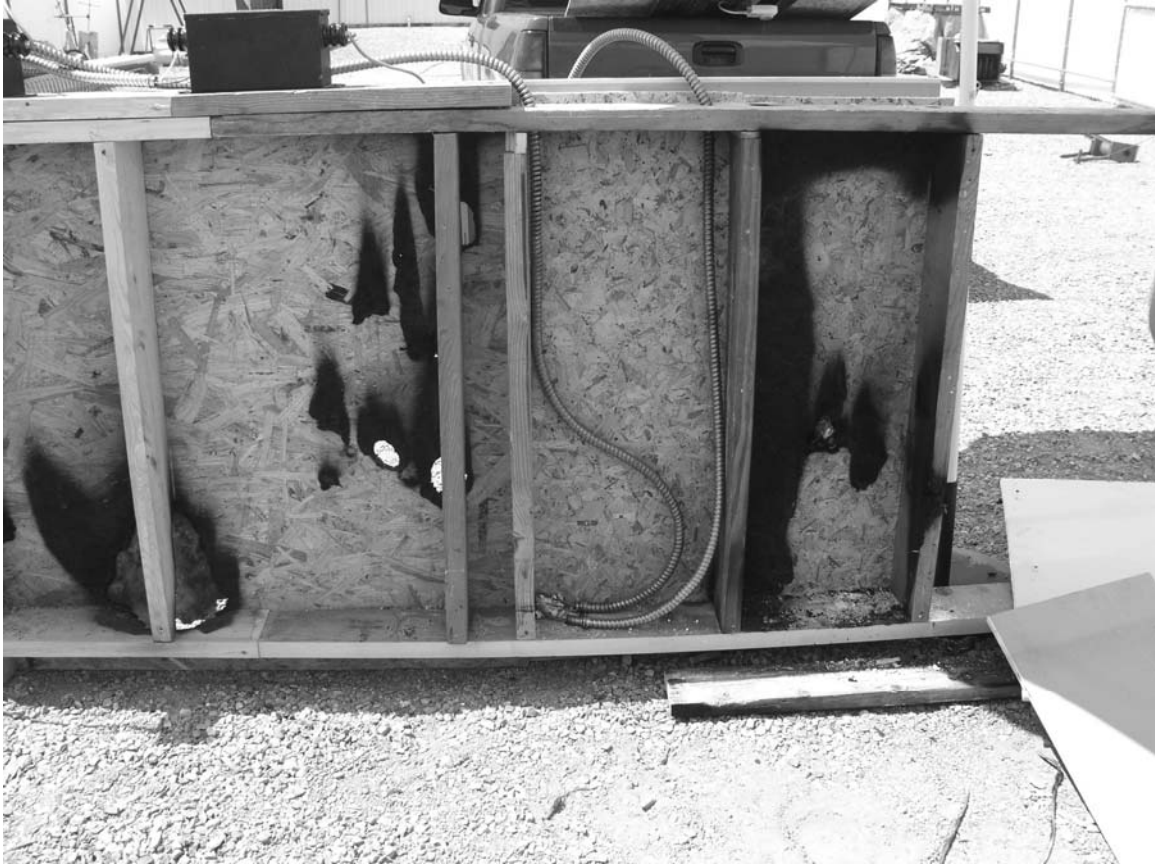
Another characteristic observed during the testing, was that once an arc was struck, the arc length could be extended to a greater length by simply moving the two objects that were arcing away from each other. An interesting aspect of the long arc lengths that these transformers can create is that a greater opportunity exists for a nearby combustible material to be ignited. This is true due to the extended exposure surface area that an ignitable fuel would have in terms of where the fuel would need to be with respect to where the arc is located. It is also of interest that temperatures of 4,000 to 6,000 degrees Fahrenheit within the extended arc would be continued for a long period of time since the low current (30 or 60 mA) arc would not trip the primary circuit breaker that would be supplying power to the transformer nor would the transformer be significantly overheated since it is operating within its designed current delivery rating. In the testing that was conducted, a variety of grounding conditions which resulted in sustained arcs were investigated. These arcs were, in turn, positioned against or close to wood structural components, such as 2" x 6" pine lumber and 7/16" thick OSB. It was found that with sustained exposure of these wood components, particularly for locations where the heat produced by combustion of the wood was relatively contained, the wood would ignite and a sustained fire could be initiated from the output of the neon transformer. Figure 8 shows an example of burning resulting from the tests.

Figure 8 - Neon transformer testing burn patterns

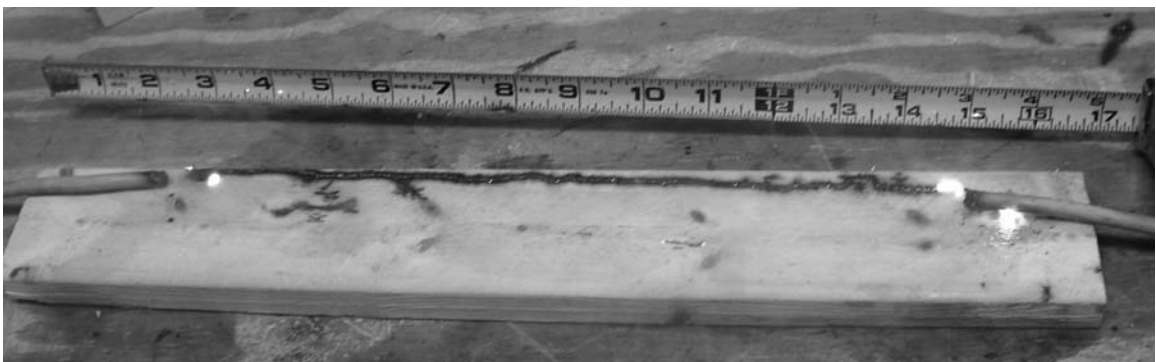
Additional testing on wet wood surfaces indicated that long arc tracks can be produced from the high voltage output of neon transformers. Arc tracks of over one foot were readily created with the exemplar transformers (see Figure 9).

Figure 9 - Arc track on wet wood surface
