# **A Case Study: Reconstruction of a Power Line Wire Strike Event**

## Reconstruction of a Power Line Wire Strike Event

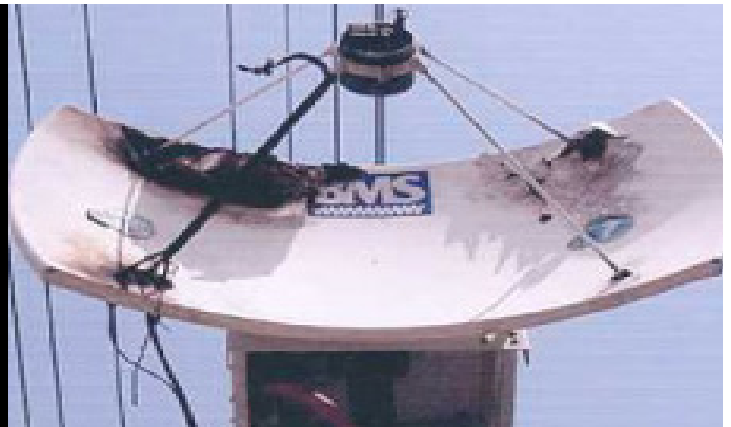
The actual antenna and transmission dish that showed visual evidence of the wire contact location and resultant burning.

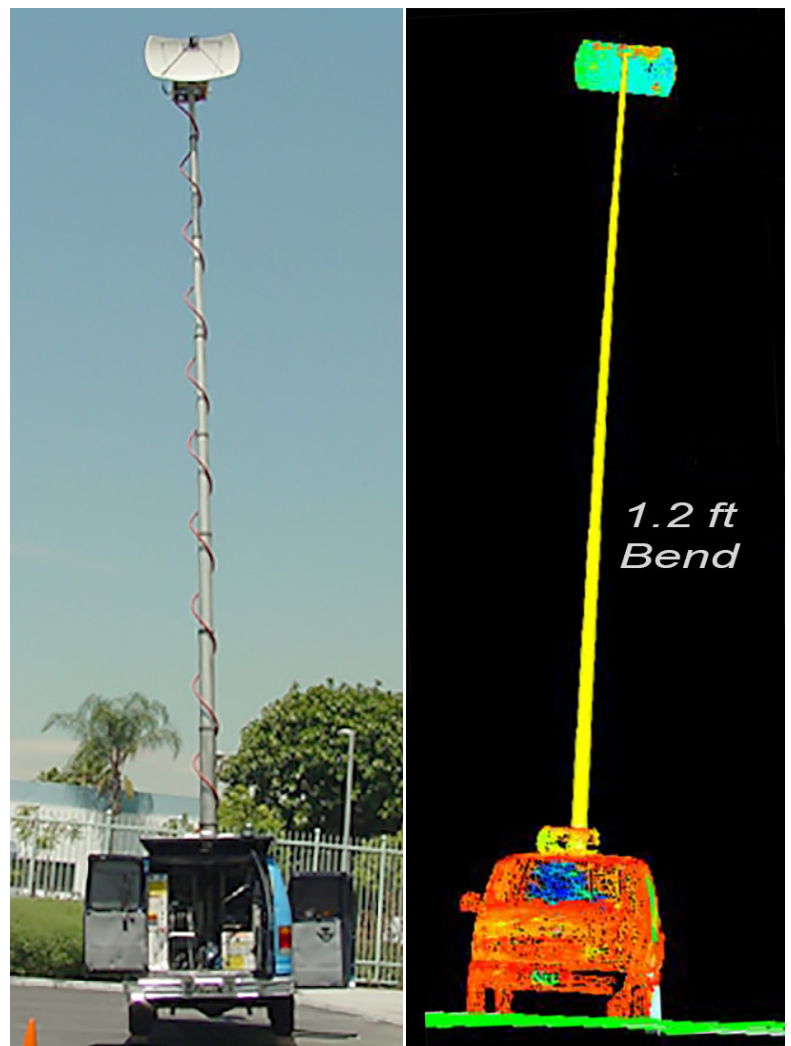
We realized that if we could park the exemplar van offsite such that the four tire contact patches were at the same relative height as the incident van's, then we could raise the antenna and scan it a second time on this angled slope and compare the data when it was raised on flat ground. Any difference in the two would be "bend" in the telescoping pole sections as they were raised and carrying the full weight of the antenna. This difference would be an unaccounted error if not measured, again resulting in a lack of fidelity of the final reconstruction. After performing the analysis, it was determined that there was an additional 1.2 feet of lateral bend in the telescopic pole that the antenna was mounted on - in the direction of the power lines. This bend was in addition to the lateral translation of the dish imparted by the angle of the van as the antennae was raised.

*Photo with Elevated Wheels and Laser Scan  
Showing Antenna Bend*

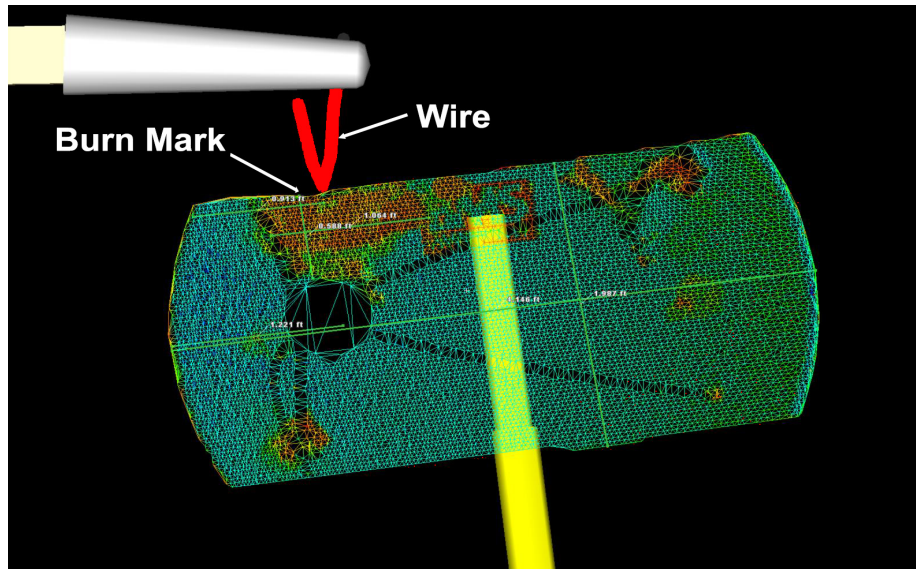
With this detail in place, PSI was ready to perform the final validation check. The 3D model of the van with the extended and bent telescopic pole and antenna was placed into the 3D model of the scene at the previously derived location on the sidewalk. We then zoomed into the area in the virtual accident scene where the dish and power lines were focused to see whether the antenna struck a wire; whether it struck the correct wire in the set, and whether this specific wire made contact with the antenna in the place determined to be the contact point by the electrical engineering expert. Three years after the fact, without benefit of having the van and the scene together in the "real world" at any point during the analysis, PSI's 3D reconstruction based upon then revolutionary 3D laser scanning and laser-assisted photogrammetry was shown to be accurate within an inch!

*Laser Scan Data Showing Wire and Burn Mark Alignment on Antenna  
Showing Less than One Inch of Deviation*

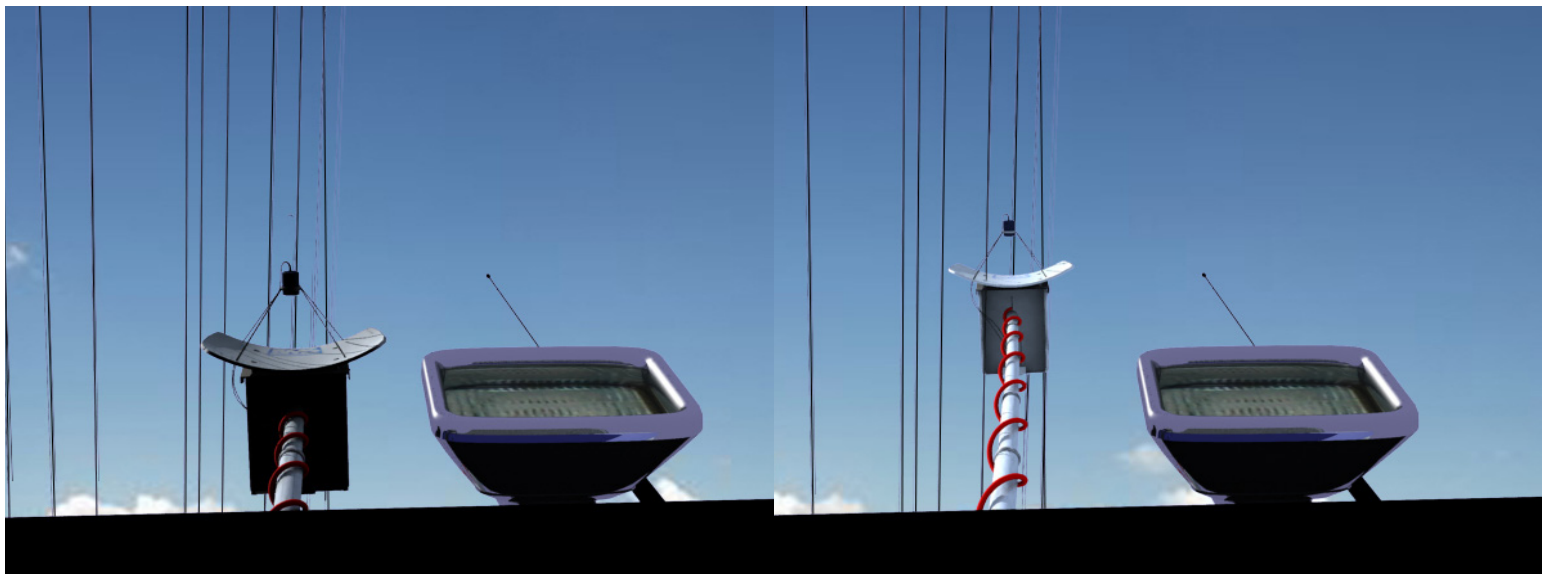
*From 3D Animation; Operator's Point of View  
Antenna Touching Power Line*

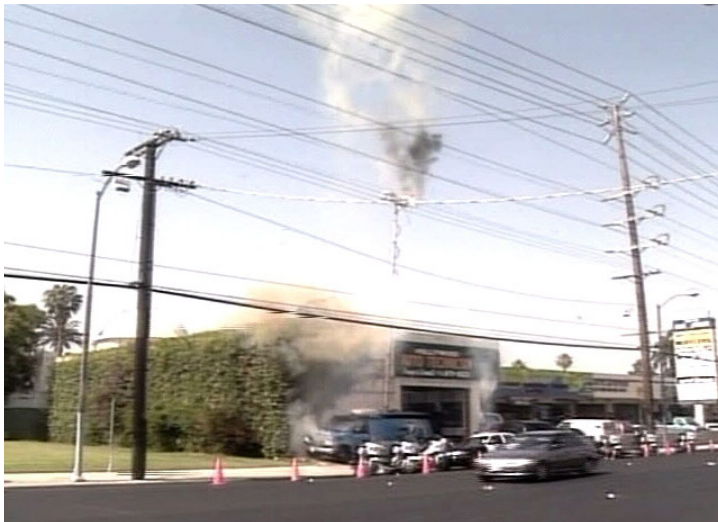
*Photo of Actual Wire Strike Explosion*

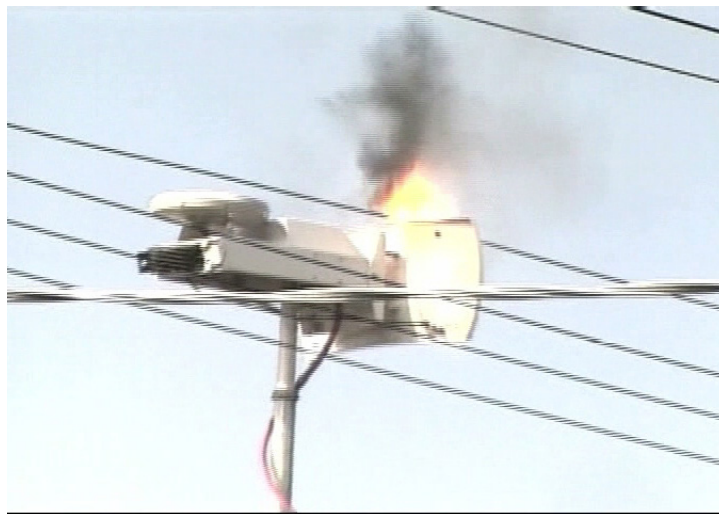
*Photo of Actual Wire Strike Explosion*

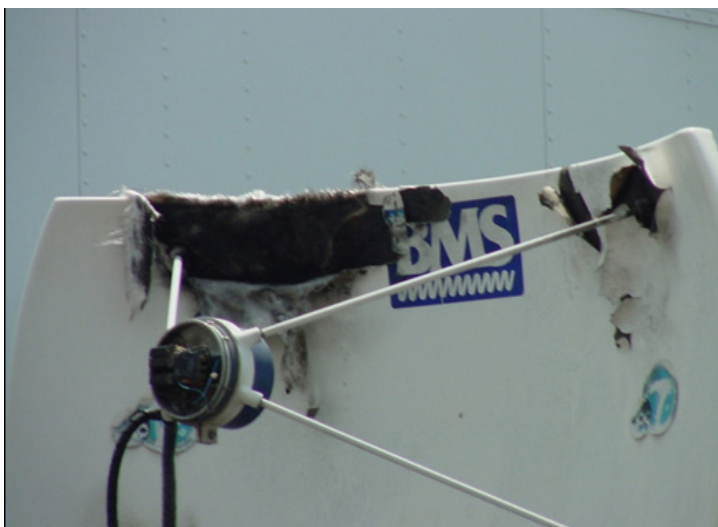
*Photo of Burned Antenna*
