# Practical Case Studies of Thermal Events in Buses

Aaron J. Jones, ITC Experts  
Nicole Schimpf, ITC Experts  
Normand Dube, First Group America

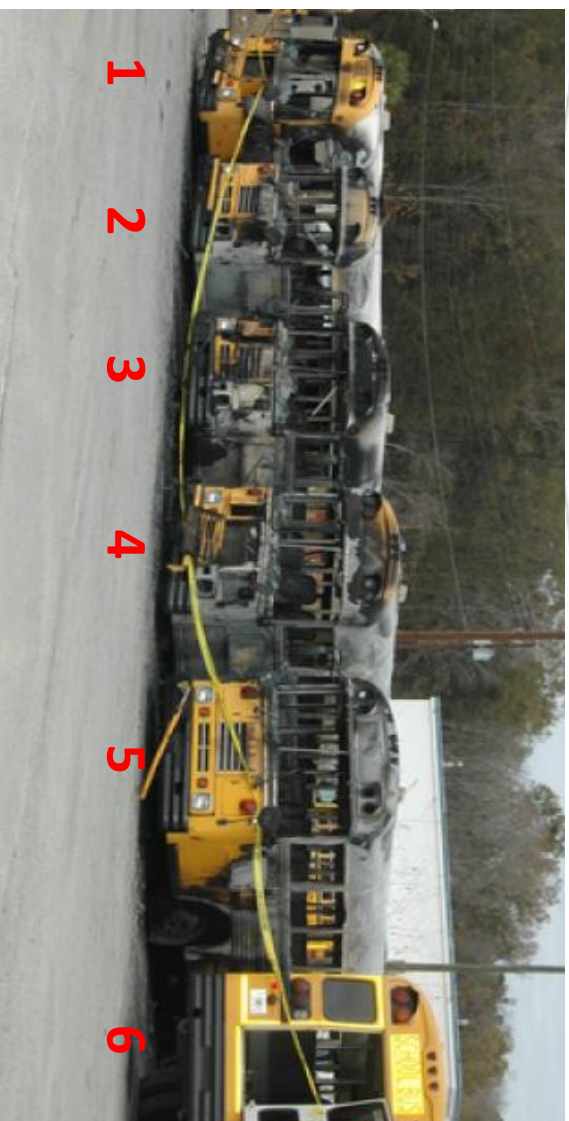
- Six school buses involved in overnight fire
- Based upon relative damage and burn pattern, origin narrowed to buses 2-4
- Bus 2 and 4 had more significant suspension sagging on driver's side and significant arcing/separation of primary power cables
- No evidence of primary battery cable faulting forward of battery box on buses 2 and 4

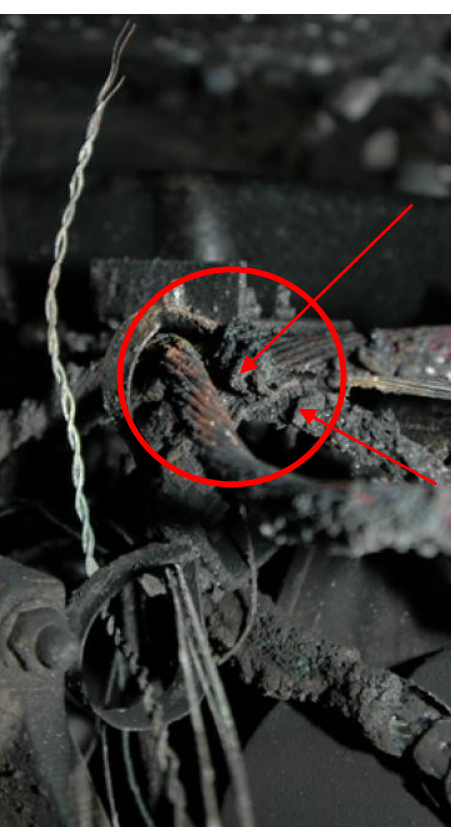
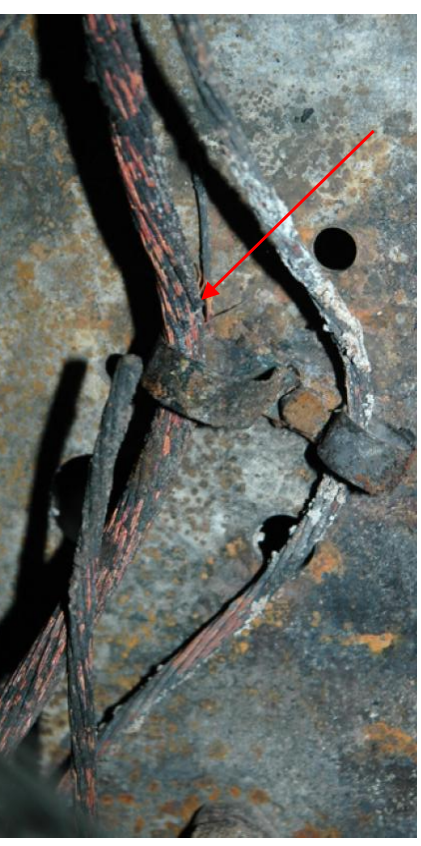
- Bus 3:
  - Burn damage throughout engine compartment
  - Most considerable suspension sagging
  - Electrical activity observed where 3 power cables enter engine compartment near front left leaf spring
  - Arcing at primary power cable where it passed p-clamp on left hand side rail

- ◆ Determine that fire resulted from electrical arcing of the power cables routed through the P-clamp of bus 3
  - ◆ Resulted in ignition of plastic/elastomers
  - ◆ No evidence of electrical arcing near battery box
- ◆ As a result, inspections of fleet were performed
- ◆ P-clamps on battery cable runs from the battery box to the engine were replaced with plastic blocks and zip-ties
- ◆ Changes resulted in significant reduction in reported fires due to chafing of the battery cables

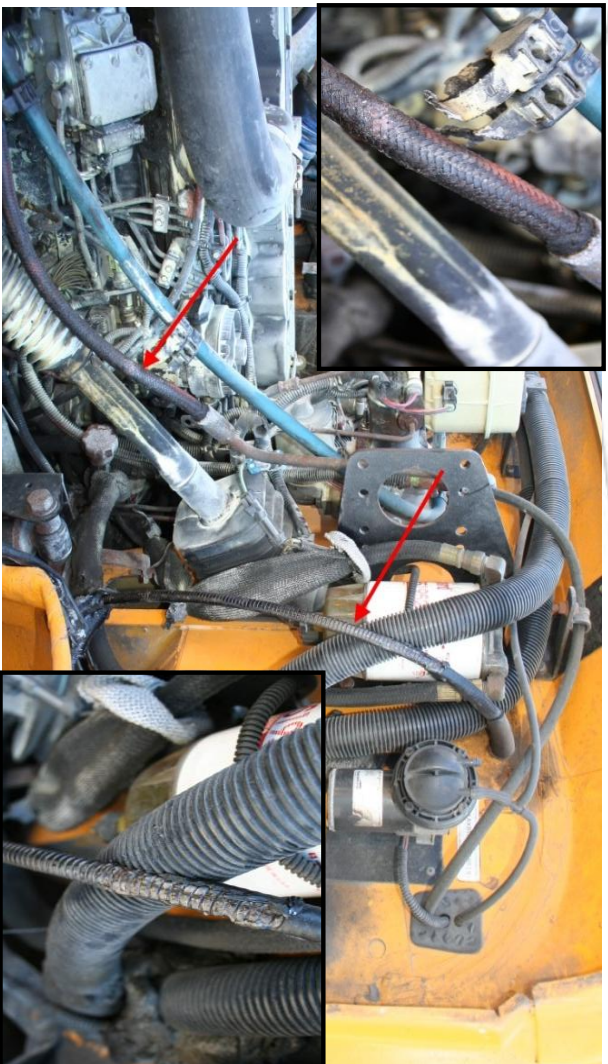
- School bus in operation when driver lost engine power
- Fire observed on left side of engine compartment
- After the fire, the parking brake cable was inoperative
- Stainless steel high pressure power steering hose had signs of significant resistive heating

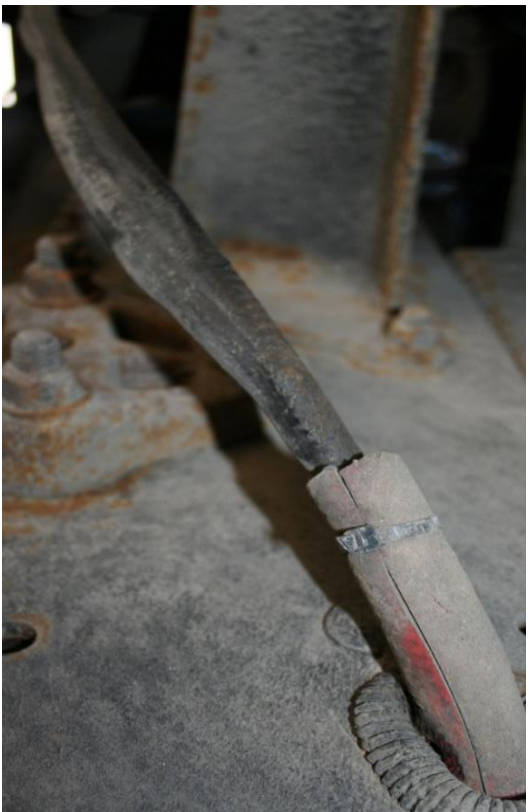
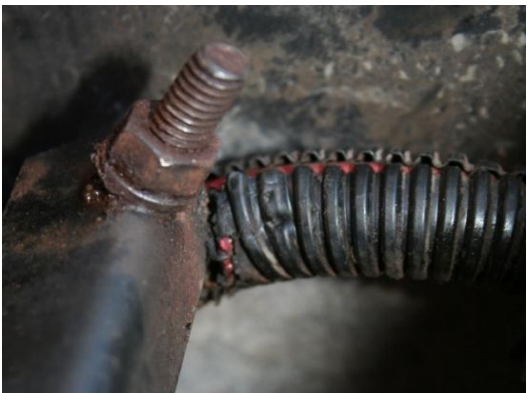
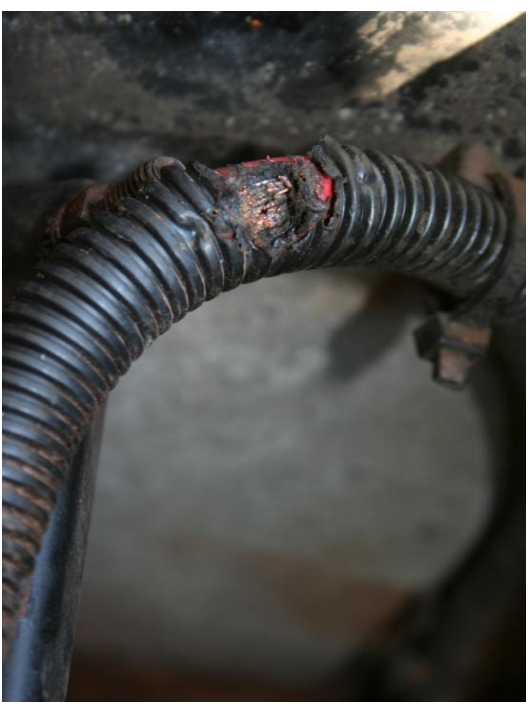
- ◆ Parking brake cable melted from body to transmission-mounted parking brake
- ◆ B+ battery cable had evidence of fault activity
- ◆ B+ battery cable pinched at hold down bolt and insulation was chafed through

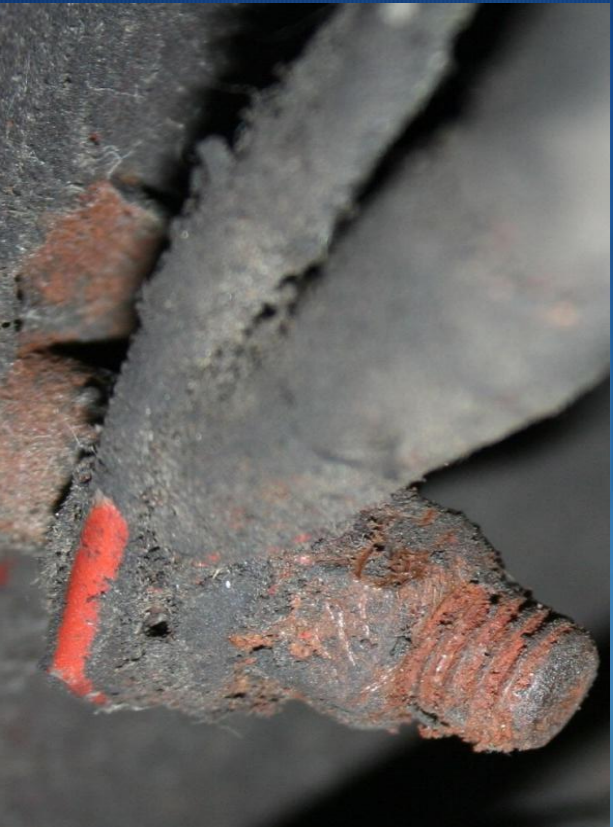
- ◆ Sufficient ground not achieved between body and primary ground at frame (highly corroded connection at ground stud on frame rail)
- ◆ Chafing of B+ battery cable resulted in significant fault current, which flowed through alternative paths to ground
- ◆ As a result, new procedures were established for inspecting and maintaining ground cables

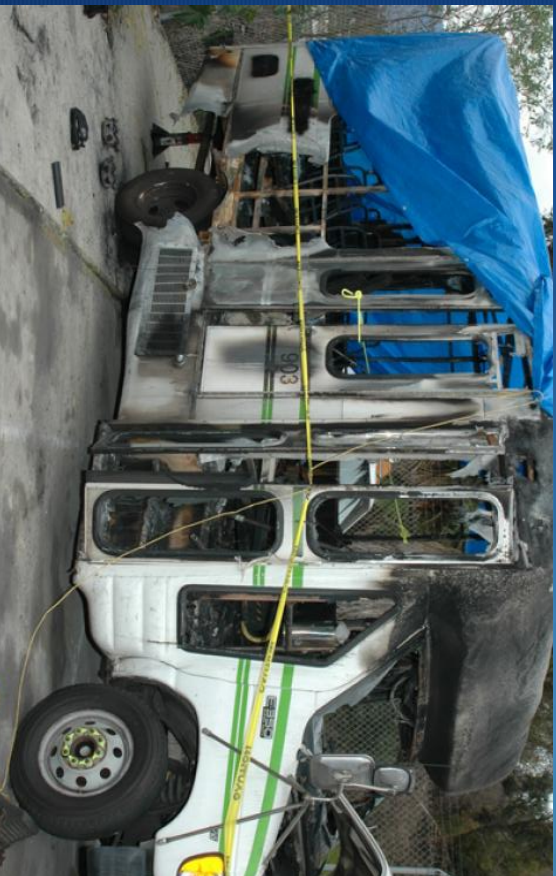
- ◆ Paratransit in service when fire initiated at right rear wheel
- ◆ Bus equipped with wheelchair lift
- ◆ Bus in operation several hours before smoke
- ◆ Two days prior, bus was taken out of service for complaints of rear brakes dragging
  - ◆ Rear calipers and pads replaced, brake system bled

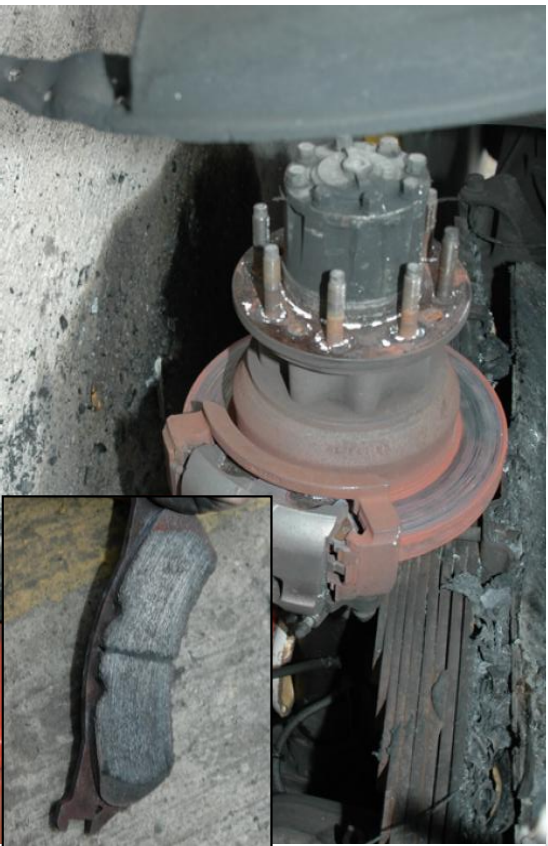
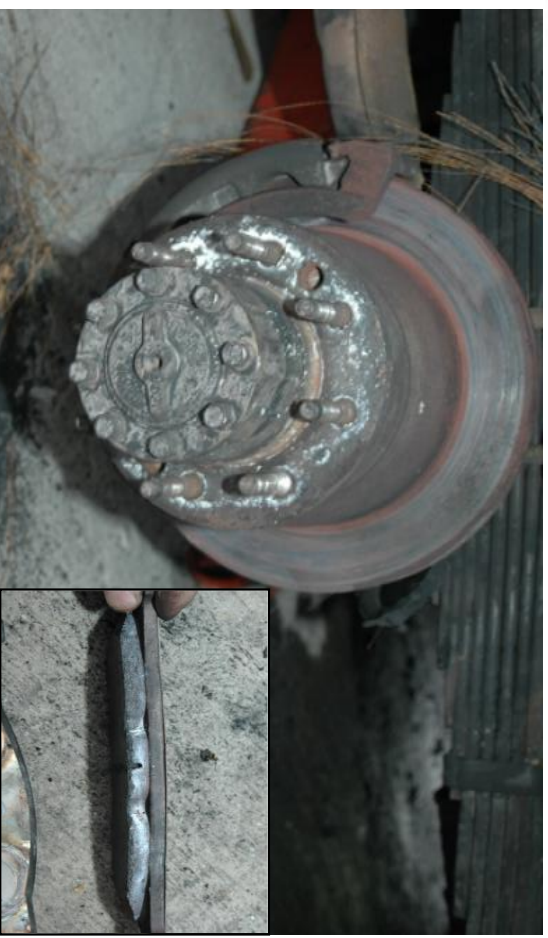
- Left rear: rotor bluing, friction material degradation
- Right rear: tires partially consumed, more significant bluing of brake components and degradation of friction material
- Front brakes undamaged

- Bus was equipped with brake interlock system that applied the rear brakes when the wheelchair lift door was open
- Testing ruled out mechanical problem with brake interlock system
- Brake interlock system tested on similar buses
  - Door could be latched without completely closing
  - Door switch remained activated and brakes remained applied
- Determined that improperly closed door allowed door switch to remain active with brakes applied while bus was in operation
- As a result, all wheelchair lift doors and interlock systems were properly adjusted and are now inspected regularly

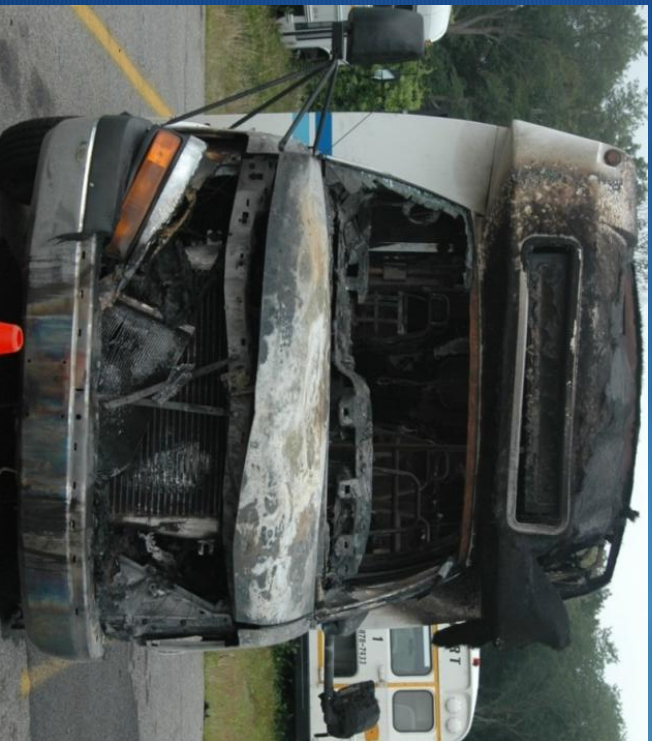
- Cut-away paratransit in service for ~6 hours
- Bus parked for 5 minutes, then restarted
- Driver lost ability to turn steering wheel and heard flapping noise under hood
- Driver then heard popping noise under hood
- Smoke observed from engine compartment, emanating from left side

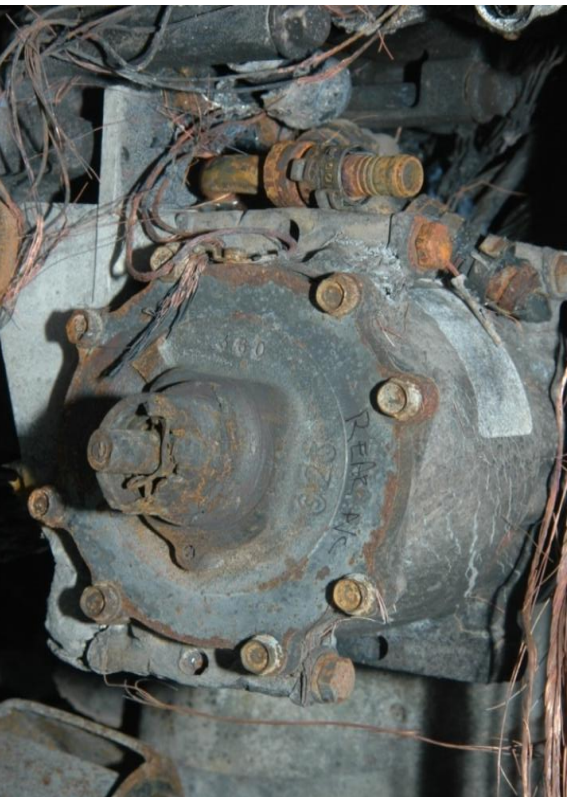
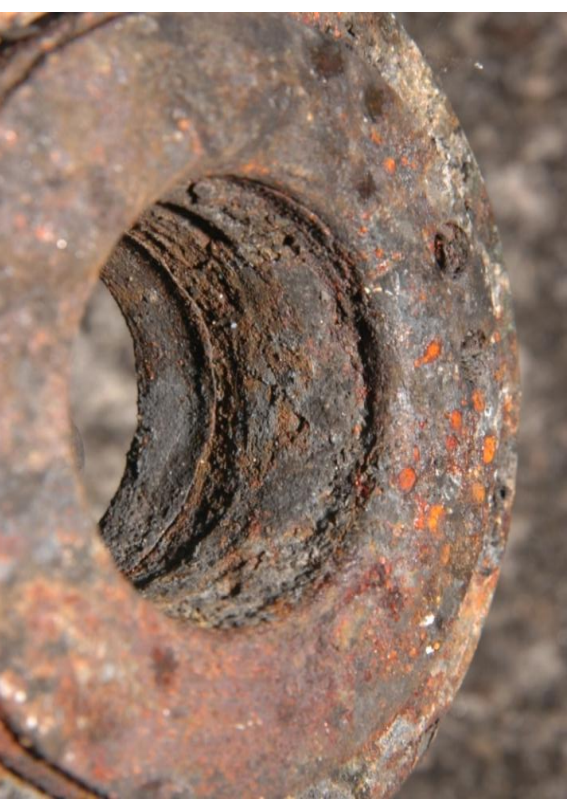
- ▶ Circular melt pattern on air cooler charge
- ▶ Clutch bearing race fused to compressor
- ▶ Compressor body displayed incipient melting
- ▶ Clutch bearing completely destroyed due to friction

- Air compressor clutch failure resulted in fire
- Bearing failure caused significant heat generation
- Thermal damage prohibited determination of first ignited material
- Prior to fire, bus was serviced for alternator and junction block replacement
  - Technician heard noise from air conditioning compressor
  - Technician placed out-of-service placard on bus but didn't submit new work order prior to leaving for the day
  - Shop manager saw original work had been completed and no new work order was issued, so he released the bus with the failing clutch assembly

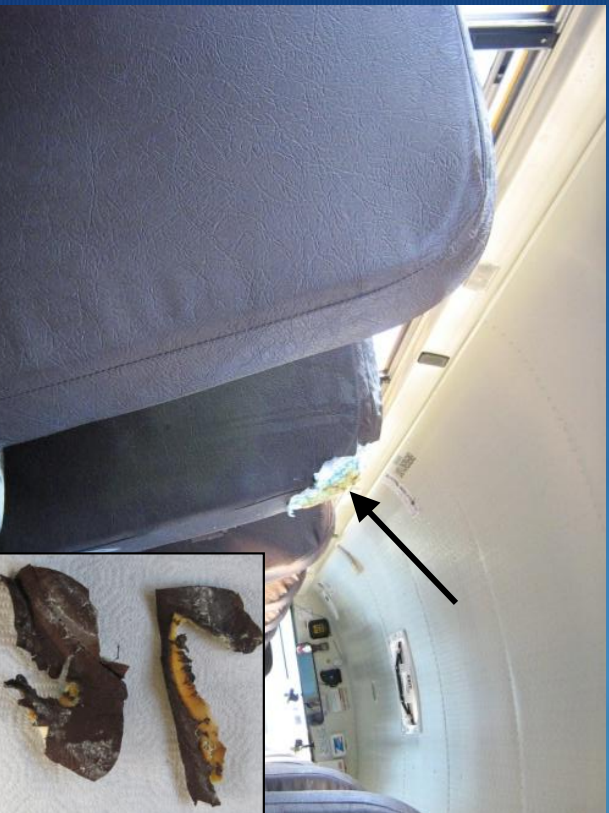
- Two buses parked outside school in November (week following DST end)
- Seat began smoking and caught fire
- Another seat also smoldering
- Exemplar bus parked in same location, pyrometer indicated material temperature rose to 320F before bus was removed

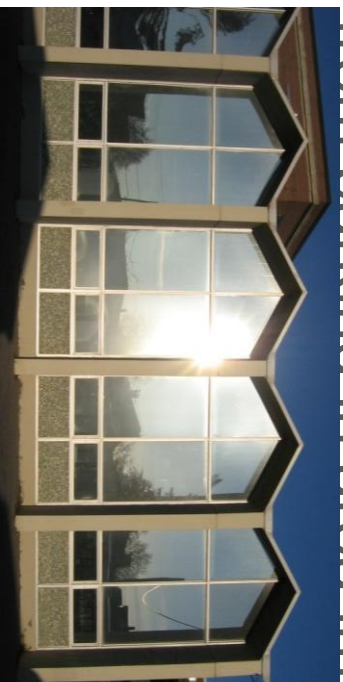
- School had added new tinting material to windows, which increased reflected intensity
- Sunlight concentrated onto buses, causing increase in temperature
- End of DST changed angle of sun at the time buses were parked
- Seat material confirmed to meet FMVSS 302
- Buses prohibited from parking in area impacted by reflection
