PORTAL LANDSLIDE ANALYSIS OF THE NEW HAIBAT SULTAN TUNNELS IN KOYA, KURDISTAN REGION, IRAQ

ABSTRACT: The road connecting Koya town to Dukan town is the primary conveyance for vehicles between these two municipalities. Numerous rock falls or slope failures occur annually along various segments of this road on Haibat Sultan Mountain. These slope failures can potentially, kill passengers and block the road for several days and sometimes weeks. In order to mitigate this problem, the Ministry of Construction & Architecture has enacted to build a double tube tunnel, referred to here as New Haibat Sultan Mountain Tunnel. This tunnel was under construction for several months, but lack of funding prevented their completion. The portals of the tunnel and approximately 60 meters of each tube were completed. Shotcrete had been applied to the area above the portals. After construction were terminated, a massive slope failure occurred above each tunnel portal. It would appear that the efforts to stabilize the slope above the tunnel were insufficient. This document proposes to investigate the area above the tunnel portals to determine the cause of the slope failure and provide recommendations.

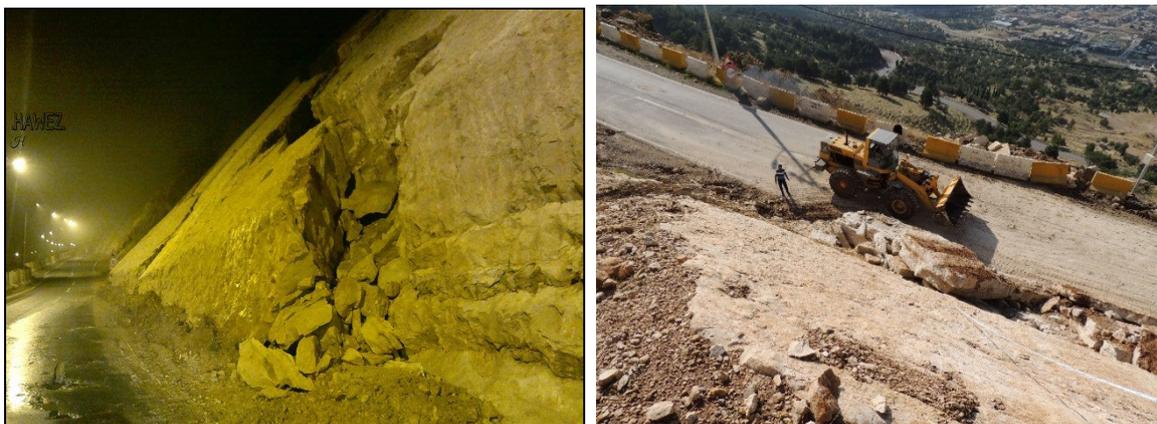
Numerous rock falls and landslides and/ or slope failures occur annually along various segments of this road on Haibat Sultan Mountain, especially during heavy rains in winter. These slope failures (Fig. 2) can potentially kill passengers and block the road for several days and sometimes weeks.

Figure 2: Slope failure at Haibat Sultan Road: **Left**) on 14.12.2013, **Right**) on 8/5/ 2016.

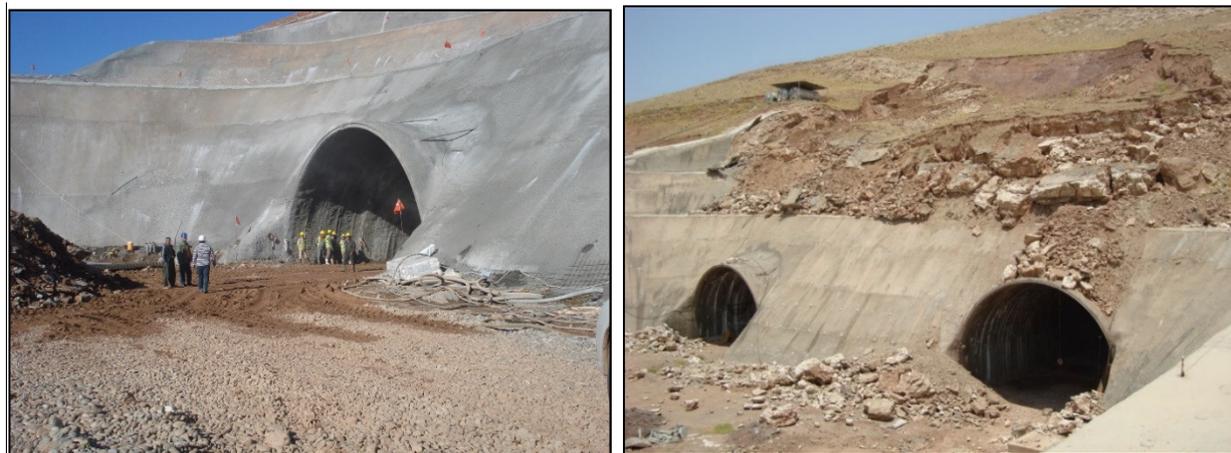
This tunnel was under construction for several months, but lack of funding prevented its completion in mid. 2016 as it was planned. The portals of the tunnel and approximately 60 meters of each tube were completed. Shotcrete had been applied to the area above the portals. After construction was terminated, a massive slope failure occurred above the portals after heavy rains in March 2015 (Fig. 3). It would appear that the efforts to stabilize the slope above the tunnel were insufficient. Figure (3)

Figure 3: **Left)** The status of the tunnel portals before the failure (pictured on 17.12.2014), **Right)** The tunnel after tunnel portals sliding in March 2015 (pictured on 25/11/2017).

As it is clear from the Figures (3 and 5), a major portal landslide happened in March 2015 after heavy rains which took place in the area. The comparison is clear between the status of the tunnel portals before and after the sliding (Fig. 3). This landslide is described, discussed and analyzed in the following section, whereby the technical reasons for it have been addressed.

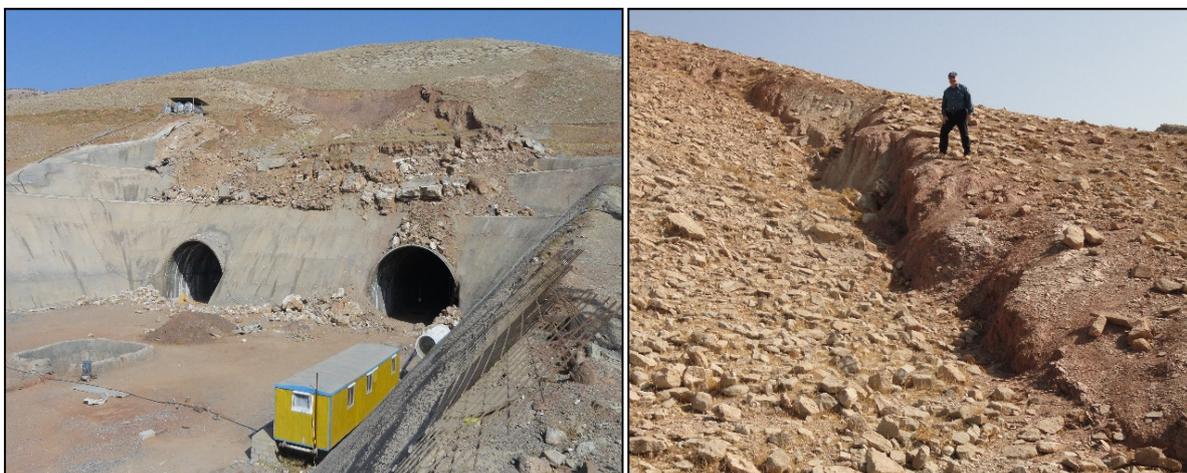
Another outstanding geomorphic feature is the main landslide, (Fig. 5 Left) which had happened along the contact between the Pila Spi and Fatha formations. The former includes many tension cracks of few meters' length and up to one meter in depth with spacing of (0.5 – 1.5) m (Fig. 5 Right), which is filled with small disintegrated limestone fragments and clayey soil. These cracks will be filled by water during rainy seasons and will decrease the cohesion and friction angle of the rocks; accordingly, will accelerate and facilitate failure of the slope.

Figure 5: **Left)** General view of the landslide with the two portals, **Right)** A large tension crack, note its length, depth and opening.

- Detailed inspection of existing tension cracks further ahead along the tunnel portal and securing their filling with suitable filling material to ensure that no water percolation will happen inside the formation structure during future rain falls.

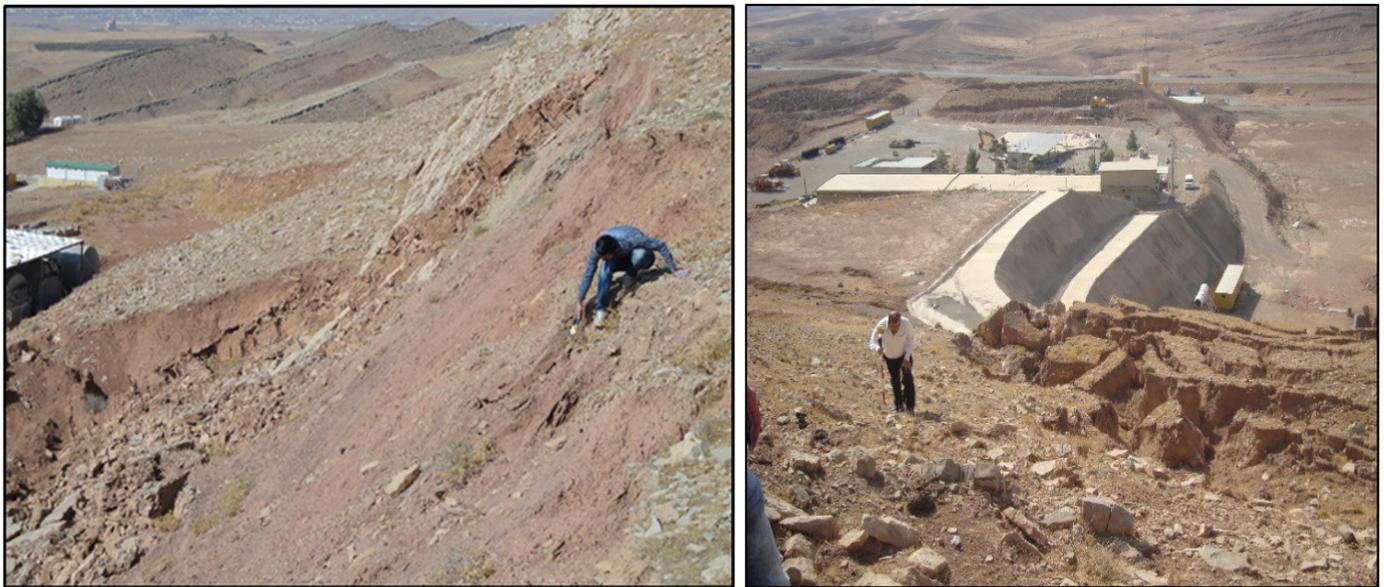
The portal landslide is one of the planar sliding type which happened to the weak claystone layers of the Fatha Formation resting on the limestone layers of the Pila Spi Formation (Fig. 7 Left) with a clear nature of progressive failure; as it is clear in Figure (7, Right).

Figure 7: **Left**) The contact between the claystone and limestone layers along which the failure happened, **Right**) Illustration of the progressive failure nature of the portal landslide.

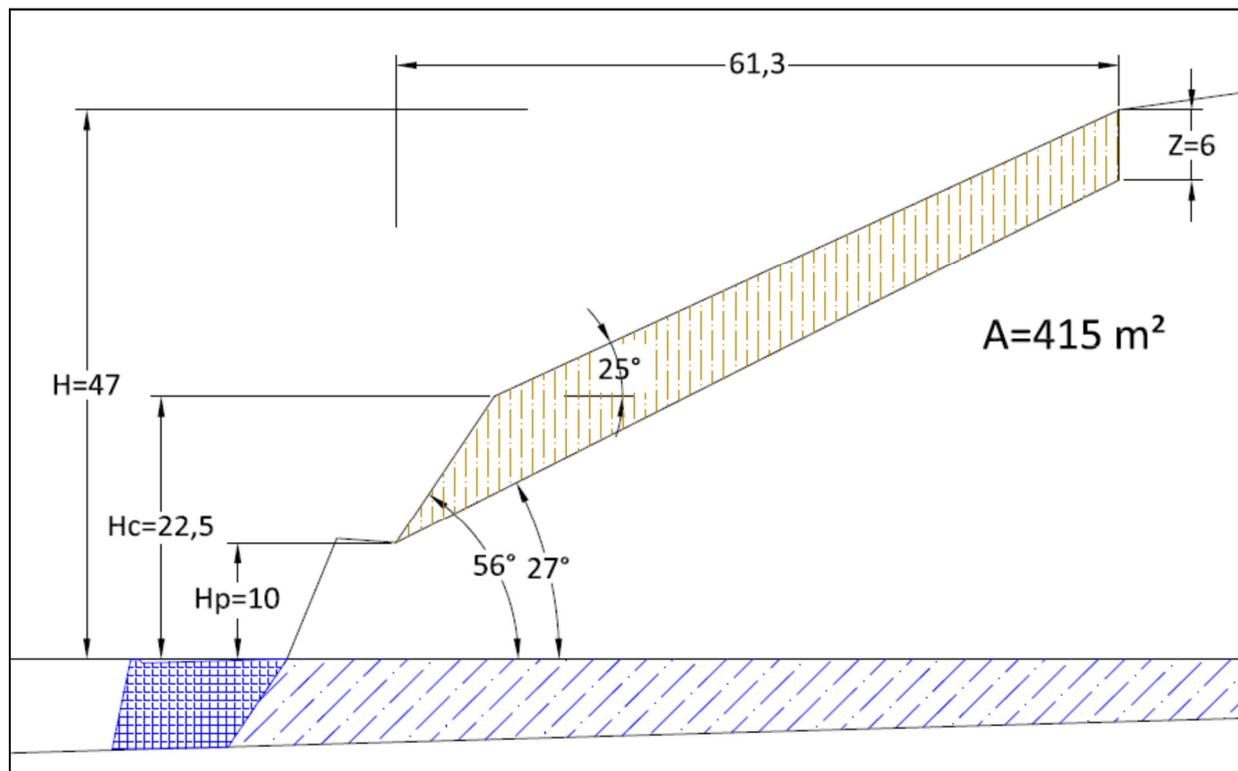
Figure 8: Landslide geometry.

The use of total station is characterized by its flexibility, high speed, high efficiency, automatic data saving and accuracy. The measured points were chosen according to the failure shape and hazard areas. Final survey results acquired from the data measured directly and the indirect data analysis (using excel and Survey Software) are illustrated in Figure (8).

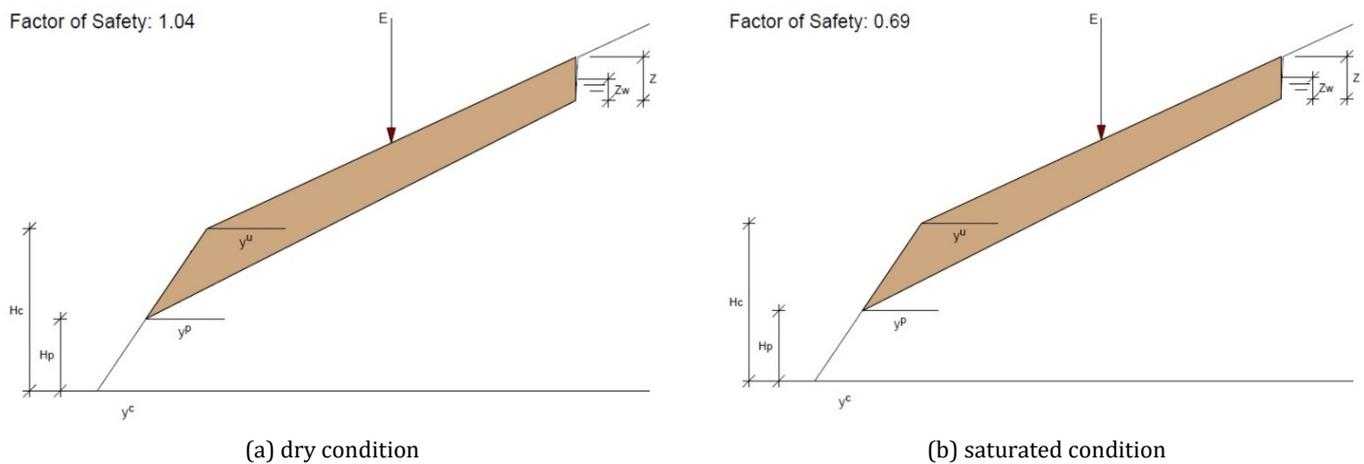
Figure 9: ROCKPF Program outputs

Based on the above works which are related to the reduction in shear parameters as a result of saturation, 45% reduction factor for the friction angle, and 40% for the cohesion are proposed in the current study and the results are illustrated in Table (1) and Figure (10).

Condition	Dry	Saturated
Cohesion	22	13.2
Angle of friction	20	11
Factor of Safety, FOS	1.04	0.69

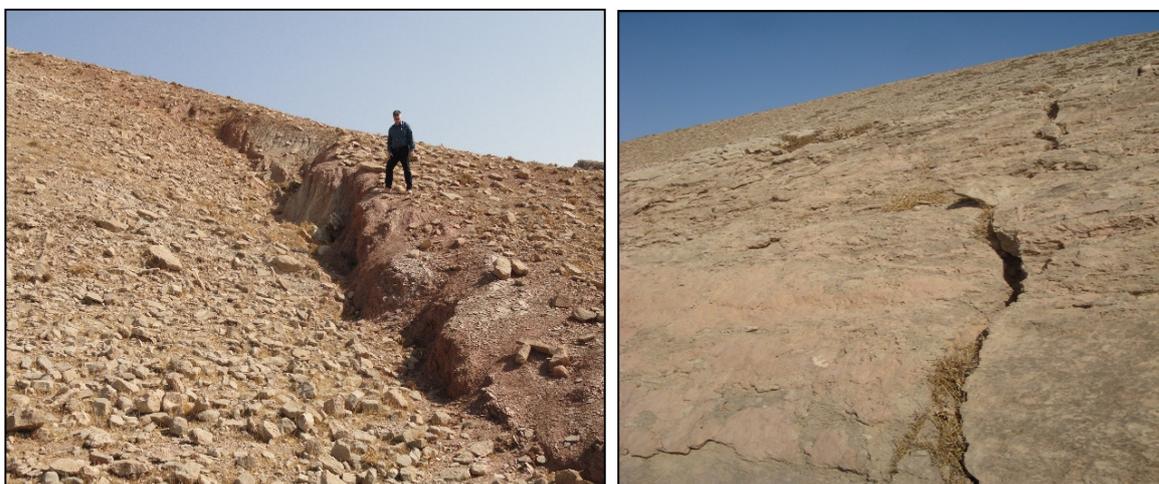
It appears that tension cracks exist ahead above the tunnel portals (Fig. 5, Right) and as are shown in Fig. (10). These tension cracks were filled with small disintegrated limestone fragments and clayey soil followed by water during rain falls in March 2015. This decreased cohesion and friction angle of the rocks adding to the downward pressure due to the pore water pressure and the volume expansion on freezing of water filling the tension cracks in winter. These reasons have triggered the failure. As the materials and beds above the portal have increased in saturation, the progressive nature of the failure developed gradually with time. The effect of stress redistribution on transferring from the primary stress field to the secondary stress field as a result of tunnel construction may have added to the triggering of the portal landslide. The results of the analysis have given a drop in the overall factor of safety from 1.04 for the dry condition to 0.69 for the saturated condition. This is considered as low leading to the landslide which had occurred.

Figure 10: Tensions cracks: **Left)** Perpendicular on the slope within the claystone
Right) A tension crack above the tunnel portal.

- Horizontal drains and sub-horizontal drains need to be installed into the slope of the mountain and behind any shotcrete to reduce the build-up of pore water pressure.
