INSTALLATION DEFECT AND INCIDENT REPORT

June 27, 2023

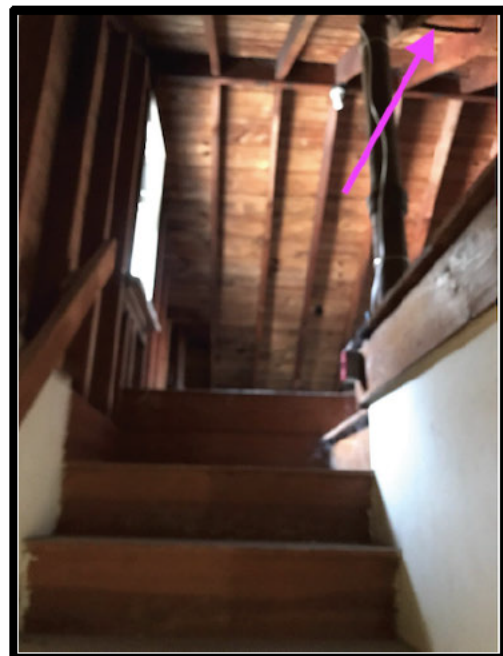
Image 5, stairs to attic, arrow
Pointing to flexible gas pipe

The vertical black item at the top right of image 5 is the plumbing vent stack observable in images 11 & 12

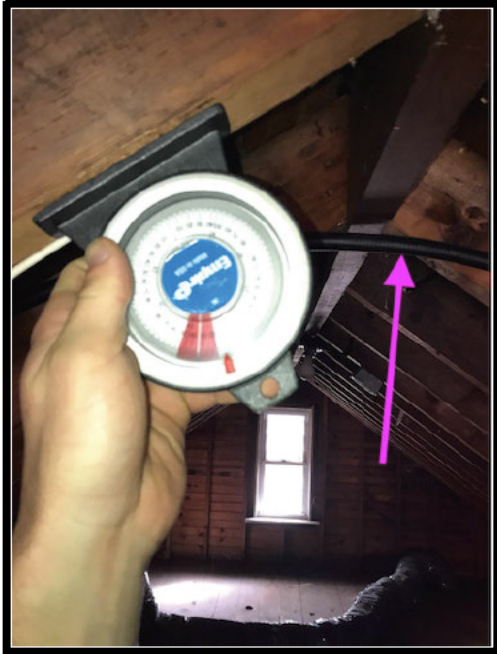
- 13 Image 6, Technician measuring
- 14 Angle of rafters. Note flexible
- 15 Gas line in background

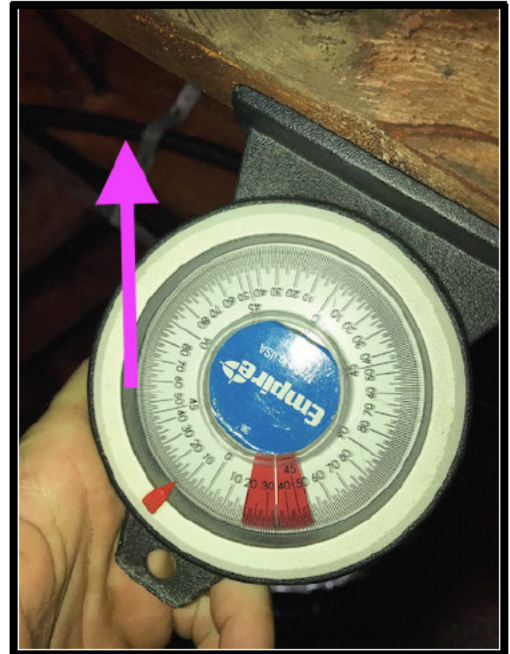
- Image 7, Technician measuring
- angle of rafters. Note flexible gas
- pipe in background

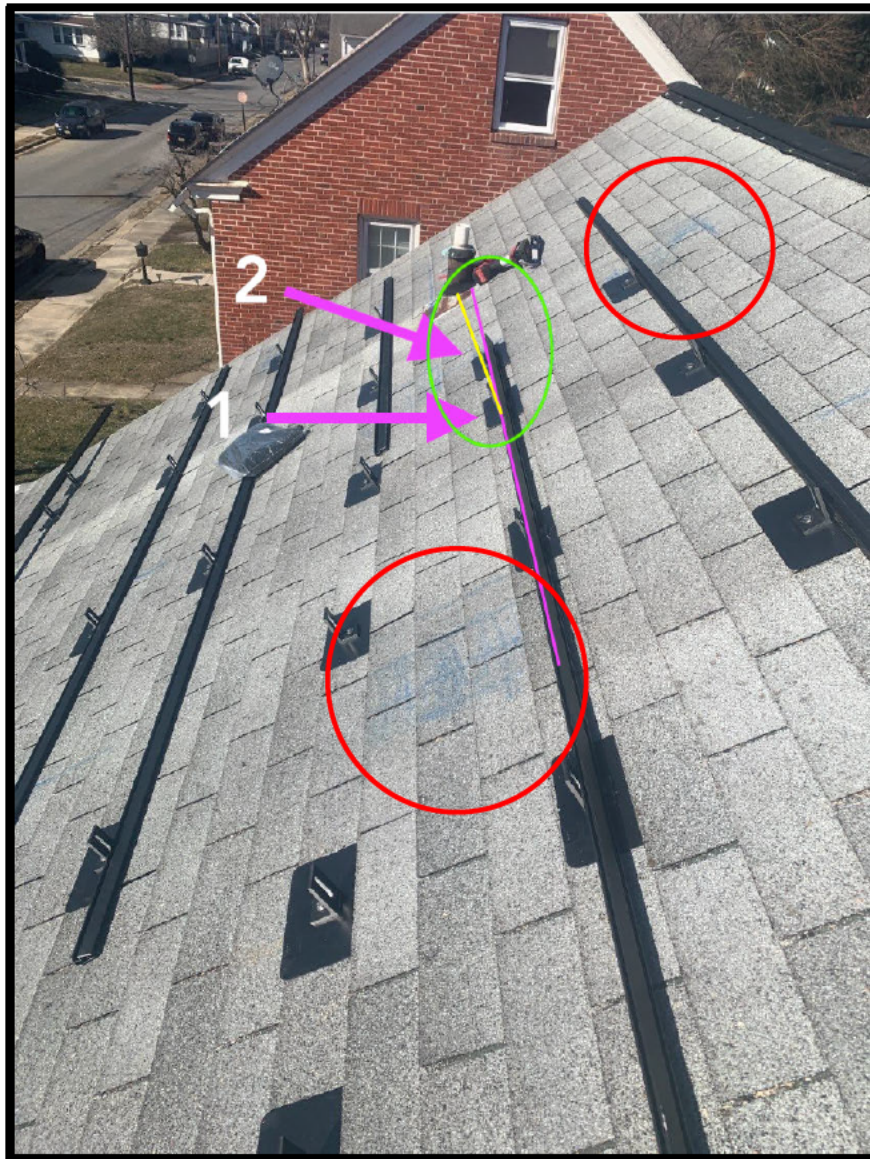
Image 14 shows the roof with flashing, L brackets and rails being installed, looking West. Note 1 corresponds to the location of bracket 1 of evidence image 16 and note 2 corresponds to bracket 2 of the same evidence image. There are two lines inside the green oval, annotated over the rail. The pink showing the path of a straight rail and the yellow showing the path of the rail once fastened to L bracket 2.

The blue dust inside the red circles provides evidence of blue chalk dust residue, consistent with what would be left from snapping chalk lines, providing alignment for brackets.

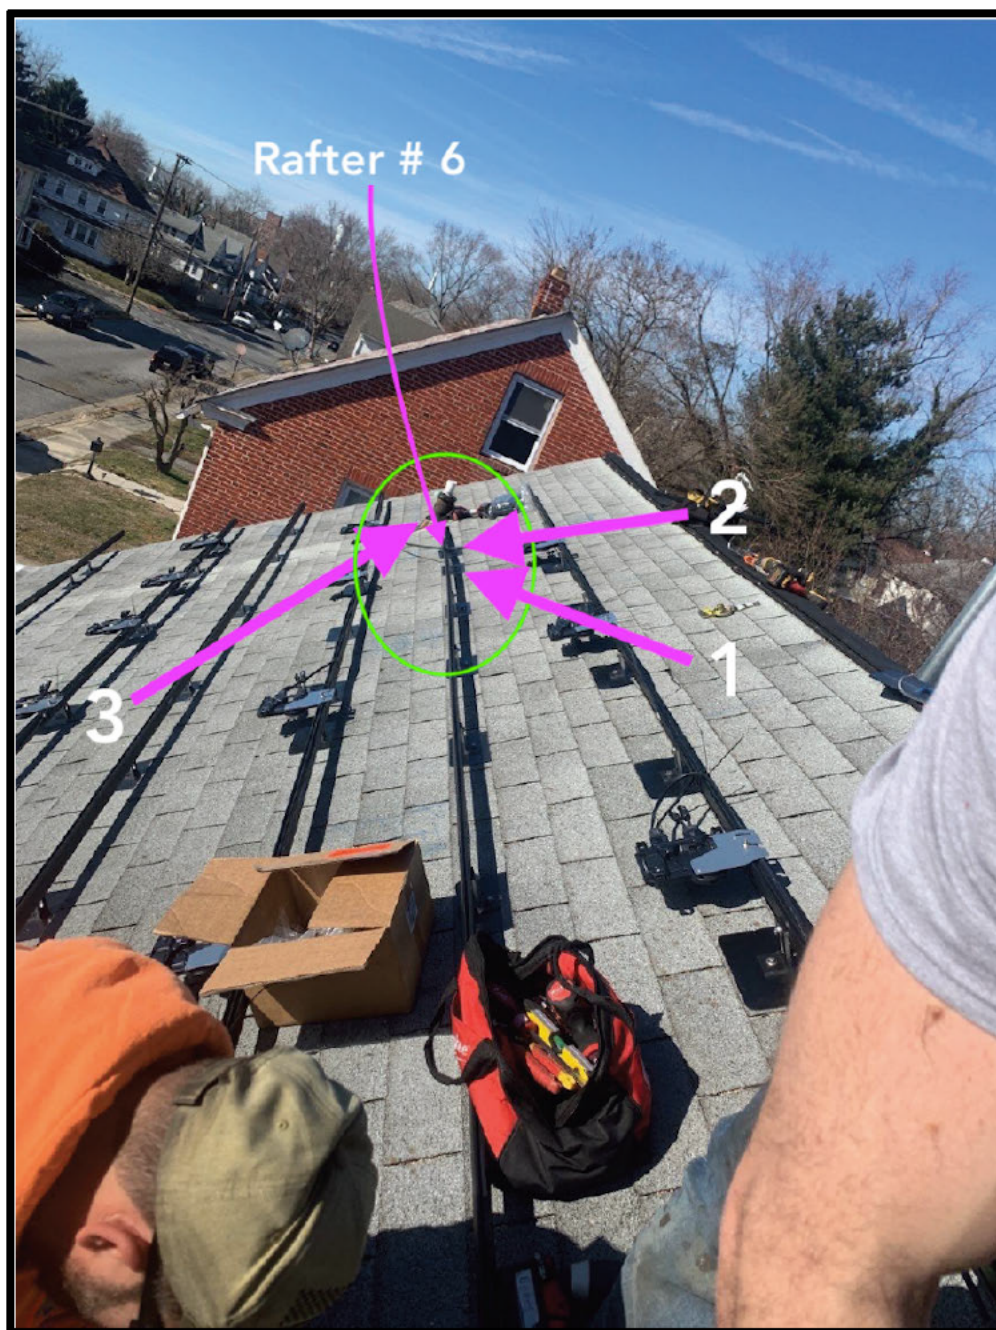
Image 15 shows the rail extension with brackets 1 & 2 in the same locations described in image 14. It is easier to observe in this image that bracket 2 is significantly lower on the roof than bracket 1, allowing the screw at bracket 1 to avoid penetrating the gas line.

Defendant, in his deposition, page 49, line 21 describes how chalk lines are snapped to provide a location for “mounts”, aka L brackets. Based on experience, It is inexplicable though how a stretched chalk line can produce anything other than a straight, not a curved line.

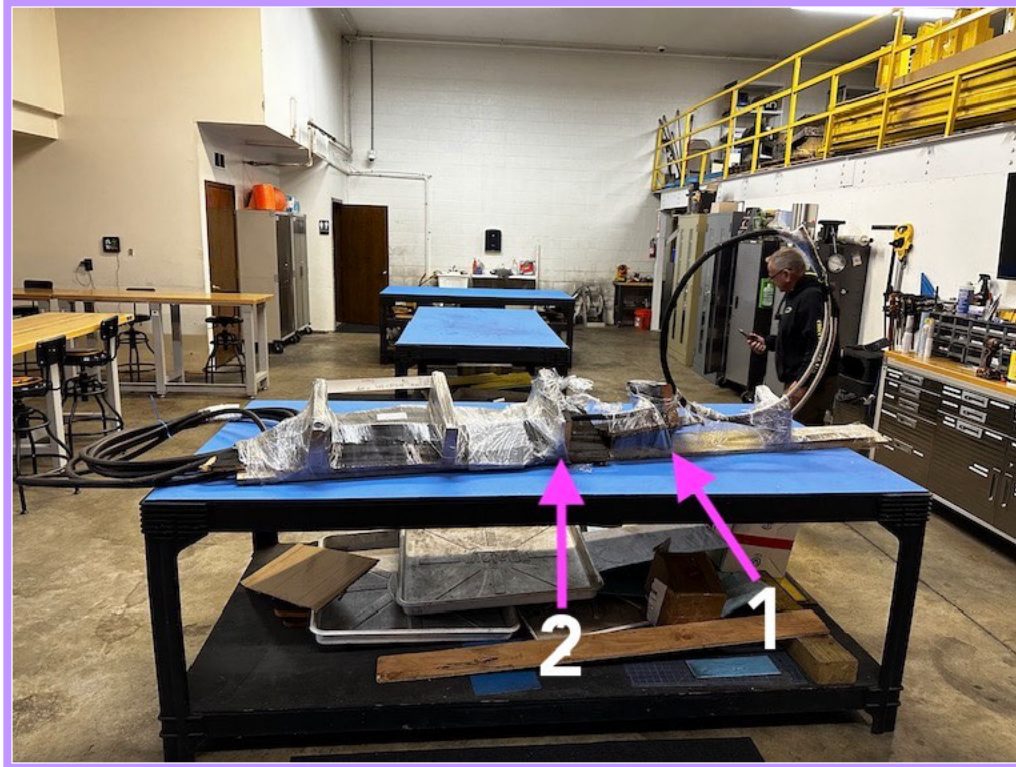
Image 16

1 Examining the evidence section removed (image 16), the left side of the section is the
2 West side, and what would have been closest to the plumbing vent stack. What can be
3 observed is that brackets 1 & 2 are only 1 rafter bay apart from one another as can be
4 viewed in images 14 & 15.

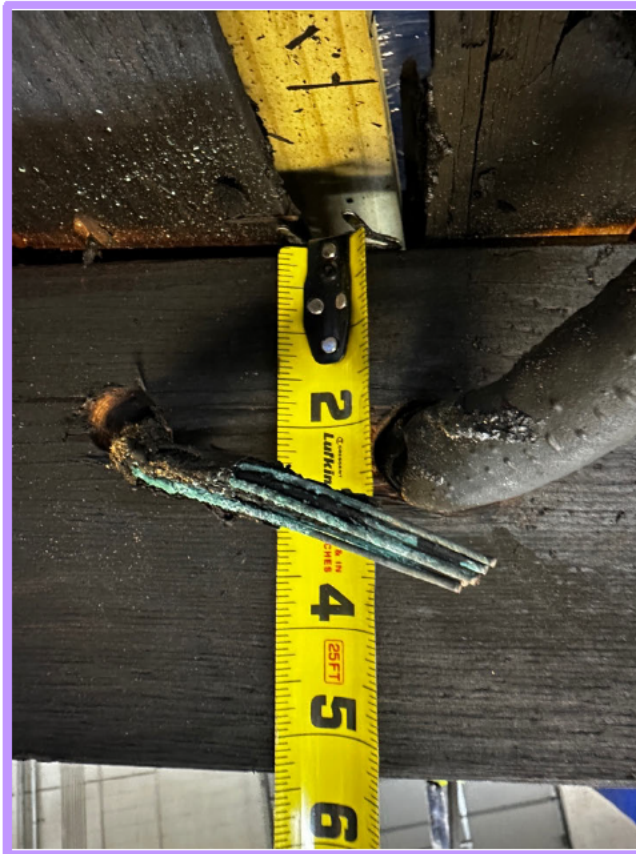
Image 17

8
9 In observing the location of the gas line and wires and their proximity to the top edge
10 of the rafter, image 17, noting that the top edge of the bored holes are 2" and 1 5/8" from
11 the top of the rafter, respectively, a 3/4" thickness of sheathing, the approximate 1/2"
12 thickness of shingles and felt and 1/4" thickness of the L bracket and there is still
13 approximately 1/2" to 1" of space for the lag screw to penetrate the gas pipe or electrical
14 wires if a 4" bolt is used.

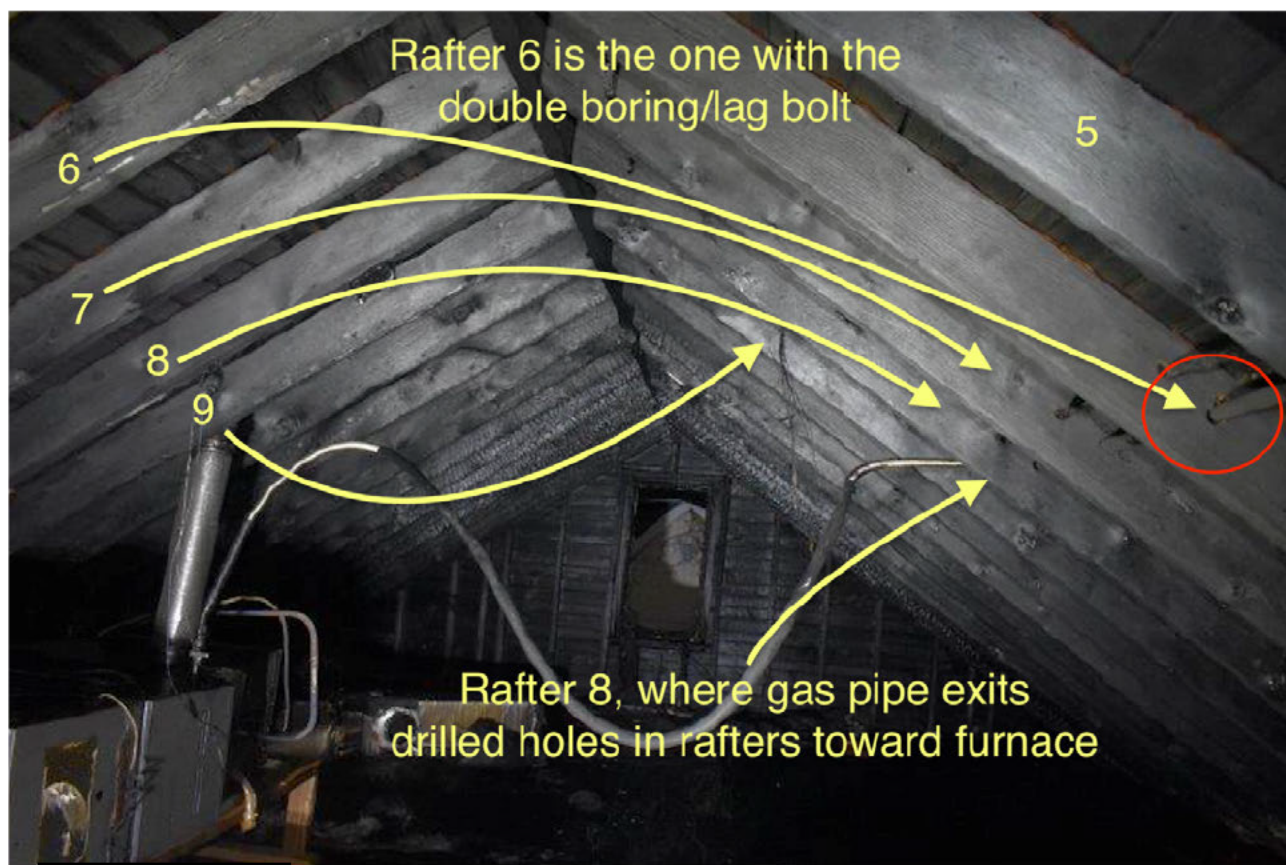
Image 21

1 With images 19 & 20 establishing the locations of the various rafters, image 21 provides
2 the overall point of reference, establishing where the rafters are in relation to the
3 section of roof where the flexible gas pipe runs through the rafters, the same section
4 of roof preserved as evidence, shown in image 18. Additionally, image 21 provides the
5 best (in my opinion) vantage point of Fire Marshal images obtained at the scene,
6 showing rafter and location where a lag bolt that Defendants tradesmen installed,
7 penetrated the gas line. This is corroborated by the ability to still observe the bolt
8 through the bracket and into the gas line when observing the roof section evidence in
9 images 25 – 28. The location of the lag bolt is within the red circle of image 21.

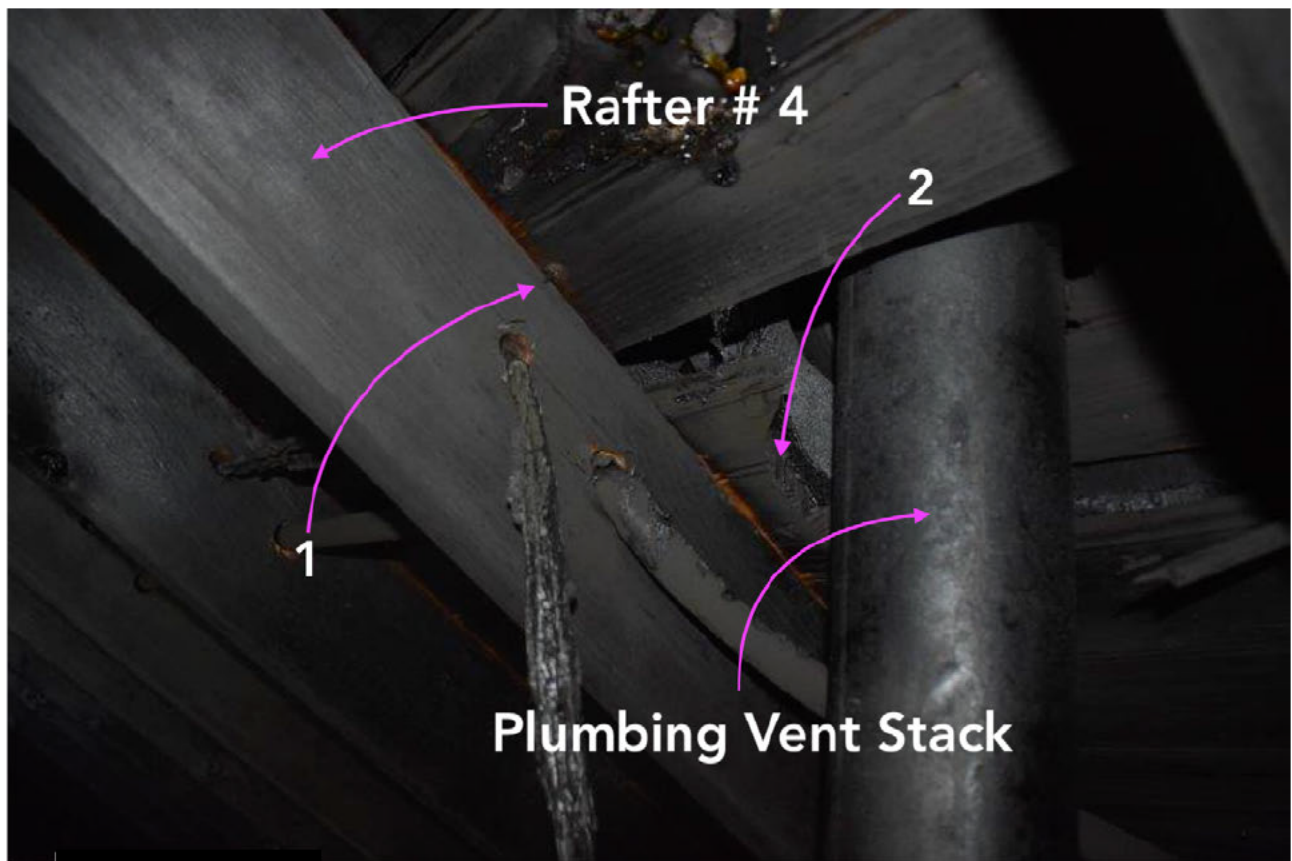
Image 22

000155 (Image 22), is an image of the attic space looking South near the plumbing vent stack as it was after the explosion and fire, produced by the Fire Marshall during his investigation. Rafter #4 was to the East of the plumbing vent stack.

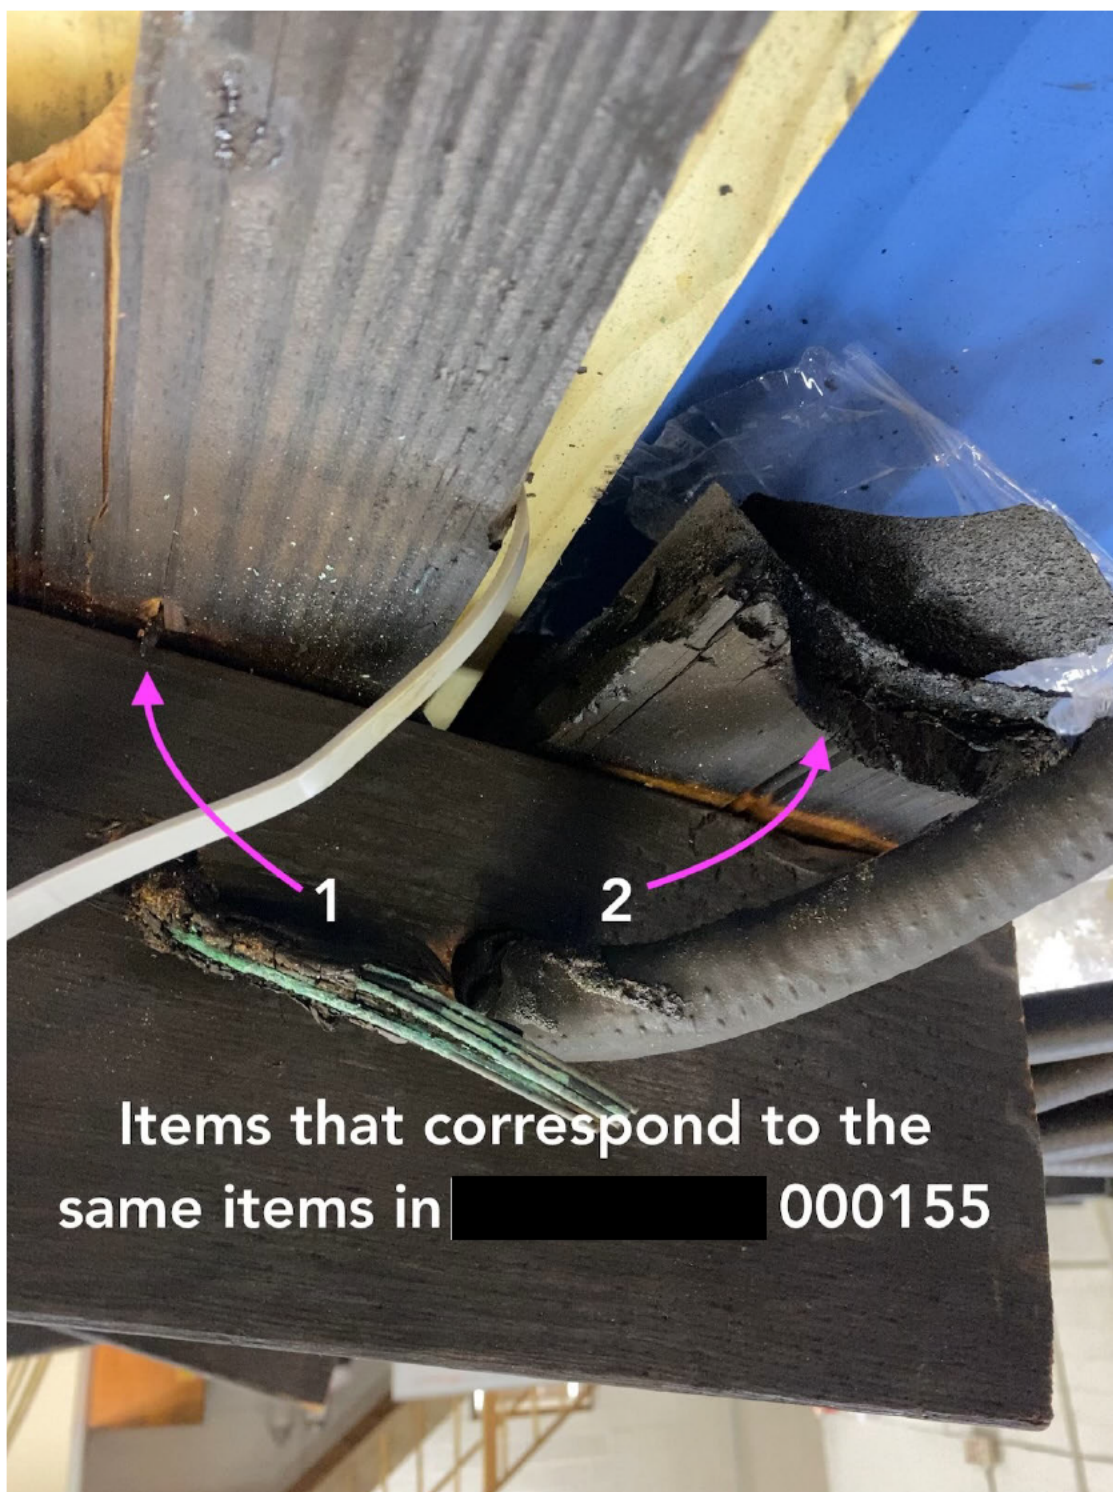
Image 23

Arrows 1 & 2 of image 23 point to the same item's observable in image 22 of the roof section in the evidence facility as a point of reference. The pointed end of a roofing nail is evident at arrow 1 and the circular edge cut-out of the roof sheathing is evident at arrow 2.

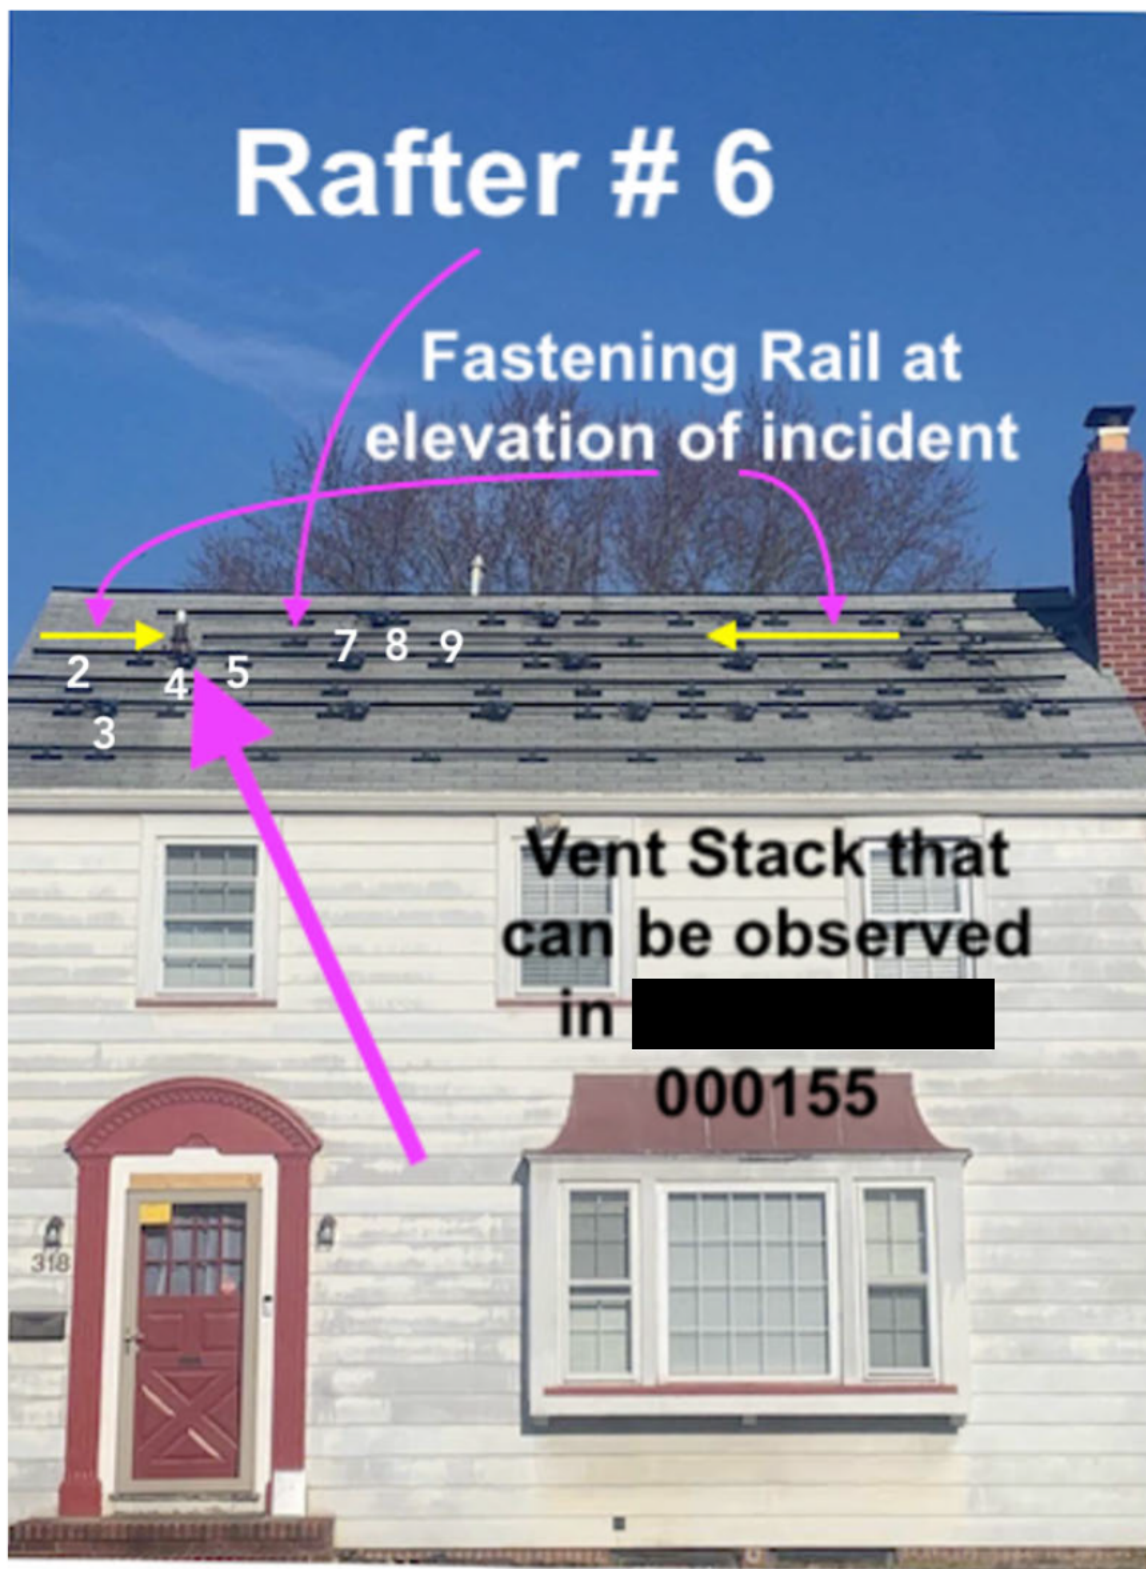
- 1 Image 24
- 2 Image 24 is an image provided by the Defendant, taken by tradesmen on the day of
- 3 installation. I have numbered the rafters as they correspond to the rafters in images 19
- 4 – 21. The yellow arrows identify the horizontal location of the rail, relative to the
- 5 horizontal location of the gas line, perpendicular to the rafters.

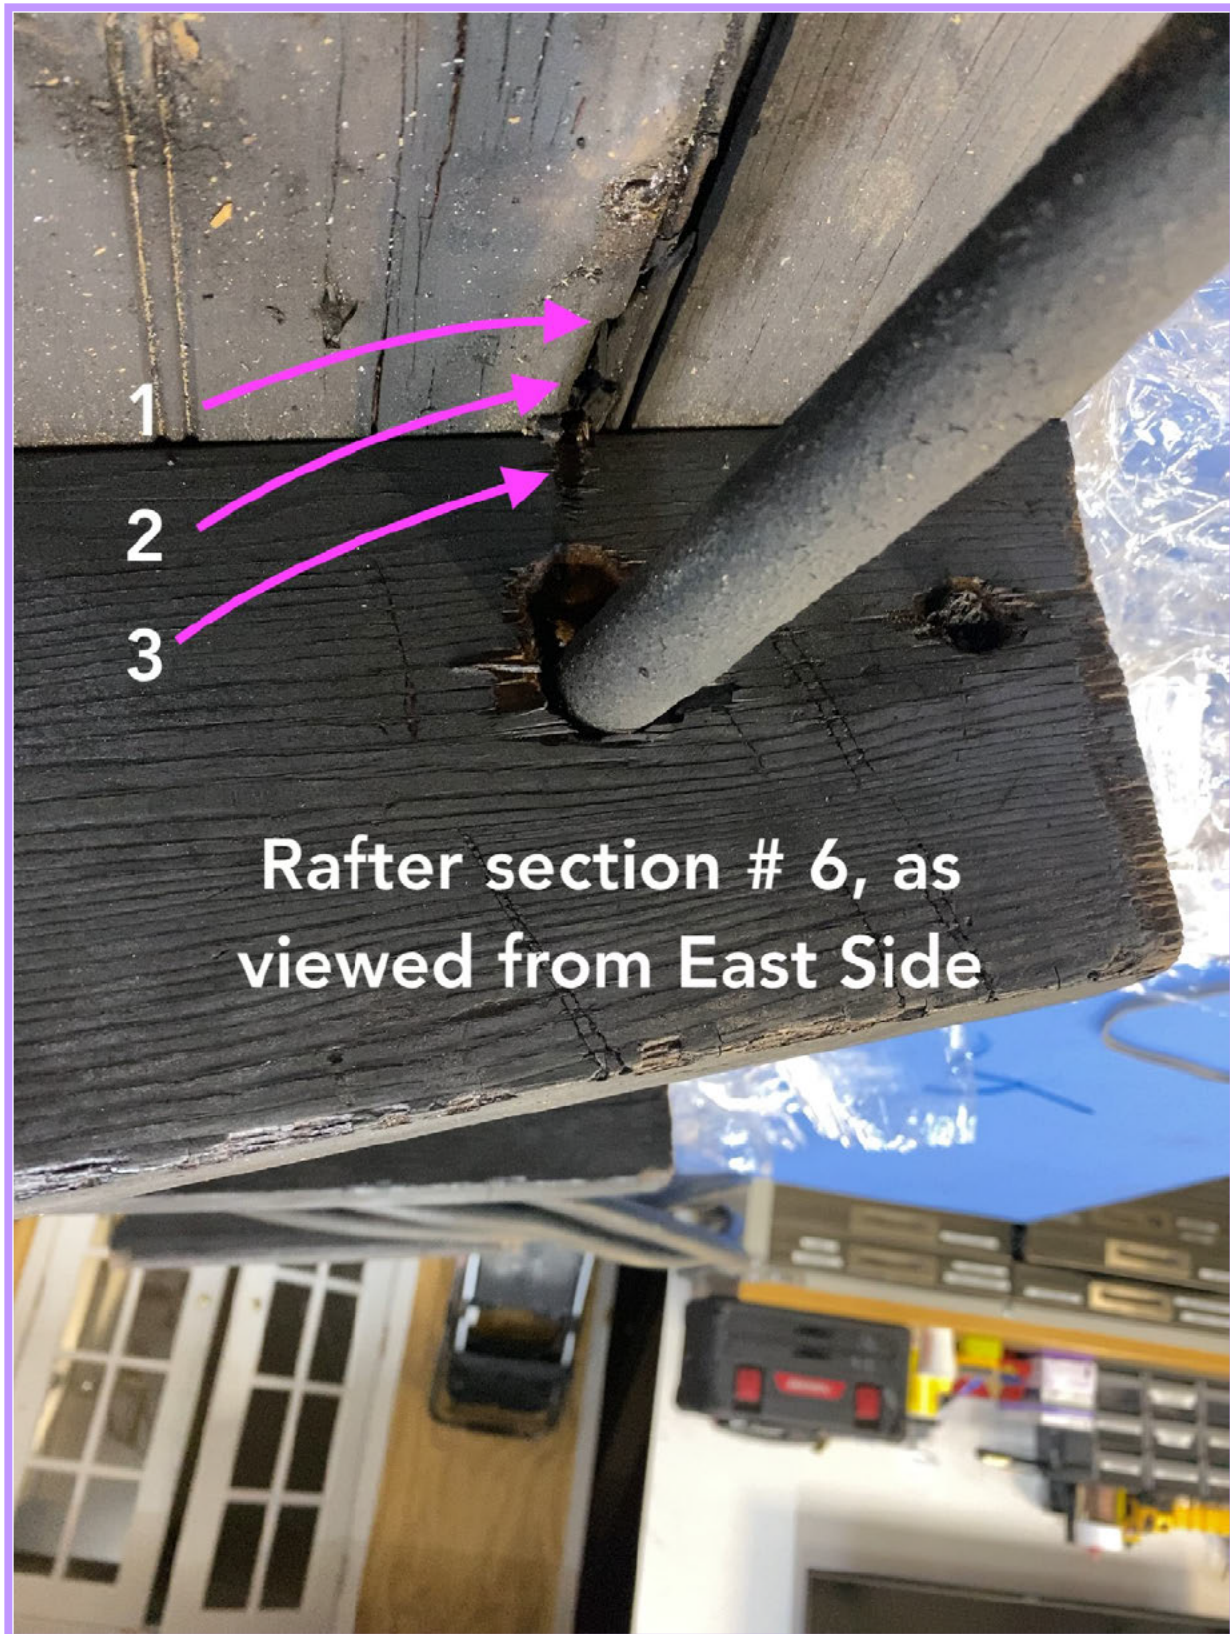
2 Image 26

3 Image 26 is of rafter #6 as viewed from the East side. In this image the following can
4 be observed: Arrows 1 -3 point to evidence of lag bolt penetrations where 3 attempts
5 were made at locating the rafter prior to the 4th attempt engaging the rafter.

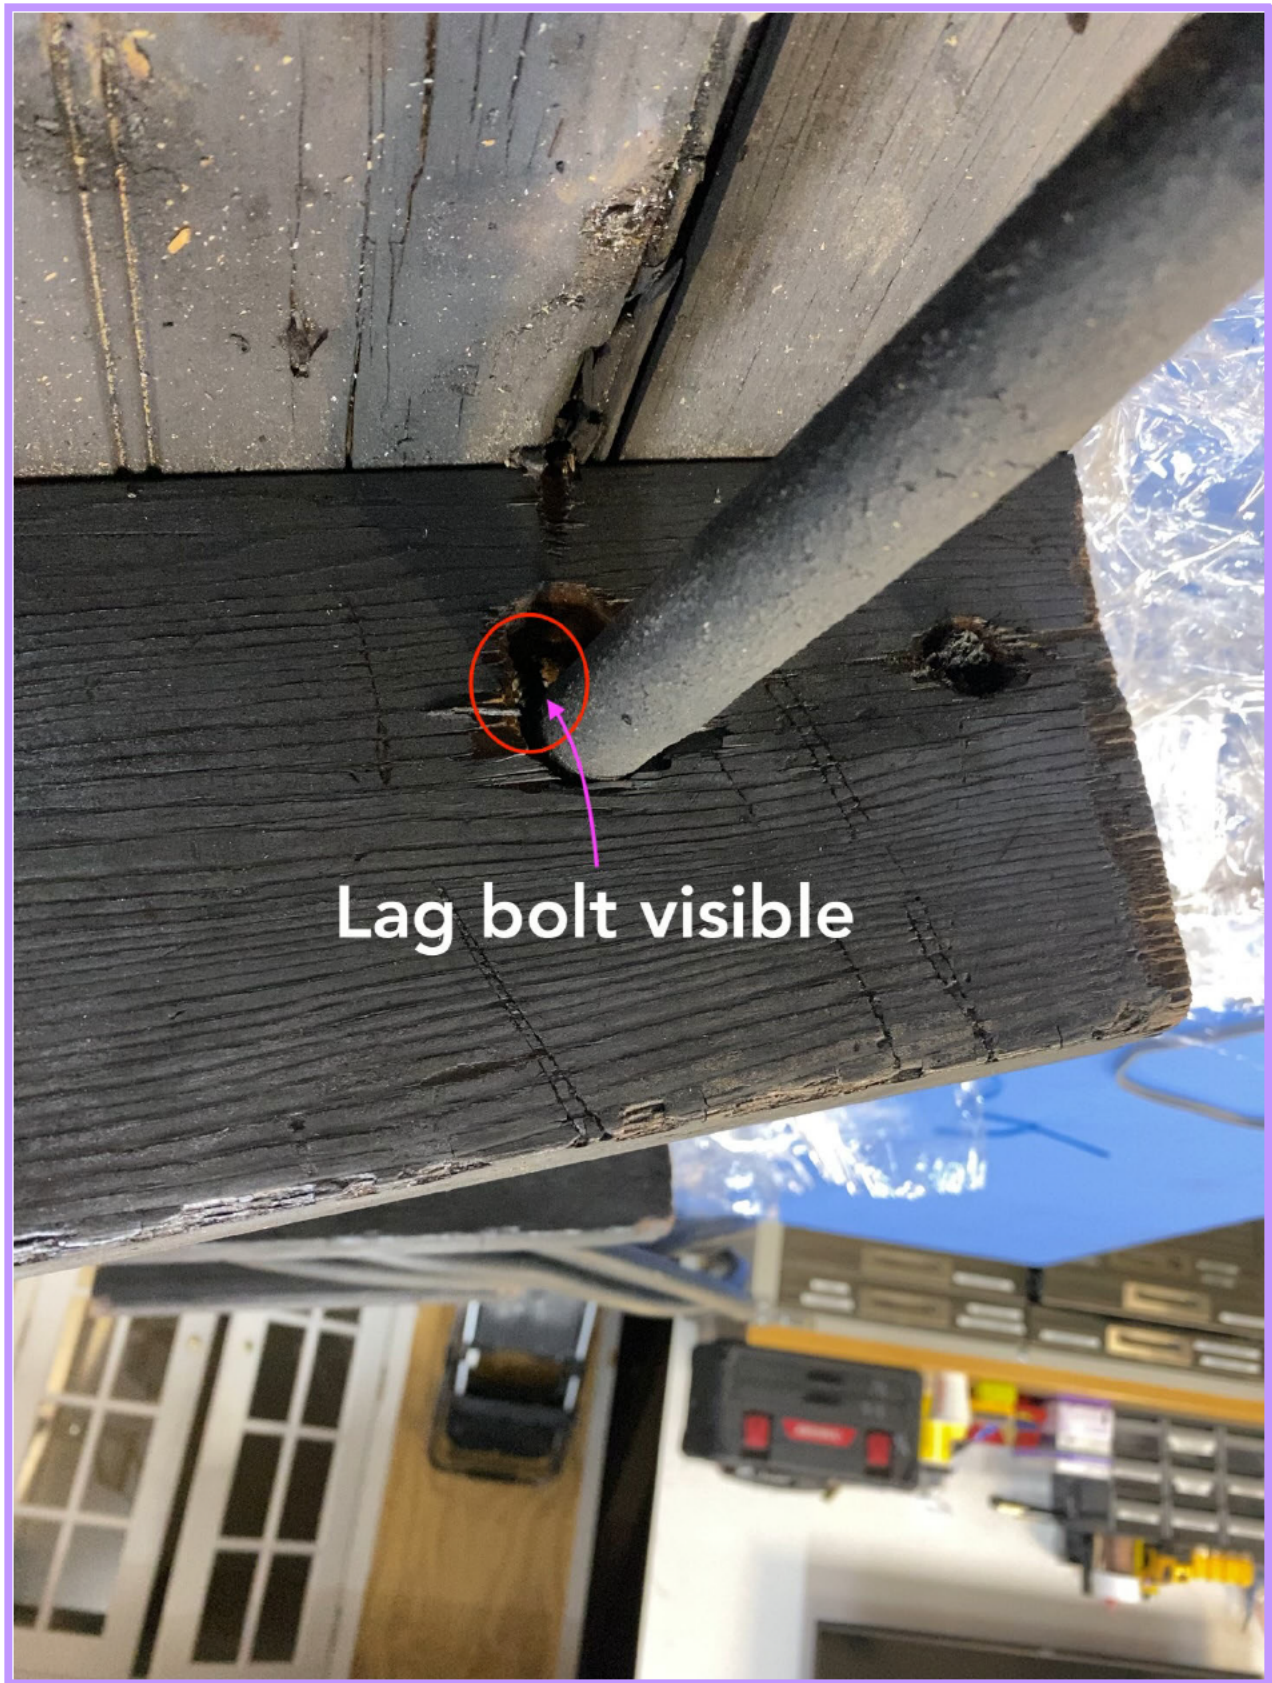
- 1
- 2 Image 27
- 3 Image 27 shows the same East side of rafter #6 with the lag bolt visible in the double
- 4 bored opening for the gas pipe.

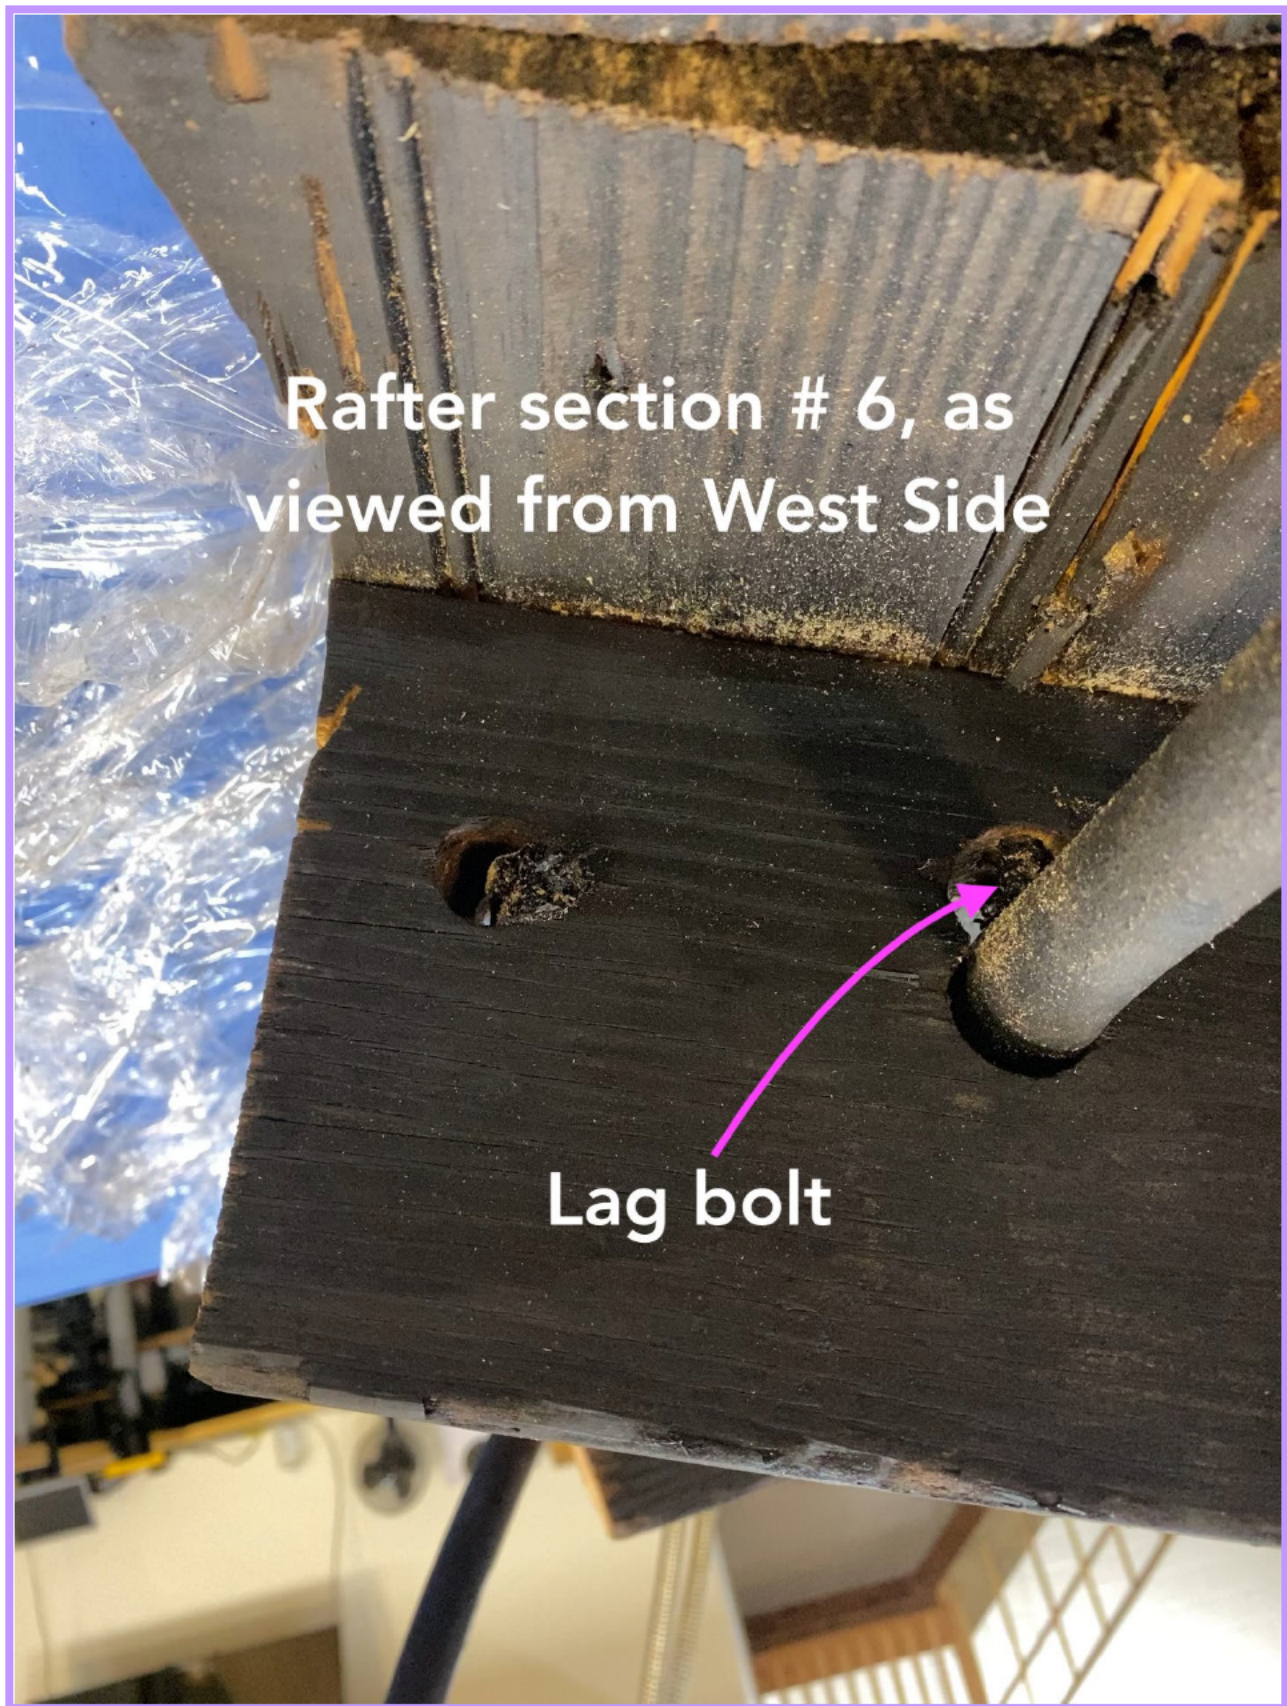
- 1
- 2 Image 28
- 3 This image shows the lag bolt when viewing rafter #6 from the West side.
