# 5 KEY STRUCTURAL BLIND SPOTS IN HISTORICAL BUILDING RENOVATION FOR CONSTRUCTION-DEFECT DEFENSE LITIGATORS + 1 BONUS BLIND SPOT CHECKLIST

# PREEMINENT SOLUTIONS, INC.

## STRUCTURAL ENGINEERS

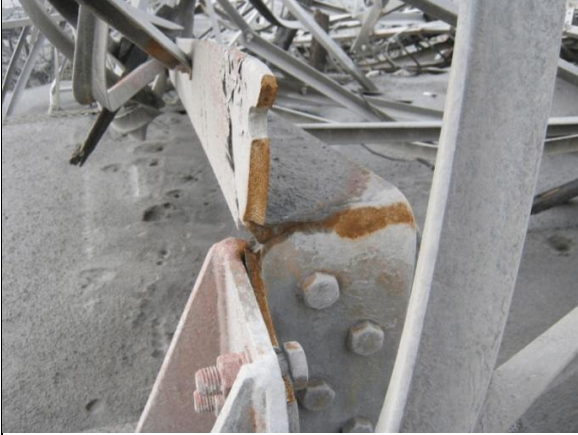
Many historic buildings have shallow or mixed foundation types, making them susceptible to shifting or tilting during Renovation.

Renovation changes including demolitions, heightened vibration loading, overloading, and additions, may negatively impact the structure's foundation resulting in differential settlement.

Key signs of differential settlement include:

- Structural Cracks at Building Corners
- Structural Cracks at Building Openings
- Sloping or Uneven Floors
- Separations of Main and Auxiliary Structures

Cracking patterns must be carefully mapped to separate old movement from new Renovation construction-caused movement.

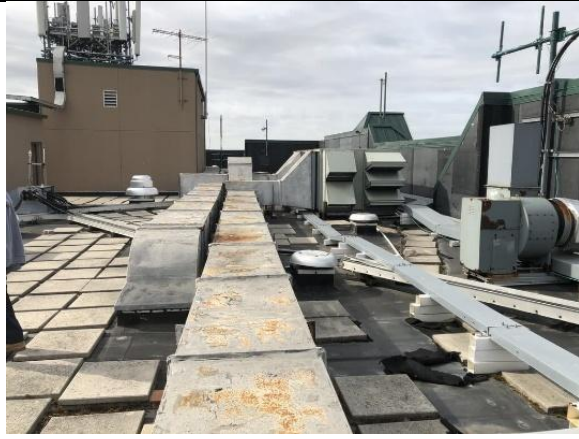
Significantly rusted connections, deformed bolts, cracked welds, and failed metal plate connections pose a significant risk to historic buildings under modern loads.

Furthermore, rusted or brittle connection failures can be sudden under dramatically increased loading.

Key Signs of connection failure include:

- Severe cracking, especially severe cracking with bulging.
- Excessive Floor Deformation
- Excessive Ceiling Sagging
- Rusted Connection Bolts, Rivets, and Plates
- Deformed Connection Bolts, Rivets, and Gussets
- Fractured Welds
- Concrete Cracking directly under heavy bearing plates and joist seats.
- Deformed, Buckled, Bent, or Warped Gusset Plates and Brackets.

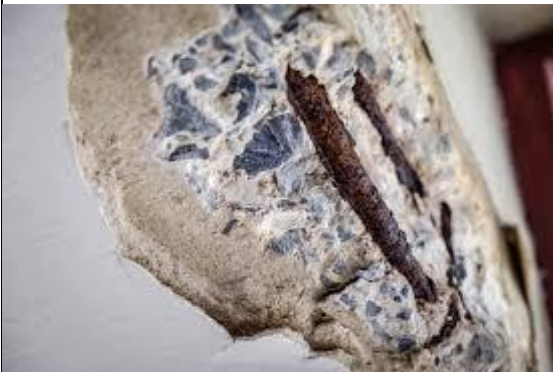
Concrete carbonation is a chemical reaction that occurs when atmospheric carbon dioxide reacts with the alkaline compounds (i.e. calcium hydroxide) within concrete to form calcium carbonate. Concrete carbonation reduces concrete's pH and leading to corrosion of the steel reinforcement.

Although carbonation is a slow process, older structures with insufficient concrete cover concrete ~~buildings may have shallow~~ cover, ~~variable quality~~ cracking, and ~~poor resistance~~

Key signs of concrete carbonation include:

- Chalky Concrete Surfaces.
- Rust-Colored Discharge or streaking on the surface
- Concrete Cracking, Spalling & Delamination
