## Complex Reconstruction of Single Vehicle Accident

## The Scenario

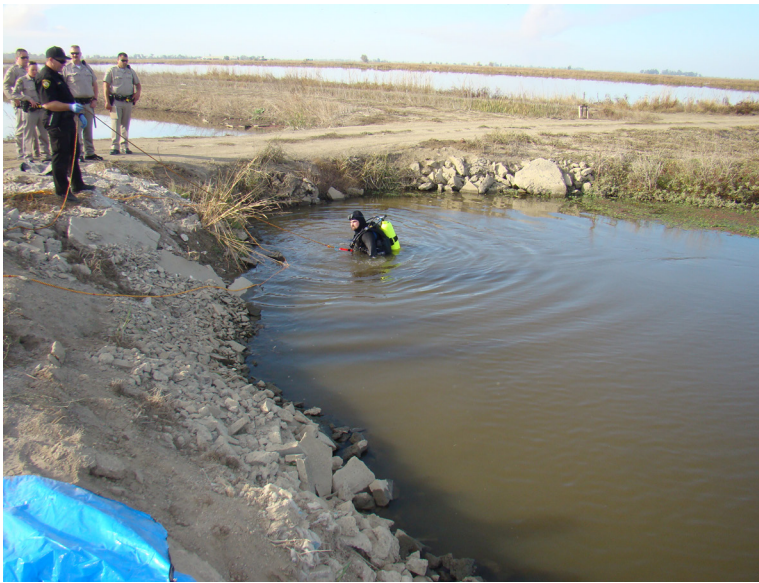
*Accident Scene Photo at the Time of Incident*

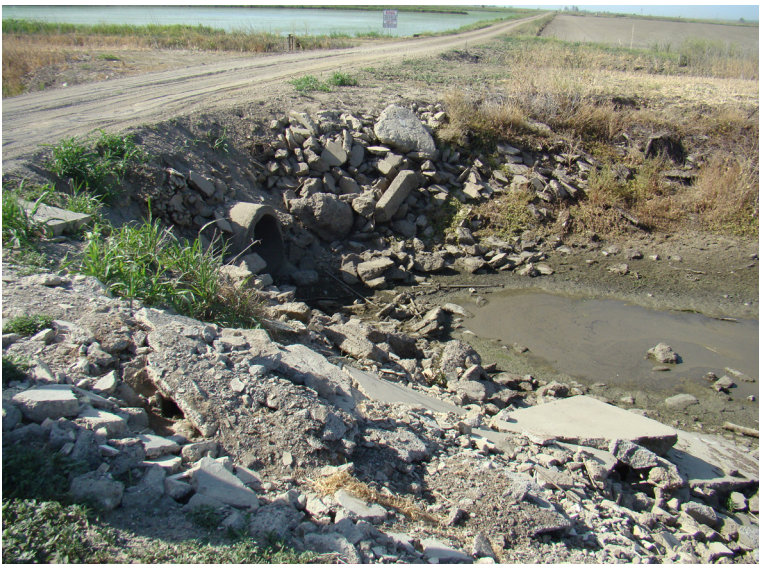
*Accident Scene Photo at the Time of Analysis*

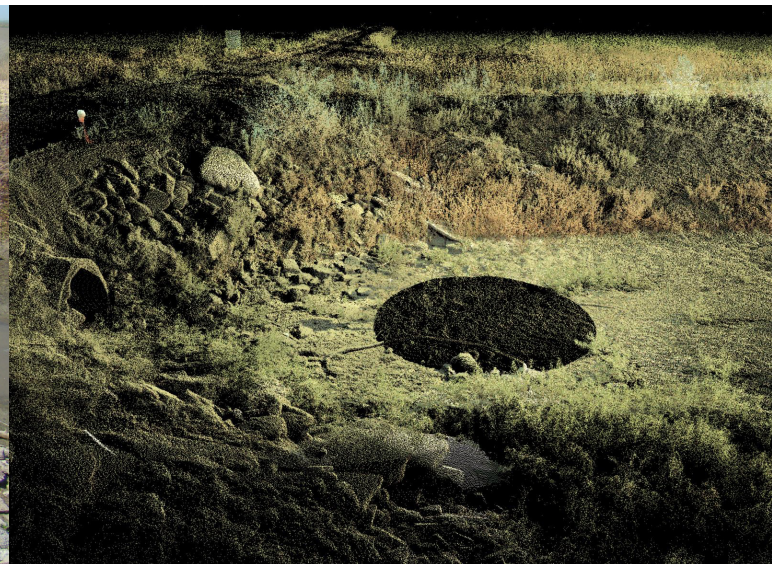
*Laser Scan of Accident Scene*

PSI visited the scene months after the crash when the ditch was empty of water, and utilized our 3D laser scanner to create an accurate 3D model of the surface of the embankment, the floor level under the water and the pipe that was struck by the truck.

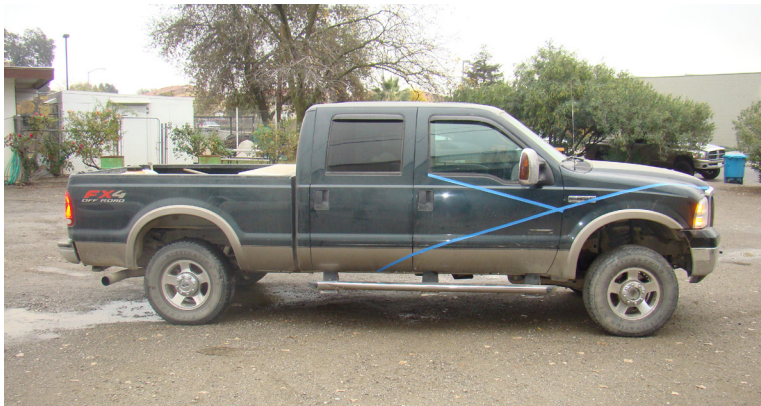
*Photo of Truck Involved in Accident*

As the truck was in the water for a number of hours prior to extraction, there are water marks on the exterior and interior of the truck indicating the level of the waterline relative to the truck at rest. In fact, there are two sets of waterlines – one depicting the level relative to the truck with both doors closed, as the truck was initially at point of rest, and a second waterline on the passenger door depicting the angle of the door when it was opened at a later point. In addition to the waterline evidence, there is damage to the front of the truck near the front license plate that appears to correspond to an impact strike on the underwater pipe struck by the truck, arresting its forward momentum at the point of rest.

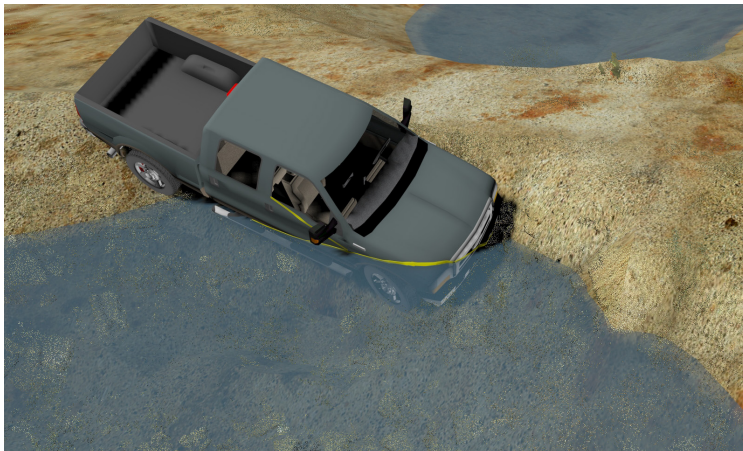
*Waterline with Door Closed*

As previously mentioned, this puzzle had a daunting wrinkle – a second waterline created when the passenger door was opened after a sufficient time to have left an initial waterline on the door in the closed position. As there was no evidence that the F-250 moved between the door open and door closed configurations, a single solution to both puzzles was necessary. Although this proved an extra challenge, it also provided a very stringent double-check as only a solution that solved both configurations would be deemed valid, and yet once derived, it was likely to prove to be a unique solution.

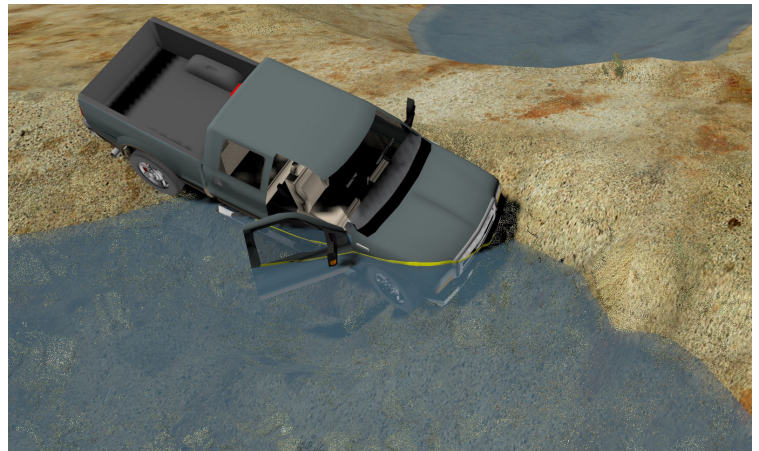
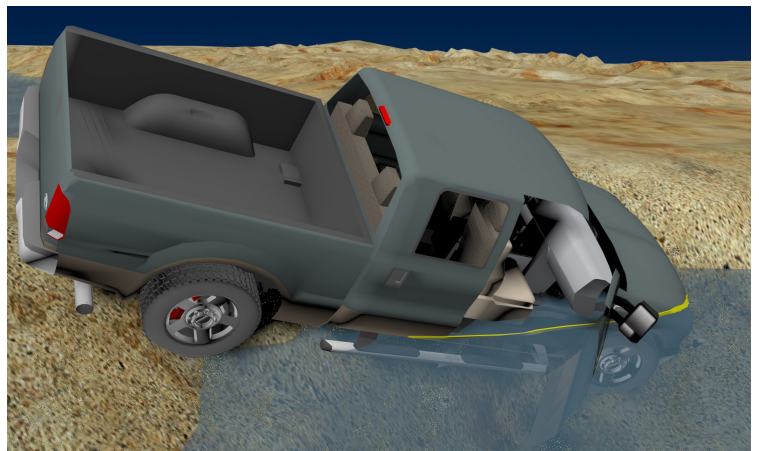
*Waterline with Door Open*

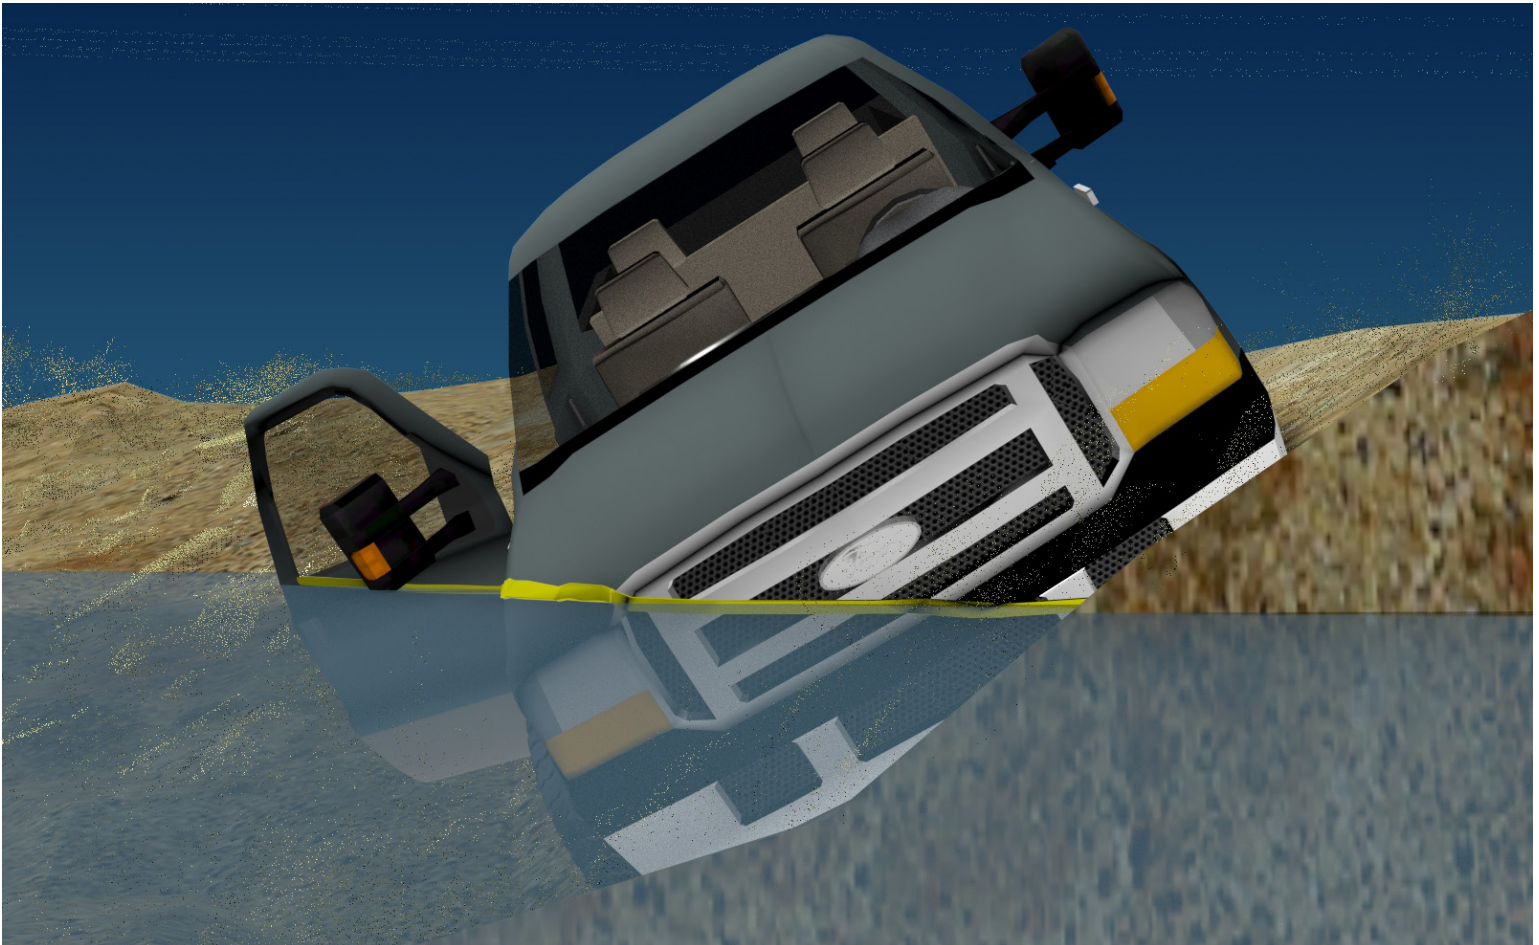
*Waterline with Door Open*

The resulting position of the F-250 and the graphics automatically generated as part of the solution process – an additional benefit to the 3D Working Model – provided the District Attorney with sufficient evidence to quickly resolve the case and seek justice for the family of the victim.
