A Case Study: Reconstruction of Municipal Bus Accidents

Using 3D Computer Simulations and Analytical Techniques to accurately reconstruct and illustrate an event.

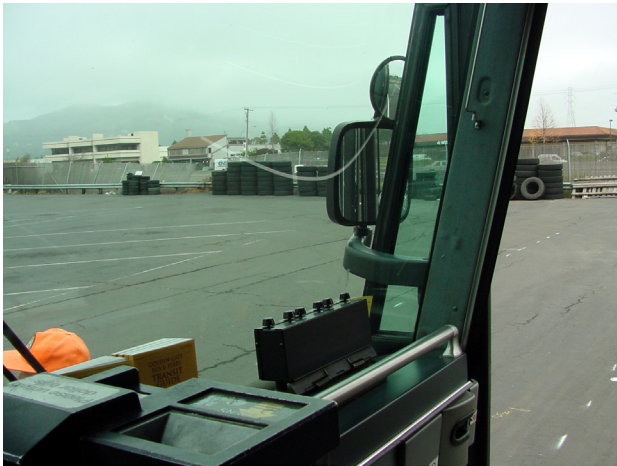
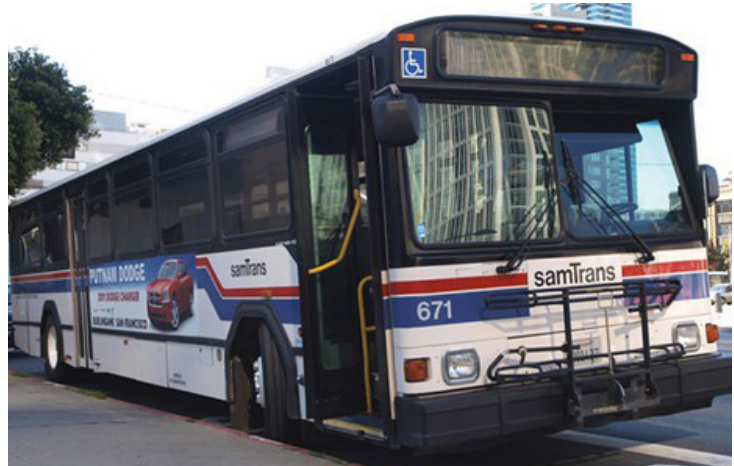
Accidents involving municipal buses often involve pedestrians or cyclists, and can be difficult to reconstruct due to the lack of physical evidence. Often there are no skidmarks, dents or scratches, which are needed to determine the velocity, acceleration, point of impact and trajectories of the involved parties. The large size of the bus, including over-sized mirrors, widow pillars and other internal sight obstructions presents unique visibility challenges.

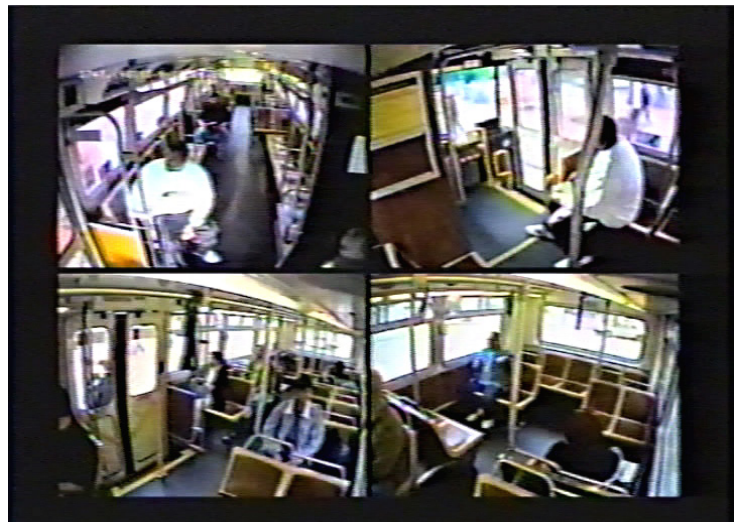
Screen Shot of Surveillance Camera Images

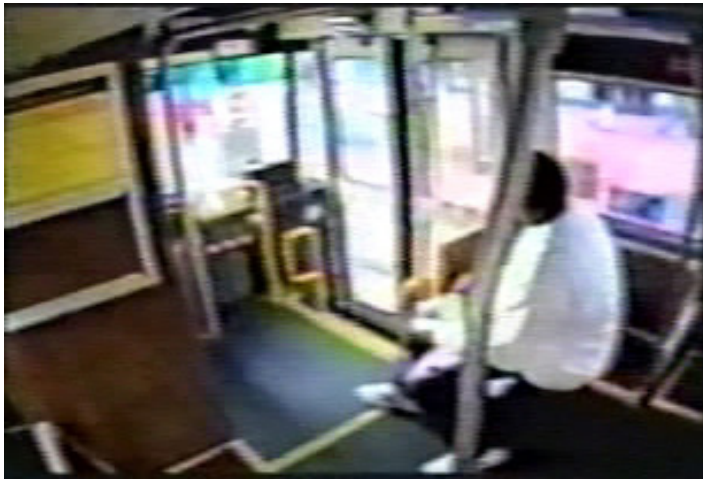
Video camera screenshot Time Segment #1

First the video from the security cameras is separated into individual frames or pictures, which are enhanced digitally to improve clarity and picture quality. These still frames each depict the bus interior and exterior at a single point in time. The rate at which the cameras record the video must be determined in order to use the sequence of frames as a timer. The recording rate, or refresh rate, determines the smallest time interval that can be analyzed for the reconstruction. Typically, today's security cameras record at a rate of 1.5Hz or 1 new picture every $\frac{2}{3}$ of a second. Therefore, objects that pass by the bus and are visible in the video 2 frames apart occurred $\frac{2}{3} \times 2 = 1.33$ seconds apart. This method can be used to determine the time between any event or object that is recorded by the video, such as the passing of trees or traffic signals.

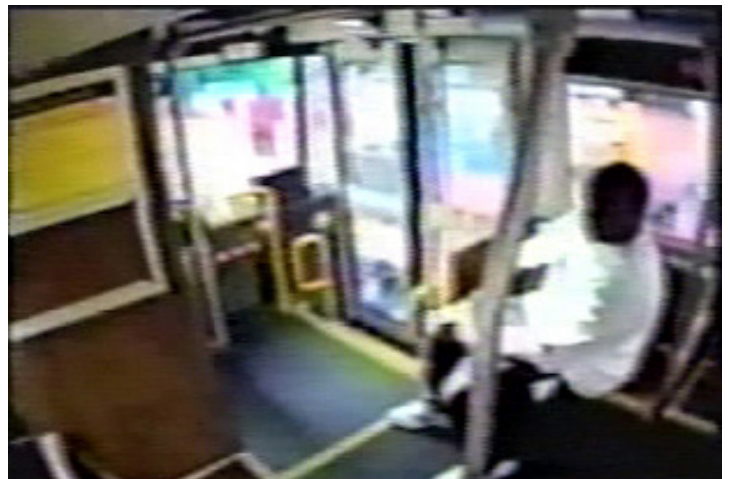
Video camera screenshot Time Segment #2

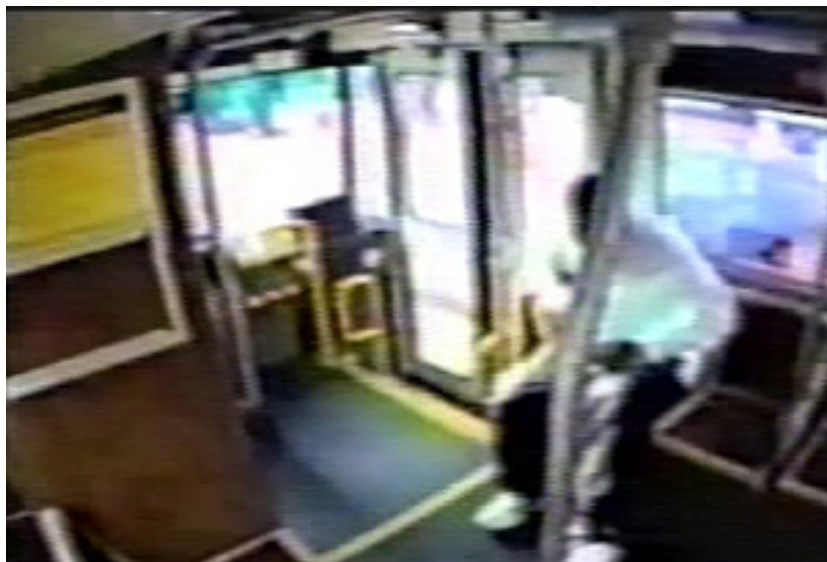
Video camera screenshot Time Segment #3

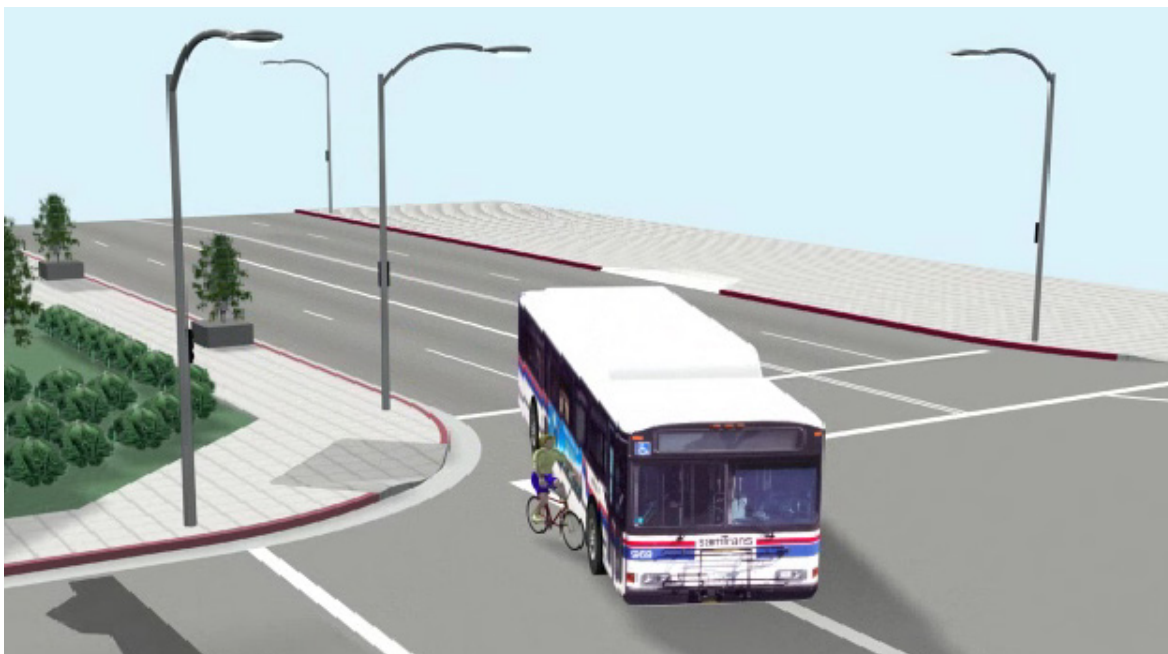
Scene from animation: Bicycle colliding into bus.

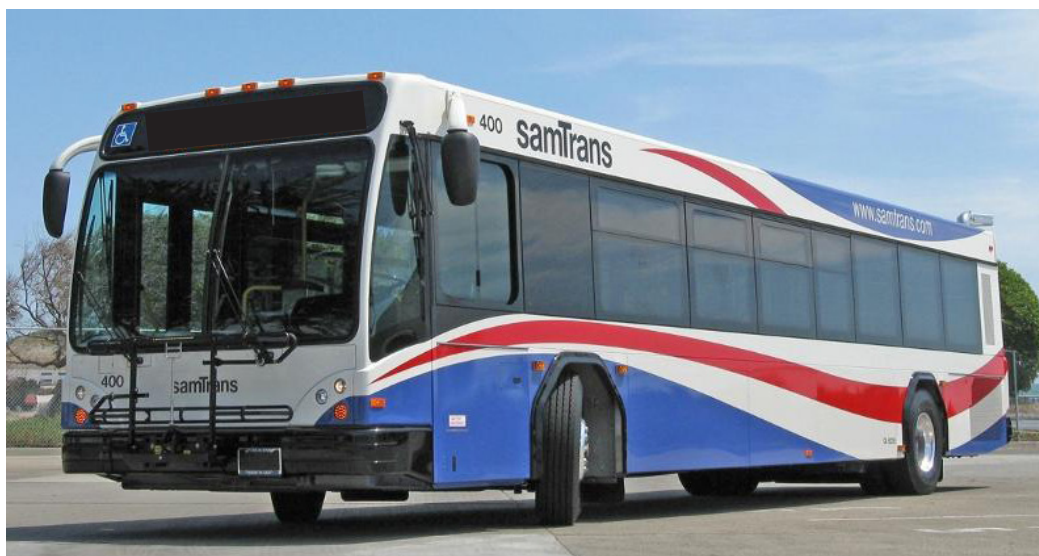
Typical City Bus.

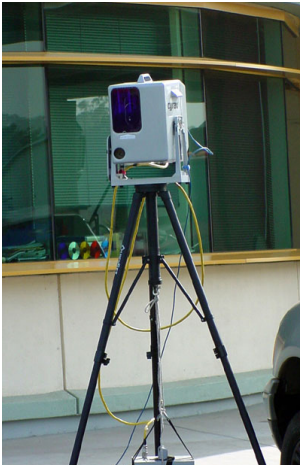
3D Laser Scanner

A 3D laser scanner is an advanced class of survey instruments that is used to remotely measure surface geometry of sites and structures with extraordinary completeness, accuracy and speed.

Unlike traditional surveying tools that are used to record certain, selected points within a scene, a 3D laser scanner automatically blankets the scene with millions of closely spaced point measurements. The resulting “point cloud” is used to create extremely accurate 3D Models of everything that the laser “sees”. No other method of scene or object data capture comes close to the level of accuracy demonstrated by the laser.
