Performance of REBAM® during ball bearing failures

By Tyler Colwell, PE

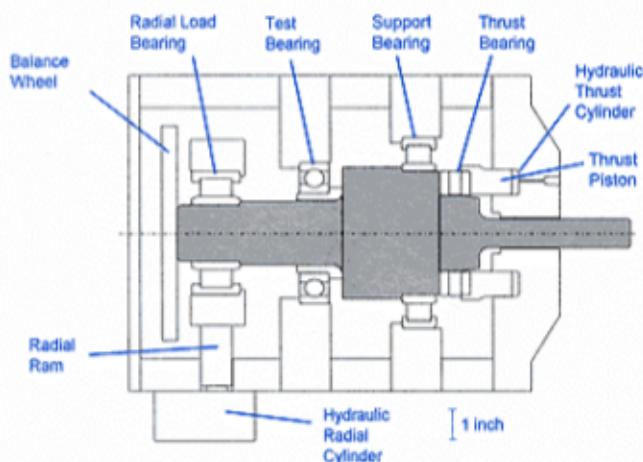
Figure 1
REBAM® test rig.

Figure 1 shows the conceptual design of the test rig. Loading of the test bearing is achieved hydraulically with independent radial and axial loading cylinders. Radial loading is achieved with a hydraulic ram bolted to the side of the casing which directly loads a cylindrical roller bearing mounted in a floating housing, in turn causing loading

of the test bearing. By mechanical advantage, the test bearing sees approximately twice the amount of radial load as that input by the radial cylinder. Axial loading is achieved by an axial loading piston mounted in an annular cylinder which is machined into the inboard endplate. This load is transferred to the shaft via a cylindrical roller thrust bearing and taken up by the test bearing. Loading can be controlled between zero and 5000 lbs (22.2 kN) radially and zero and 6000 lbs (26.7 kN) axially.

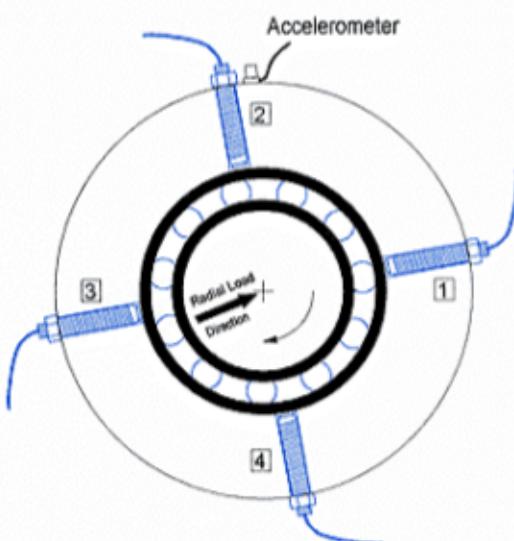
Figure 2
Test bearing transducer layout.

The test bearing was instrumented (Figure 2) with four REBAM® probes mounted 90 degrees apart around the circumference of the outer ring to allow simultaneous data acquisition from multiple probe orientations. The probes were identified as Channels 1 through 4, with Channel 1 being nearest (11 degrees clockwise from) the center of the radial load zone and the other three numbered sequentially in the direction

opposite shaft rotation (shaft rotation was clockwise). In addition to the REBAM® transducers, a high-frequency accelerometer (4.5 - 14000 Hz ± 3 dB) was mounted on the external surface of the test bearing housing. The accelerometer was mounted near true vertical orientation. From a vibration transmissibility standpoint, the accelerometer was optimally mounted. Actual machinery usually has material gaps, webbing, and longer distances between the source of vibration (bearing) and the transducer that the vibration must traverse. This causes attenuation of the vibration signal. The data from the accelerometer was therefore taken in a "best case scenario."

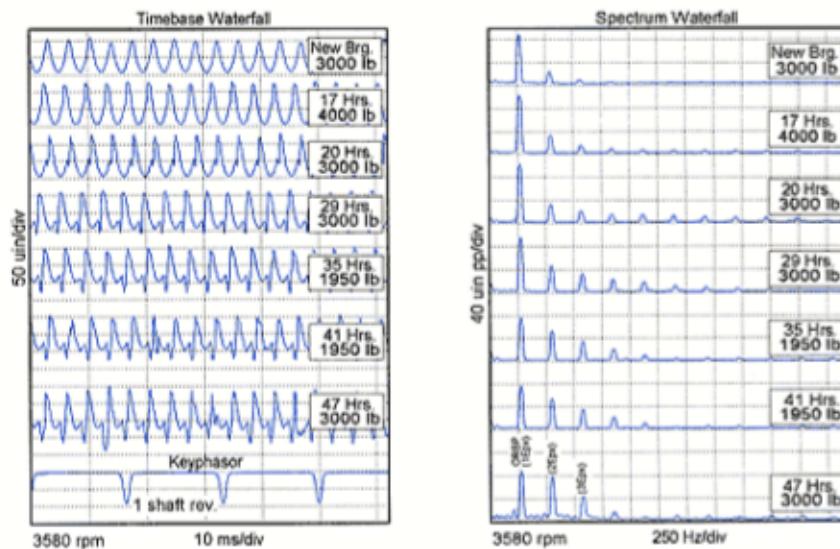
Figure 3
Failure progression under radial loading as seen from Channel 1 REBAM® Probe (11 degrees from center of load zone).

After approximately 20 hours of continuous operation, evidence of spalling could be seen on the Channel 1 REBAM signal (see Figure 3). This was seen as a small negative spike in the Timebase waveform which occurred once every element pass cycle. In the frequency domain, this manifested itself as an increase in the amplitudes of the harmonics of the Outer Race Element Pass frequency (2EPx, 3EPx, 4EPx, etc.). The 1EPx component was probably also increased, but under this excessive loading it was already very high, making the change less noticeable. After 29 hours of operation, the bearing was inspected for damage progress. The damage was limited to the spalling in the outer ring (Figure 4). This spalling occurred in the outer race very near the Channel 1 probe (initiated by the small hole). There was no visible spalling on either the elements or the inner race at this point.

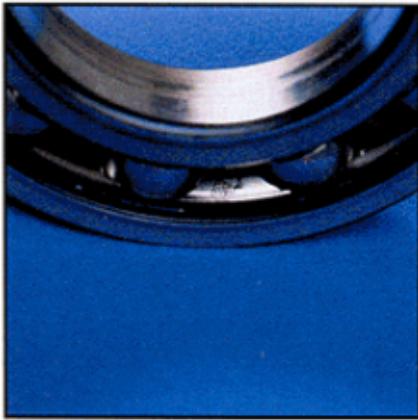
Figure 4
Evidence of spalling in the outer ring.

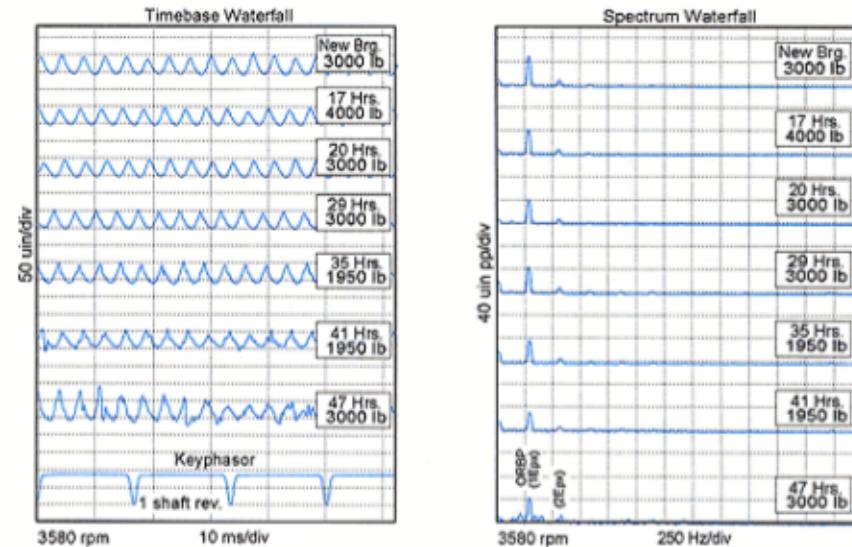
Figure 5
Failure progression under radial loading as seen from Channel 2 REBAM® Probe (79 degrees from center of load zone).

and Channel 4 REBAM® signals also started showing evidence of spalling. It did not show up in the same fashion on Channels 2 and 4 as it did on Channel 1. Instead of a once-per-element-pass negative spike, Channels 2 and 4 started showing erratic behavior with negative spiking which occurred once-per-shaft-revolution. This 1X spiking was more easily viewed in the live oscilloscope data than the data shown in Figure 5. In the frequency domain, this showed as increased amplitudes in the Prime Spike region and Rotor region. Channel 3 was in a severely unloaded location with this extreme radial load and therefore did not show much amplitude before or after spalling. This does not happen under realistic loading, as we shall see. The failure progression as seen on the Channel 2 REBAM® probe is shown in the Timebase and Spectrum Waterfall plots of Figure 5.

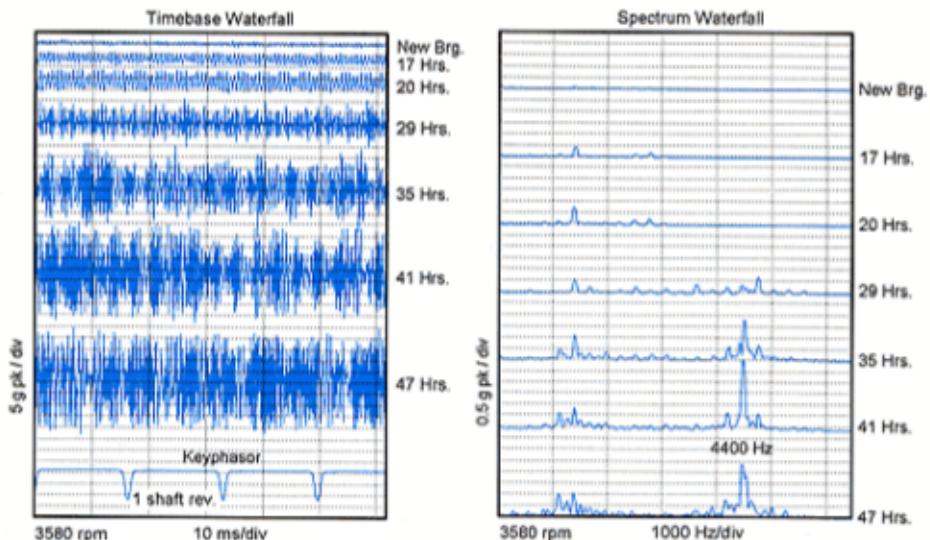
Figure 6
Failure progression under radial loading as seen from accelerometer.

Figure 6 shows the failure progression as seen from the accelerometer. After 17 hours under 3000 lbs (13.3 kN) radial load (when the Channel 1 REBAM® signal started to show damage), the accelerometer signal was already significantly higher in amplitude than the baseline level. The first three samples shown were taken with a bandwidth of 2500 Hz and the remaining samples at 5000 Hz. As bearing damage progressed, the impulse excitation caused by elements impacting

spalled areas excited structural resonances in the system. The first resonance was at about 1400 Hz, and the second (which could be seen in the Spectrum after the recording bandwidth was changed to 5000 Hz) is seen at about 4400 Hz. Transducer resonance was in excess of 50 kHz, and was therefore not a factor. Very little was seen in the accelerometer signal at any of the bearing characteristic frequencies. These components were likely below the noise level of the signal.

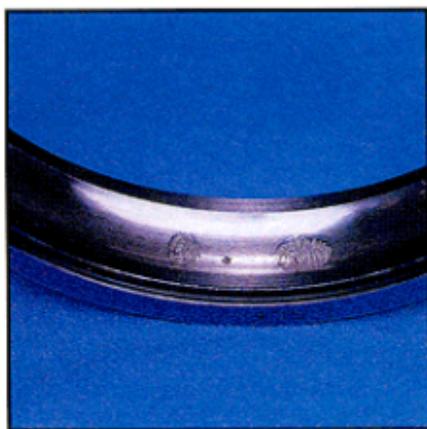
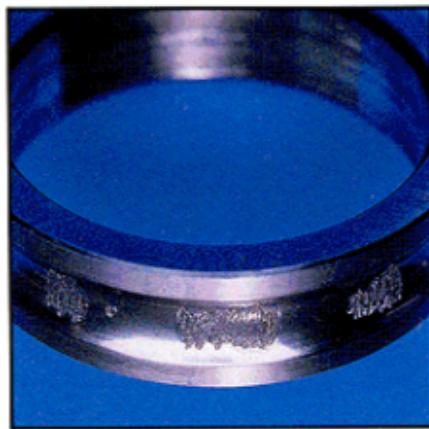
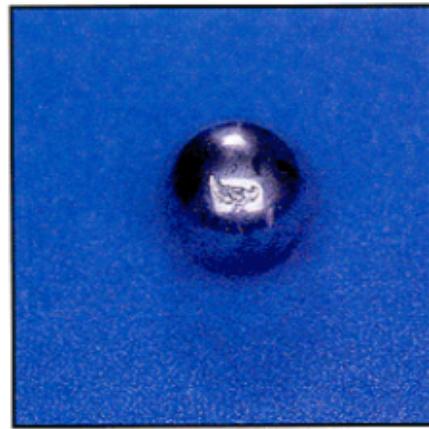
Figure 7
Final spalled condition of the bearing (from left to right: Outer, Inner, Element).

After failure was achieved on the test bearing (when the rig could no longer run without the monitoring system tripping it off-line), the bearing was inspected again. Significant spalling was seen on the inner race, and one of the elements had a small, half-moon shaped pit. Figure 7 shows the final spalled condition.

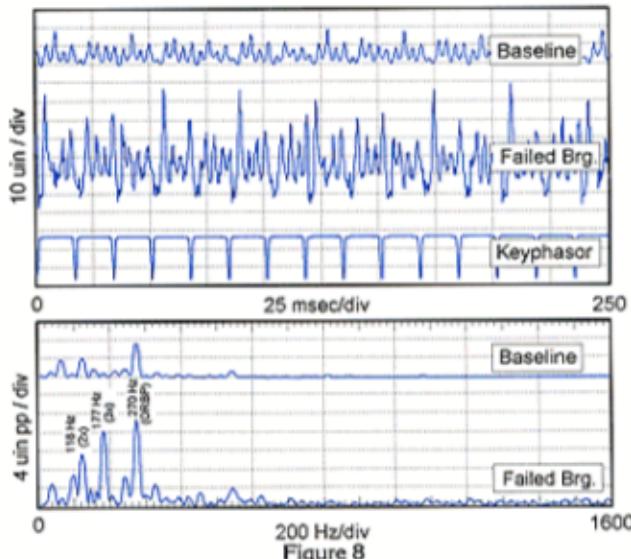
Figure 8
Baseline and failed bearing data under 300 lbs. (1.33 kN) radial load as seen from Channel 1 REBAM® Probe.

With this in mind, the next step was to use a bearing with extensive spalling and place it under low radial load (300 lbs, 1.33 kN). This was the bearing that was run to failure in the axial load failure test (the data from this failure progression will be discussed in the next issue of *Orbit* in part II of this article). It contained spalling on the inner raceway and several of the elements. The signal levels were then compared with the baseline levels at the same load. The speed was again 3550 rpm. Figure 8 shows the signal from the Channel 1 REBAM® probe for the baseline and failed bearings. The signal from the Channel 1 probe showed a 130 percent increase in overall signal level, Chan-►

nel 2 showed a 160 percent increase, Channel 3 showed a remarkable 860 percent increase, and Channel 4 increased by 214 percent. The large increase seen on Channel 3 is due to its small baseline amplitude. This shows one very important point: If a REBAM probe is mounted directly opposite the center of the radial load zone in a bearing under pure radial loading, you may not see a large signal when the bearing is healthy or new, but when the bearing fails, it will likely produce enough deflection in the outer ring to produce a large change in signal amplitude. Much of the change occurred at the outer race element pass frequency, but we also see a large change in the components in the rotor frequency region, particularly the 2X and 3X components.

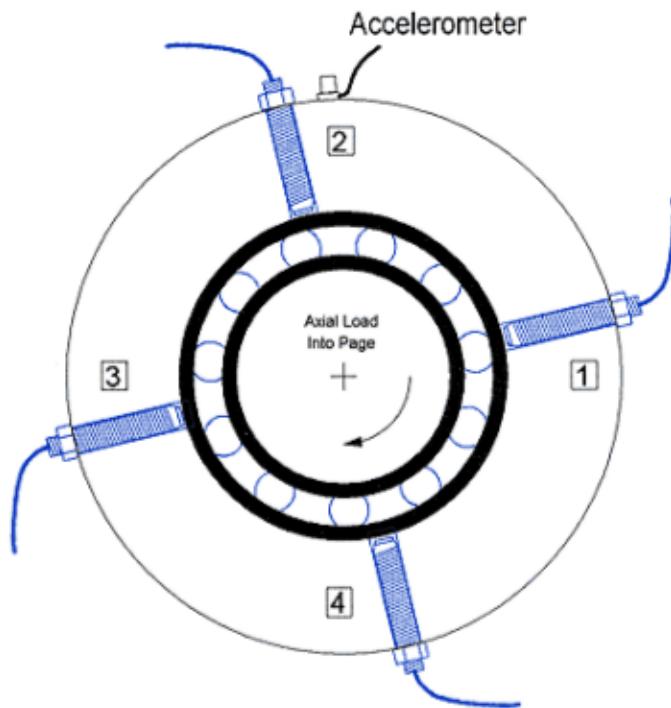
Figure 1
Test bearing transducer layout

The test bearing was instrumented with four REBAM® probes distributed 90 degrees apart around the outer ring of the bearing. The probes are identified as Channels 1 through 4, with Channel 1 being closest to the center of the radial load zone (11 degrees). The

other three REBAM® probes are numbered sequentially in the direction opposite shaft rotation (shaft rotation was clockwise). An accelerometer was mounted near true vertical orientation on the outer surface of the test bearing housing. Figure 1 shows the layout of

the REBAM® transducers and the accelerometer. The test rig was driven by a 15 horsepower AC motor equipped with a variable speed drive. For the bearing failure testing, the shaft speed was approximately 3550 rpm.

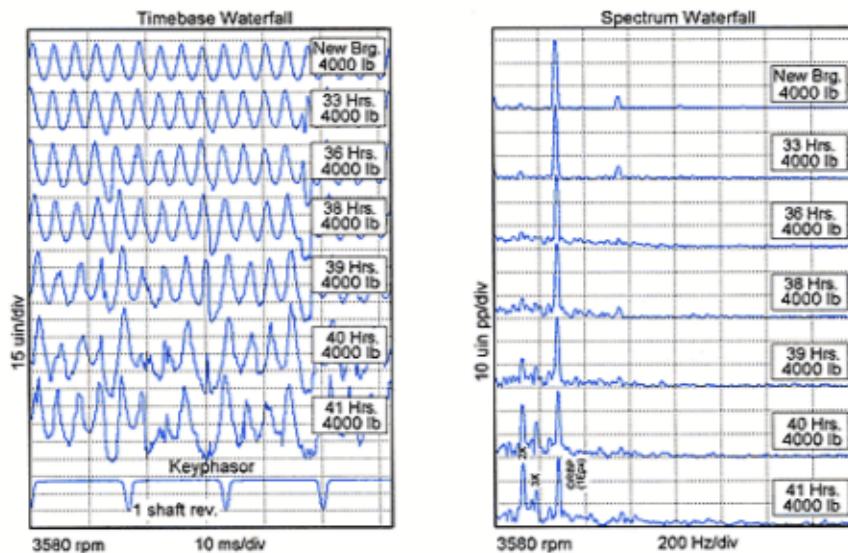
Figure 2
Axial load failure progression as seen from the Channel 1 REBAM® probe

Figure 2 shows the axial load failure progression as seen in the signal from the Channel 1 probe. The other three channels showed nearly identical failure progression patterns, with Channel 2 being slightly higher in amplitude. The spalling initially shows up as a relatively discreet negative spike once per shaft revolution. As the damage to the bear-

ing progresses, the spall area broadens, and we see a corresponding broadening of the spikes. Eventually, additional spalled areas show up on the inner race and some of the rolling elements. This makes the signal very complex, since spalling begins to coincide with contact points in a more random fashion.

From this data, we can now say that inner race and/or element spalling will also show up in this region. In particular, the Spectra in Figure 2 show a large increase in the 2X and 3X components in the final four hours of axial load testing, probably due to additional areas of spalling developing on the inner race. For example, two diametrically-opposed inner race spalls would produce element contact with a spall near a given REBAM® probe twice per shaft revolution (2X); three would produce 3X, etc. After removing the test bearing and inspecting the races and rolling elements, enough damaged areas were observed on the inner race to produce this effect. Figure 3 shows the damaged test bearing from the axial load failure test. There was no visible spalling on the outer race.

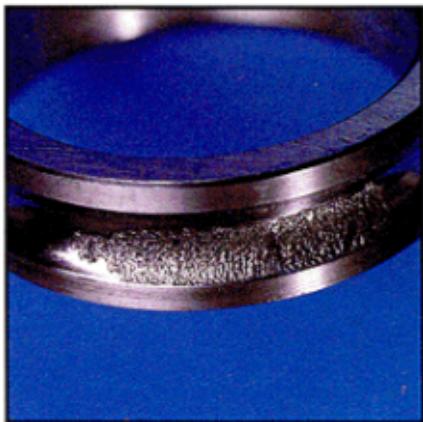
Figure 3
Inner race damage and element damage

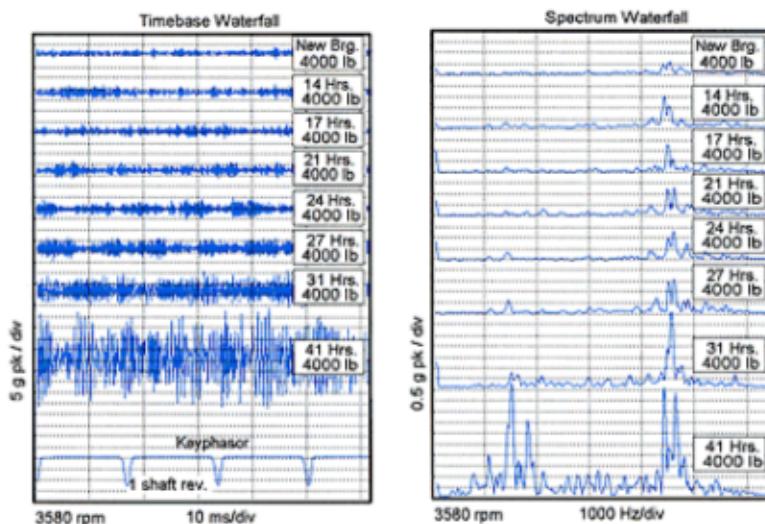
Figure 4
Axial load failure progression as seen from Accelerometer

As in the data from the radial load failure test, the data from the accelerometer during the axial load test shows excitation of structural resonances. Figure 4 shows the axial load failure progression as seen on the accelerometer. After 31 hours of testing, the accelerometer base loosened, so the data was therefore invalid between 31 hours and 41 hours. The Spectrum Waterfall plot in Figure 4 shows that the majority of the vibration energy is in two regions: one centered near 1450 Hz and the other near 4500 Hz. There is very little vibration down in the vicinity of the element pass frequencies. As in the radial load test, vibration energy at these lower frequencies was likely lost below the noise level of the accelerometer signal.

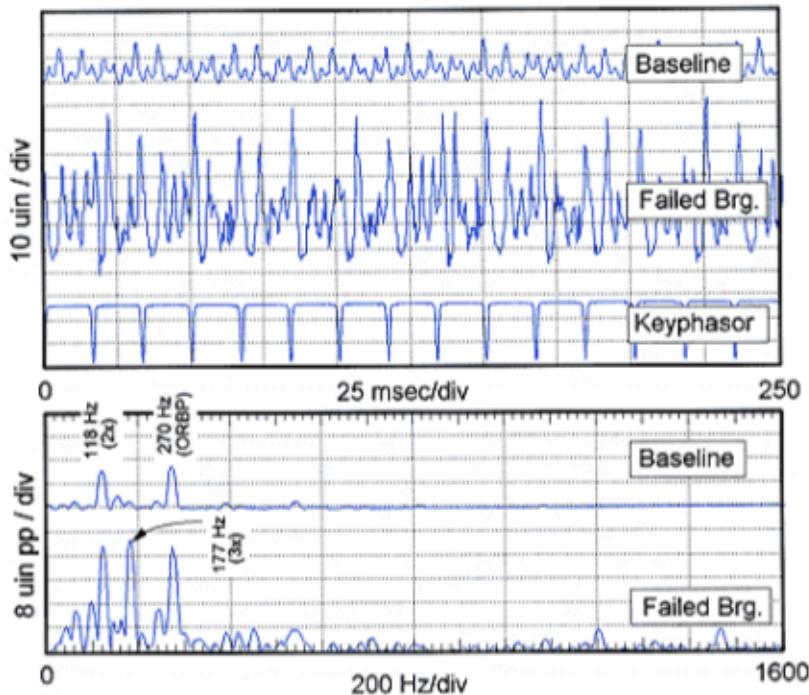
Figure 5
Baseline and failed bearing data under 300 lbs (1.33 kN) axial load as seen from Channel 1 REBAM® probe

damaged from the axial load failure test, was placed under 300 pounds (1.33 kN) of axial load, and the signals were compared to those on a new bearing under the same loading. Figure 5 shows the results in the Channel 1 REBAM® signal. It is clear that the outer race element pass component does not dominate the signal to the degree that it does under high axial load. The unfiltered amplitude of the signal increased from about 17 to 70 μ in pp (0.43 to 1.8 μ m pp), a 310 percent increase. The Channel 1 signal filtered to the Rotor Frequency Region increased from 7 to 40 μ in pp (0.18 to 1.0 μ m pp), a 470 percent increase. The Prime Spike filtered region showed a 250 percent increase from 10 to 35 μ in pp (0.25 to 0.89 μ m pp).
