# TOP SIGNS OF CONCRETE MASONRY DETERIORATION

(AND WHAT TO DO ABOUT IT)

## CHECKLIST

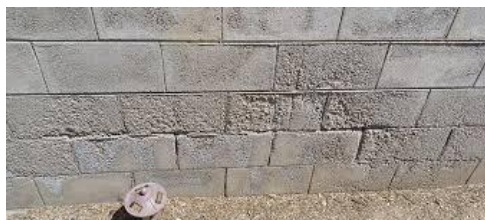
## 4. Spalling / Flaking:

Crumbling, spalling, or flaking of the CMU block surface may indicate reduction in load bearing capacity of structural elements.

Potential causes of spalling and flaking include water intrusion.

Excessive spalling can lead to overall reduced load capacity, and further structural issues.

Consult structural engineer for remediation options sooner than later.

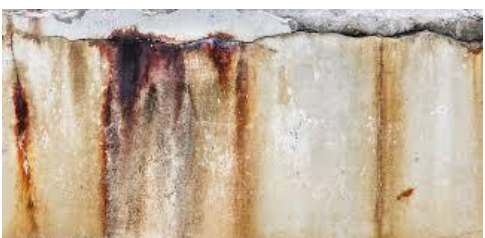
## 5. Rust Stains:

The presence of excessive reddish/brown stains along your masonry structure may indicate the permeation of water throughout the structure, resulting in the formation of rust.

Excessive water intrusion can lead to corroded steel reinforcement, reduced load capacity, and further structural issues.

Consult structural engineer for remediation options.
