NEON TRANSFORMER ELECTRIC ARCS AS VIABLE IGNITION MECHANISMS FOR WOOD STRUCTURAL MEMBERS

RESTAURANT FIRE INVOLVING NEON TRANSFORMERS

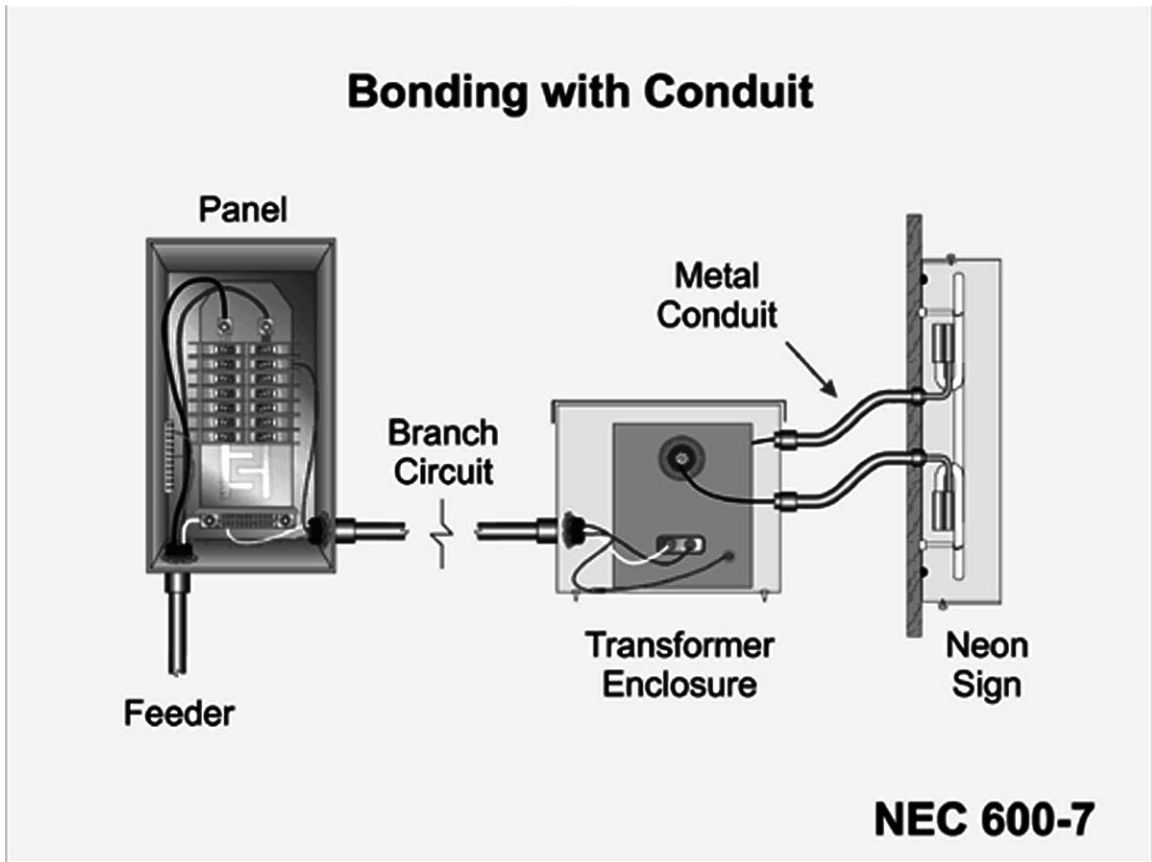
Figure 4 - Typical neon transformer connections

Neon transformers produce high voltages that are necessary to cause gases, such as neon and argon, to give off visible light that can be used for signs and for outline lighting on portions of buildings. They are widely used for signs that identify businesses. The typical application has neon tubes that are formed into letters or object shapes, some of which are contained inside block channel letters. The latter commonly have colored lenses that cover the external surface of the letters and provide for the creation of letters with a multitude of colors. The length of neon tubing a neon transformer can adequately power depends on the diameter of tube and the type of gas used in the tubing. Tables are provided by neon transformer manufacturers that can be used as a guide in evaluating a given installation. They also provide guidelines on how best to arrange a sign layout with respect to the transformer for optimum operation. The guidelines point out that the neon tube load on the transformer should be balanced, and that there is a need to limit flexible metallic conduit to no more than 20 feet total and flexible non-metallic conduit to 100 feet in the secondary circuit of a sign installation. The conduit is normally connected to facility ground (via the wire with green insulation or bare wire). Figure 4 shows a typical neon transformer installation.

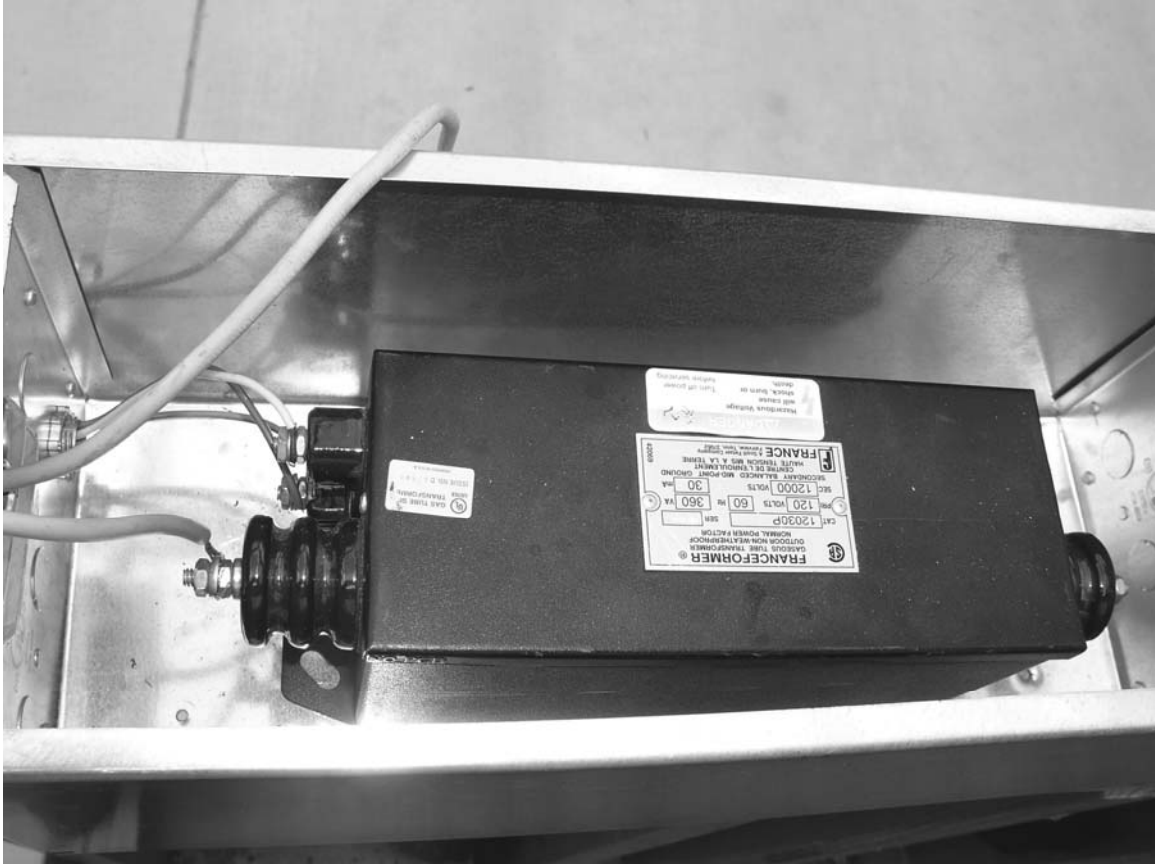
Figure 6 - Non-self contained neon transformer in metal box

The primary 120 volt input to the transformers is boosted to output voltages that range from 3,000 to 15,000 volts. The output current from the transformers are magnetic shunt limited and normally limited to output currents of 30 or 60 milliamperes. This current limiting of the secondary circuit makes it possible to have a sustained short of the secondary circuit for an extended period of time without damage or tripping a primary circuit breaker for transformer models that do not have secondary ground current interruption protection. These transformer configurations, referred to as secondary ground center tap neon transformers, come in both self contained and the non-self contained models. The non-self contained model requires the transformer to be mounted inside a metal box (see Figure 6).
