# **A Case Study: Reconstruction of a Power Line Wire Strike Event**

## Reconstruction of a Power Line Wire Strike Event

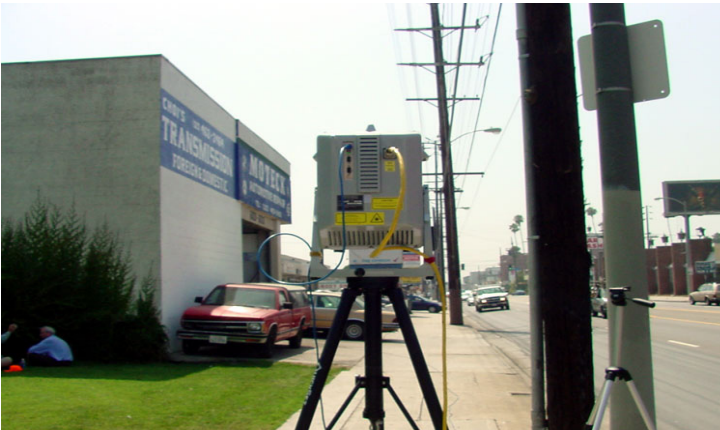
The accident scene itself

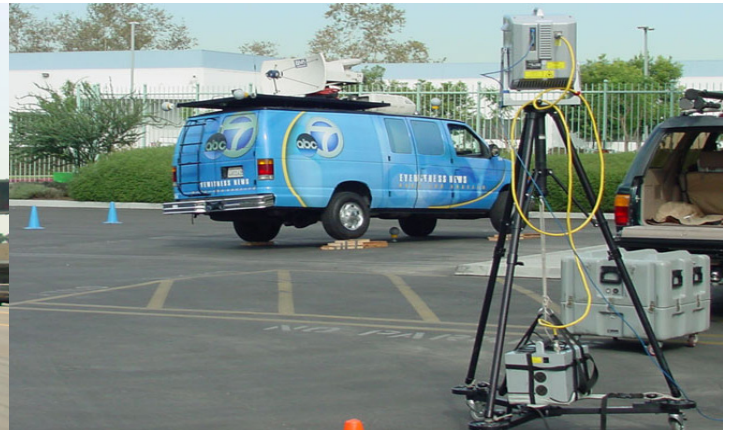
The actual news van used in the event.  
The van was stored near the event but could not be brought to the scene

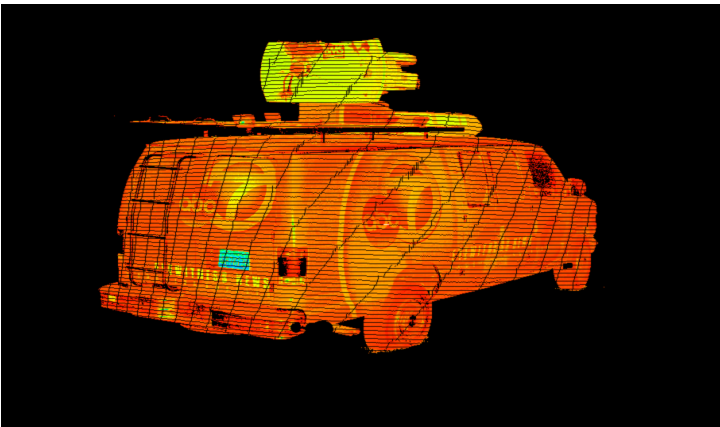
As the actual van was irreparably damaged, an exemplar was used for portions of the analysis. This exemplar needed to be proven to be an exact replica of the actual van.

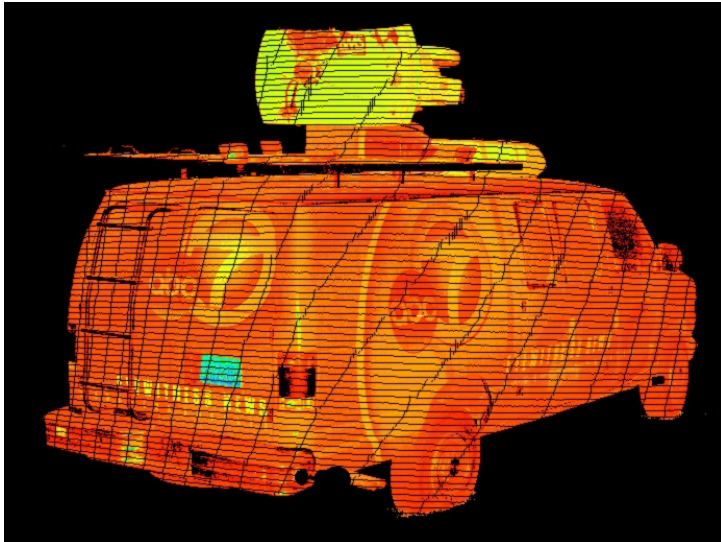
*Laser Scan of Van*

This vehicle was laser scanned for dimensions of the vehicle itself, as the telescoping antenna boom was no longer operational and could not be raised to scan it in its extended position.
