PORTAL LANDSLIDE ANALYSIS OF THE NEW HAIBAT SULTAN TUNNELS IN KOYA, KURDISTAN REGION, IRAQ

ABSTRACT: The road connecting Koya town to Dukan town is the primary conveyance for vehicles between these two municipalities. Numerous rock falls or slope failures occur annually along various segments of this road on Haibat Sultan Mountain. These slope failures can potentially, kill passengers and block the road for several days and sometimes weeks. In order to mitigate this problem, the Ministry of Construction & Architecture has enacted to build a double tube tunnel, referred to here as New Haibat Sultan Mountain Tunnel. This tunnel was under construction for several months, but lack of funding prevented their completion. The portals of the tunnel and approximately 60 meters of each tube were completed. Shotcrete had been applied to the area above the portals. After construction were terminated, a massive slope failure occurred above each tunnel portal. It would appear that the efforts to stabilize the slope above the tunnel were insufficient. This document proposes to investigate the area above the tunnel portals to determine the cause of the slope failure and provide recommendations.

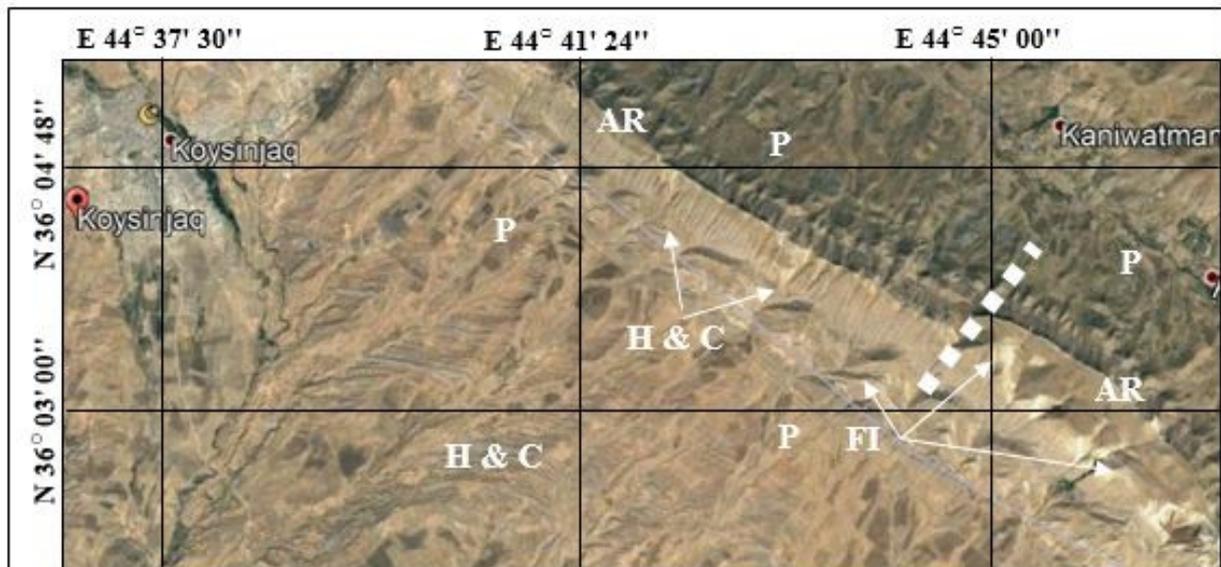
Figure 4: Satellite image of the tunnel site and surrounding. Note the flat irons (FI), anticlinal ridges (AR), hog backs and cuestas (H & C), and pediments (P). The dashed white line is the approximate location and extension of the tunnel
