## Forensic Engineering Case

### Uncontrolled Movement of an Operating Room Table

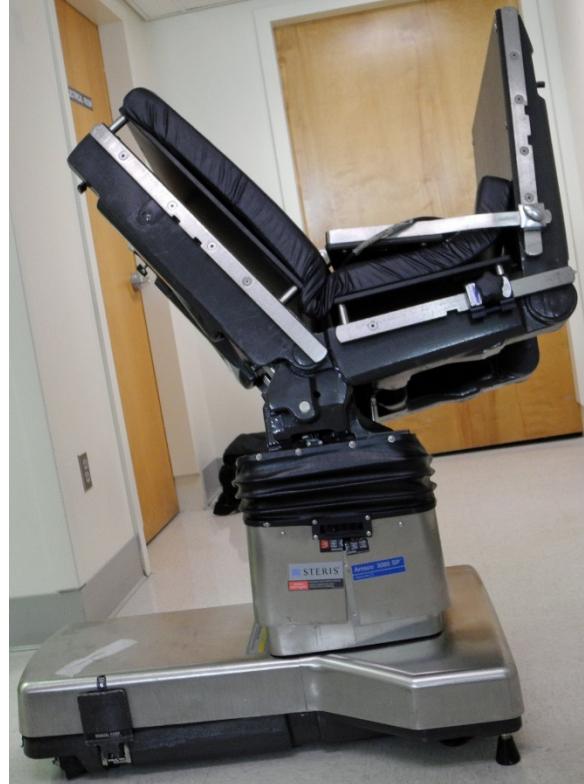
In this case, a patient was lying fully anesthetized on an OR table for a surgical procedure. Several minutes into the procedure, the table began to move without being directed by OR personnel. Efforts to stop the movement by using the standard control pendant or over-ride switches were unsuccessful. The table continued to move even after the power cord had been unplugged from the electrical receptacle. Eventually, the head and foot sections folded up to their extreme positions and the table tilted fully to one side, as shown in the adjacent photograph. The patient received severe injuries.

A detailed examination of the physical condition of the table — without touching, manipulating, or powering the table — was carried out by engineering experts associated with all parties to the lawsuit. The table was in generally good physical condition except for damage to the outermost shroud of the telescoping support column and associated damage to adjacent bank of over-ride switches.

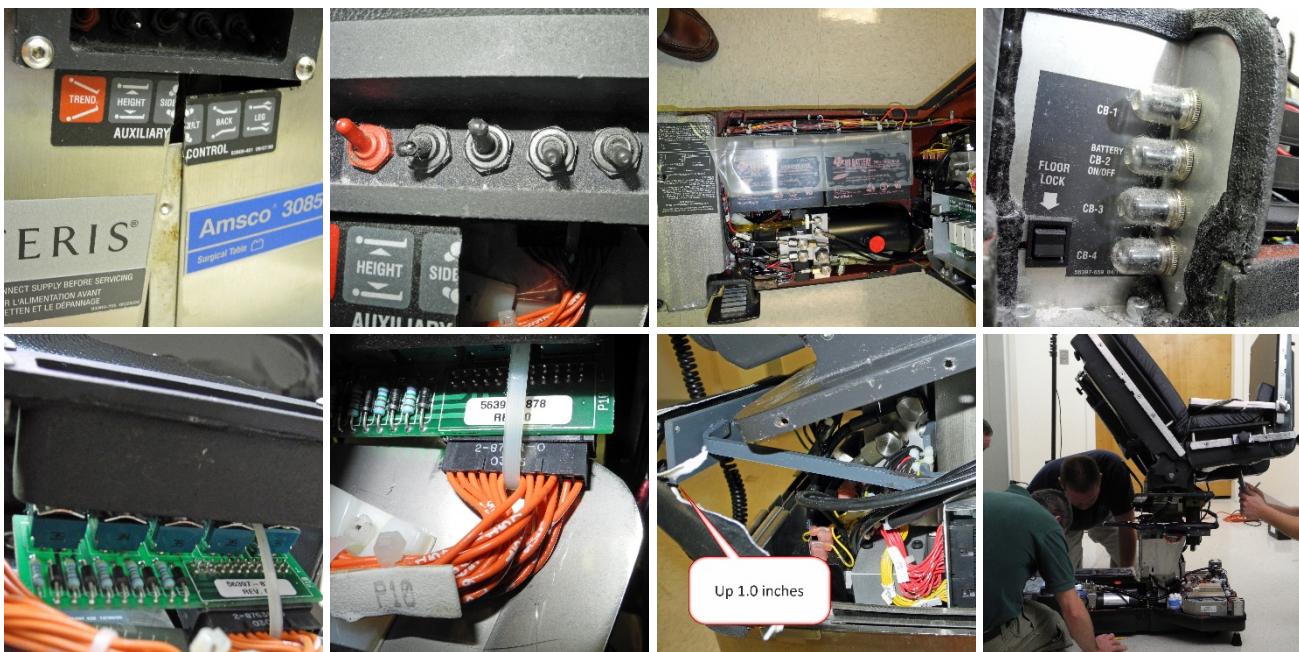
The early steps in the testing protocol were primarily disassembly of the OR table and observation of what each step revealed. Some steps involved electrical measurements and limited application of power to the table. Refer to the photo gallery below for visual details (the online version of this blog post at [baretich.com](http://baretich.com) includes larger photos and explanatory captions).

The proximate cause of the uncontrolled movement was determined to be internal damage to some of the over-ride switches. Some of the damage was apparent visually and some of it could be determined only through measurement of electrical characteristics. The damaged switches effectively caused the table to move on multiple axes toward the final observed configuration. The movement did not end until the components of the bed reached their mechanical limits.
